LEE'S SUMMIT FIRE STATION 1

FEASIBILITY STUDY

Lee's Summit, MO

May 2024

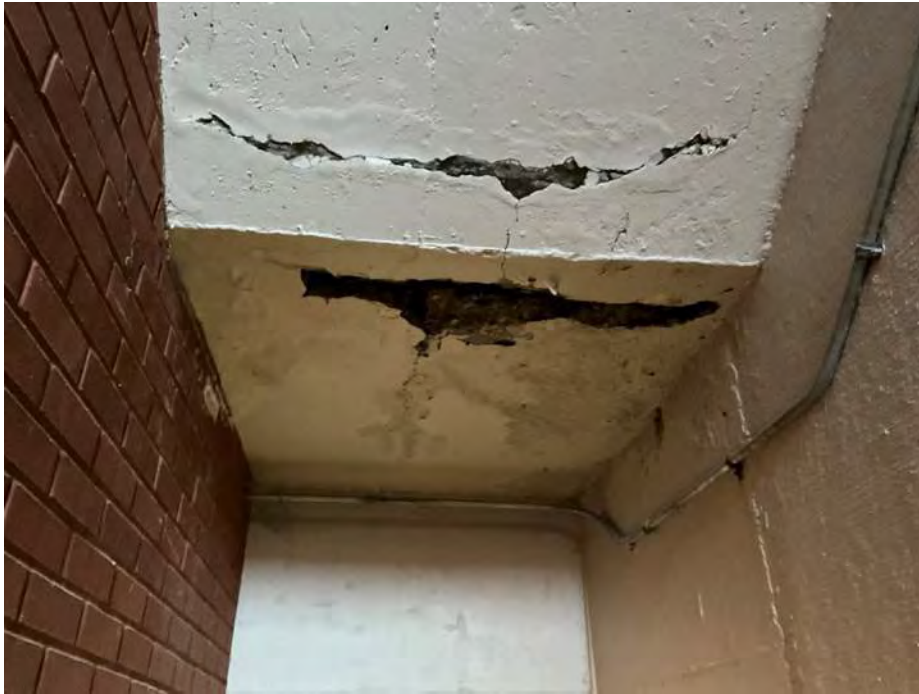
Figure 1: North exit stair concrete spall.

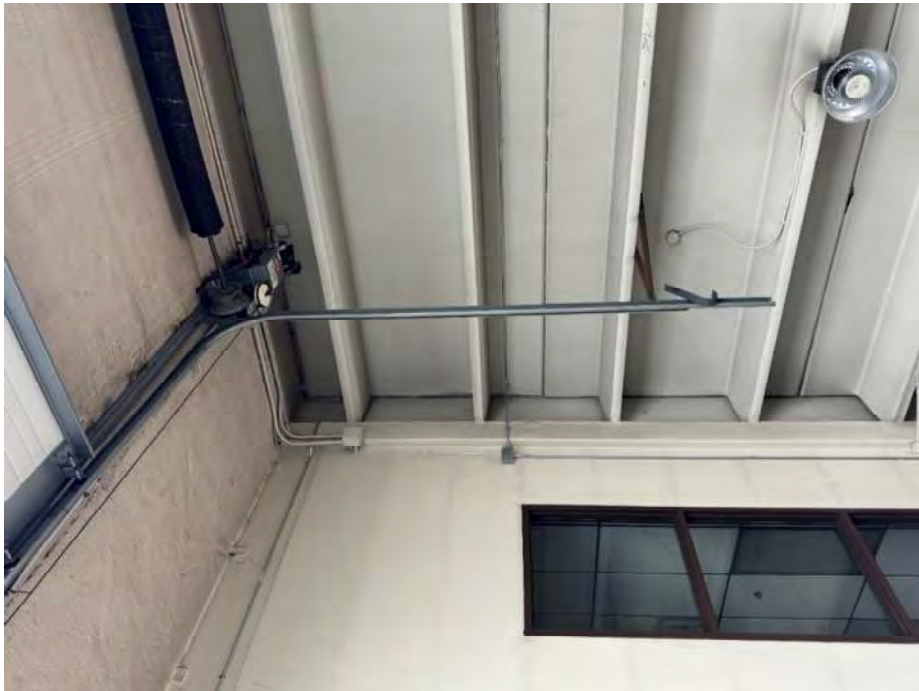
Figure 2: Precast double tee bearing on precast corbel.
