Subject: Lee's Summit Downtown Market Plaza / Ice House Assessment Summary
GLMV Project No. 18225R21006

Re: Lee's Summit Ice House Site Visit

Re: **REDEVELOPMENT STRATEGIES FOR THE L.A. HESS PACKING HOUSE/ COMMUNITY ICE COMPANY – 203 SE GREEN STREET, LEE’S SUMMIT, MISSOURI**

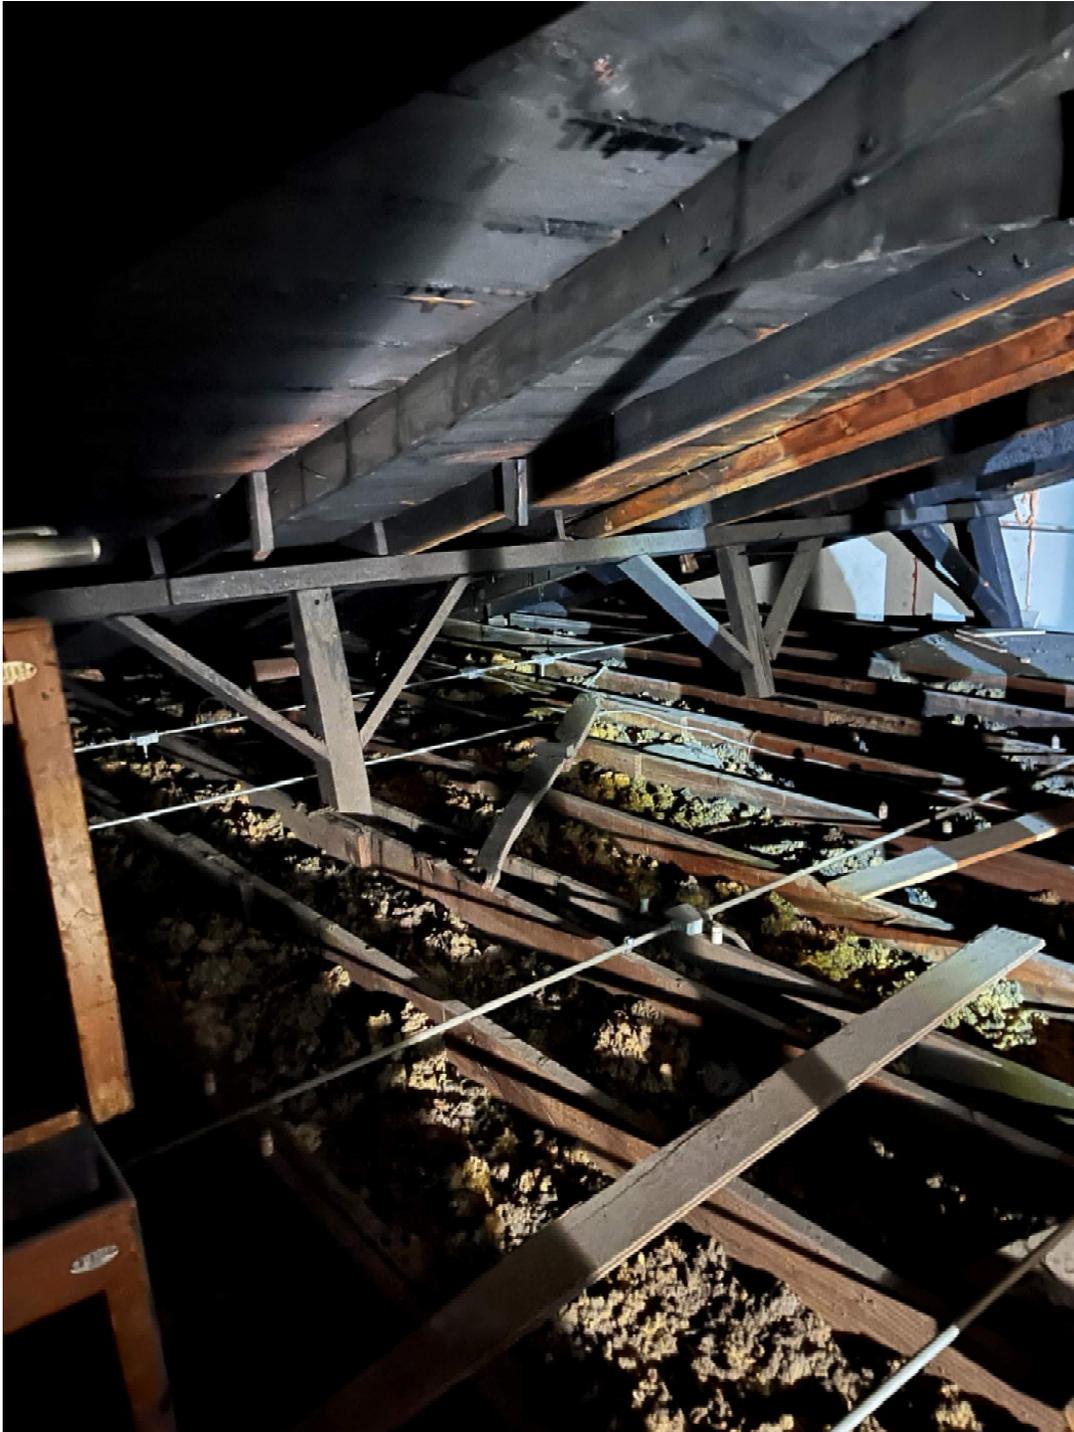
The roof structure is missing some tie rods that will need to be replaced, see *Figure 1*. There has also been fire damage to a large area of the roof. Existing rafter and ceiling joists have had new members sistered to the existing members in locations. The reasoning for the new members was not determined other than possible damage but not all damaged members were

Figure 1. Roof rafter system with knee boards and tie rods.

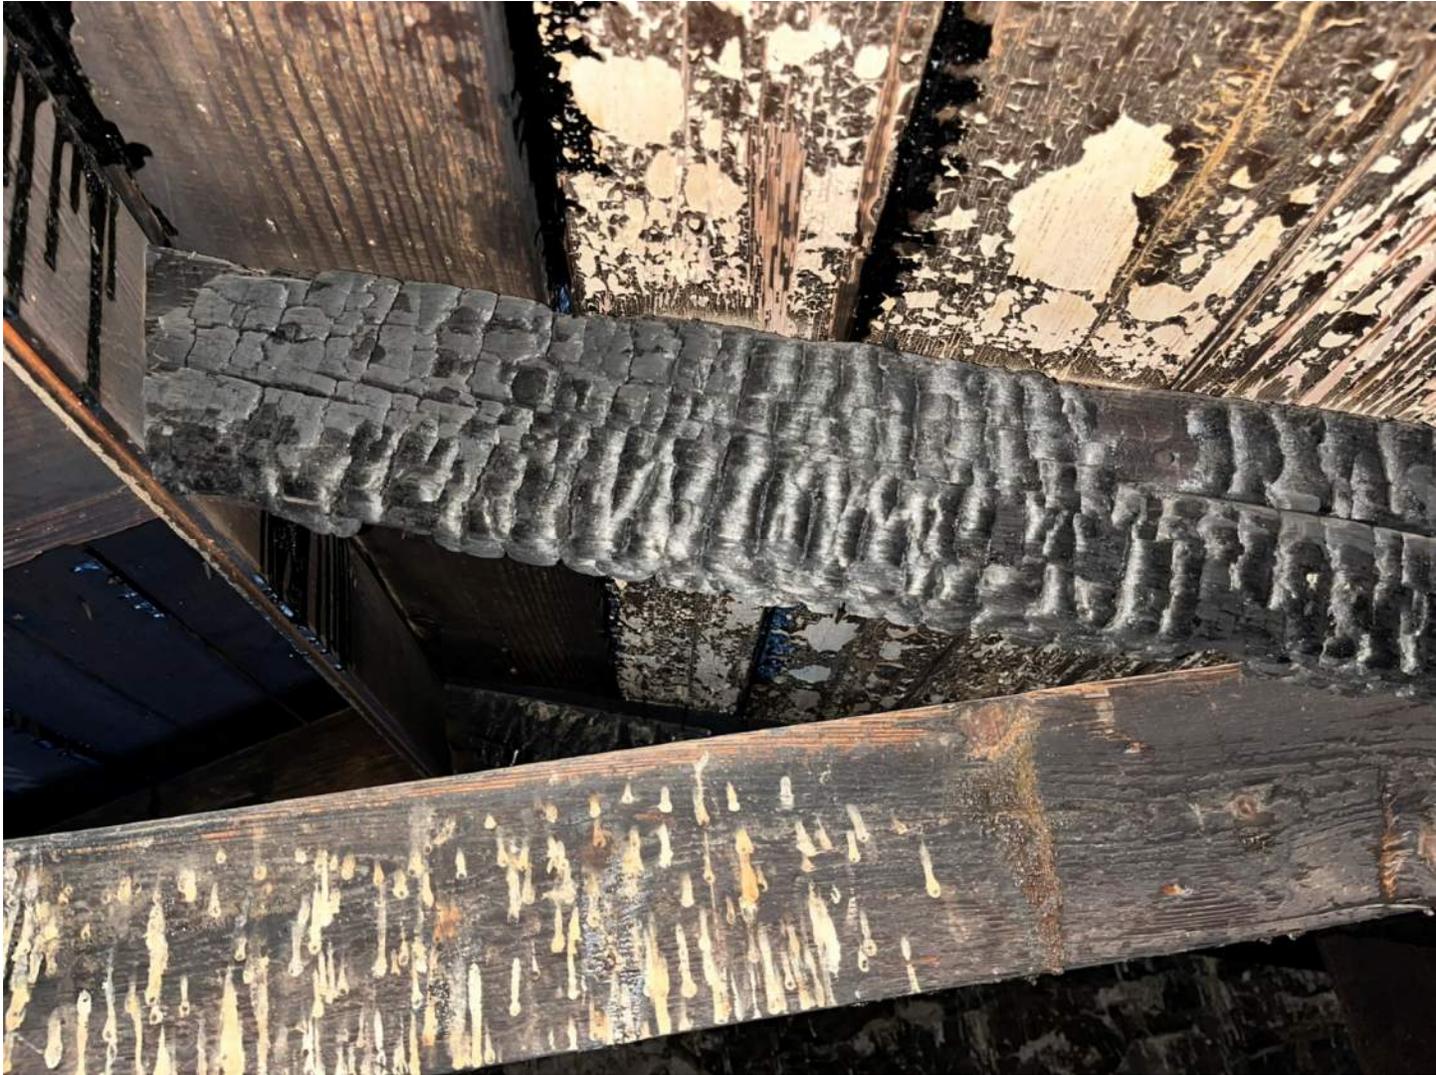
sistered. Modifications or replacements of some of the roof rafters and ceiling joists will be required, see *Figure 2*.

Figure 2. Fire damage of top chord of wood truss.

Given the age of the structure the general condition of the structural members is generally what would be anticipated. The fire damage to the roof is of concern and will require replacement and further investigation to determine the exact extent of damage and limits of replacement. The floor framing in areas appears to be under sized for an anticipated 100 psf live load for potential future occupancy needs. There are historical members that appear to be rough saw logs with bark still intact that will likely need to be replaced in order to ensure load carrying capacity. There also appears to be a floor infill where there previously existed a stair opening that looks structurally inadequate. The column line on the south of the building does not appear to follow through to the basement in the same manner as the other two adjacent column lines. The concrete columns have been replaced with timber members. These columns will need to be further investigated and determine adequate capacity and review foundations for these columns.

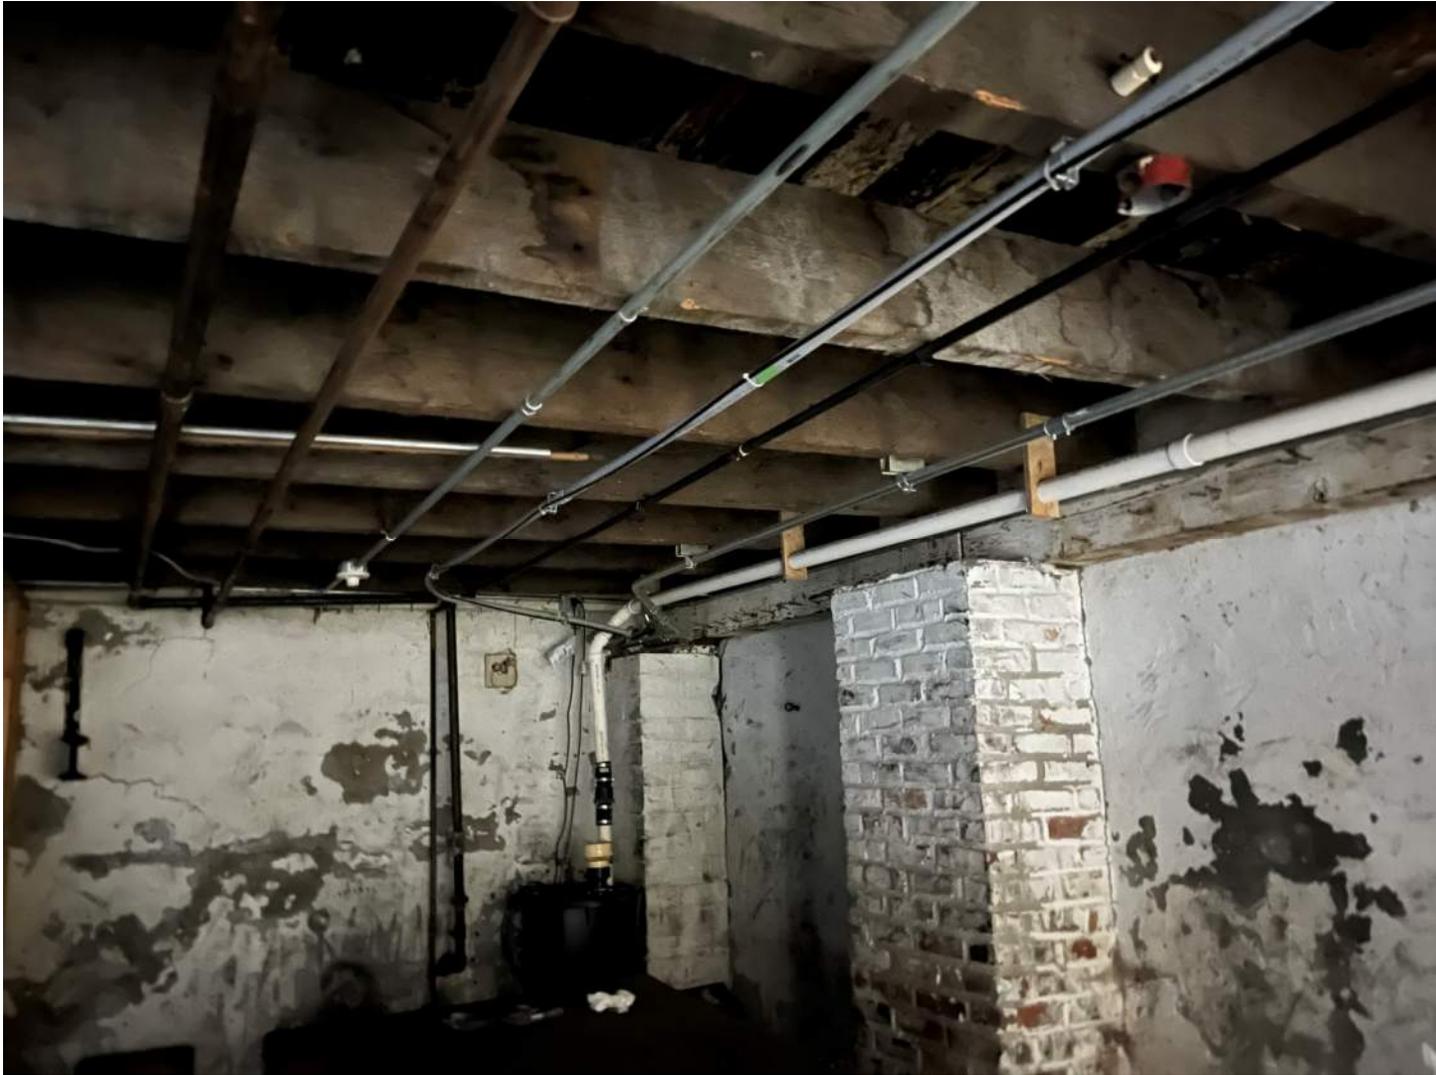
The first-floor structure will most likely require modifications as well to meet the new building occupancy requirements and current codes. Analysis of the capacity of the existing floor framing would be required to determine what occupancy live load the floor can support. See *Figures 3 and 4*.

Figure 3. Typical floor framing.

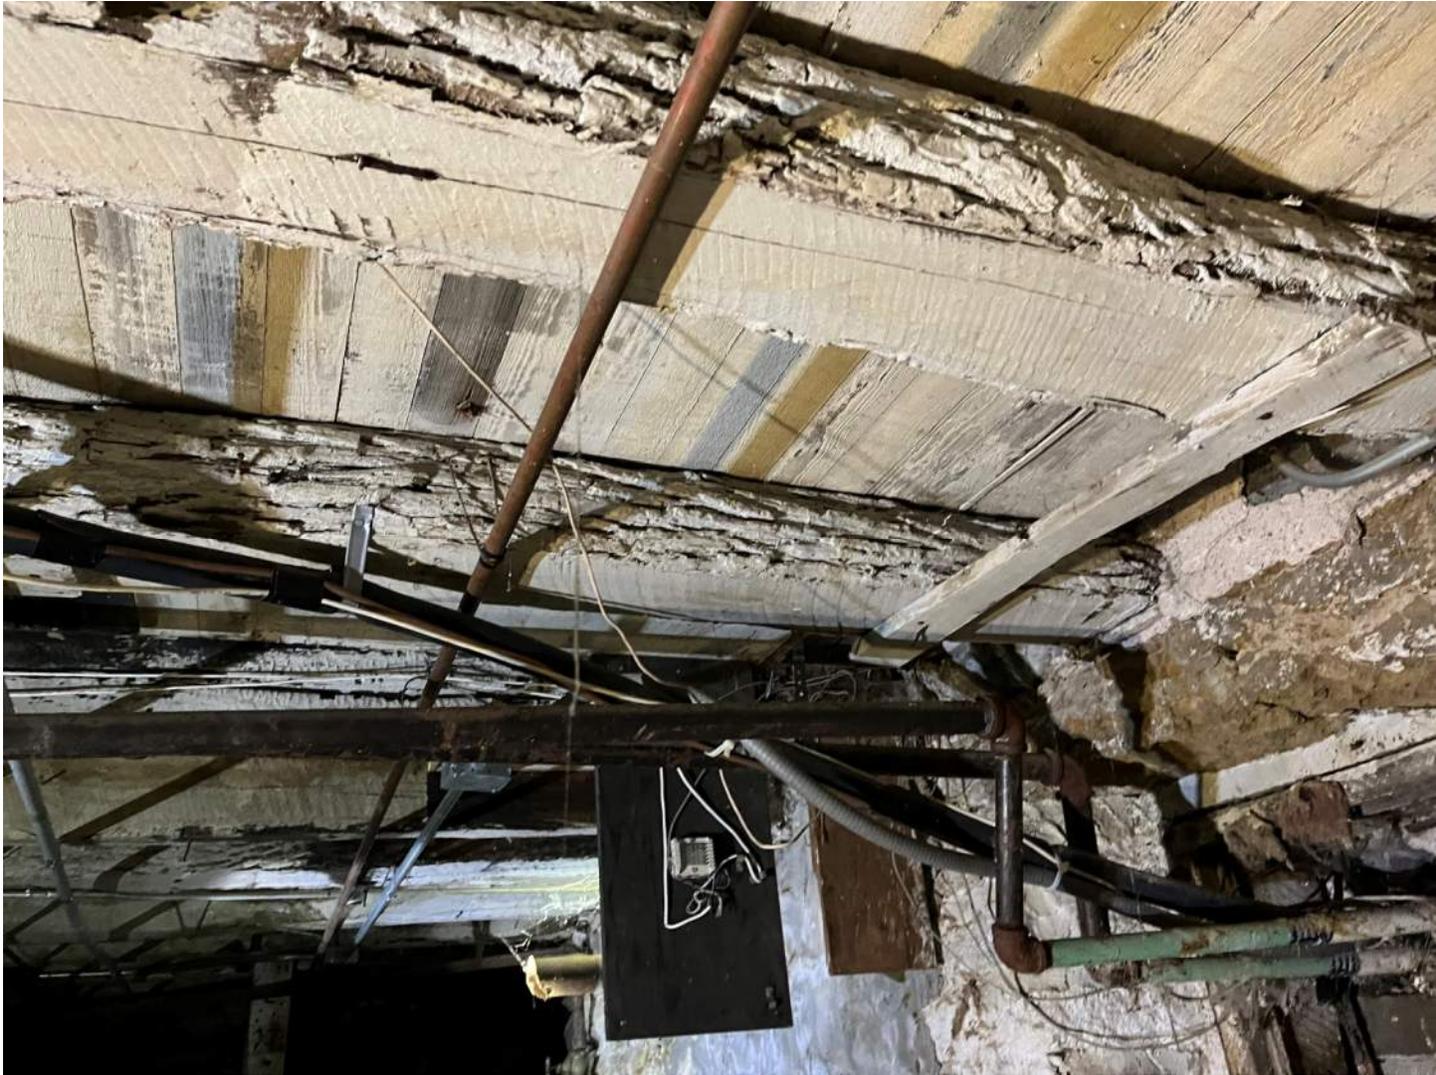
Figure 4. Rough lumber floor framing.

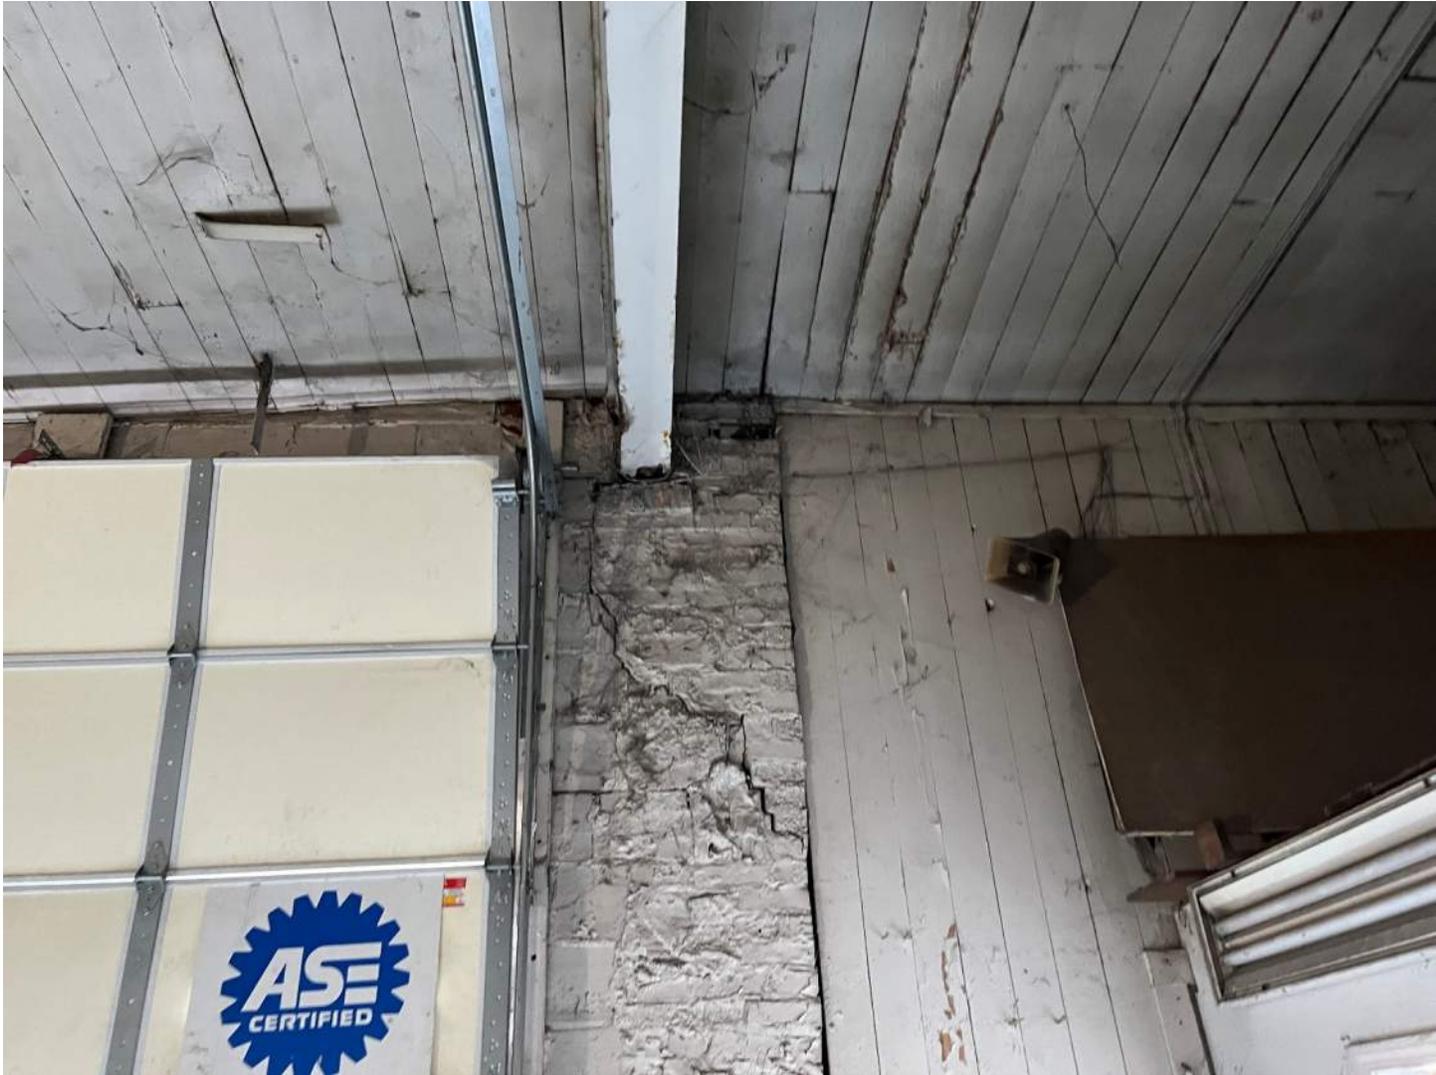
The exterior stone walls and CMU walls appear to be in fair condition. Some movement, most likely due to minor settlement is evident but does not look recent. See *Figures 5 and 6*.

Figure 5. Settlement of stone exterior wall.

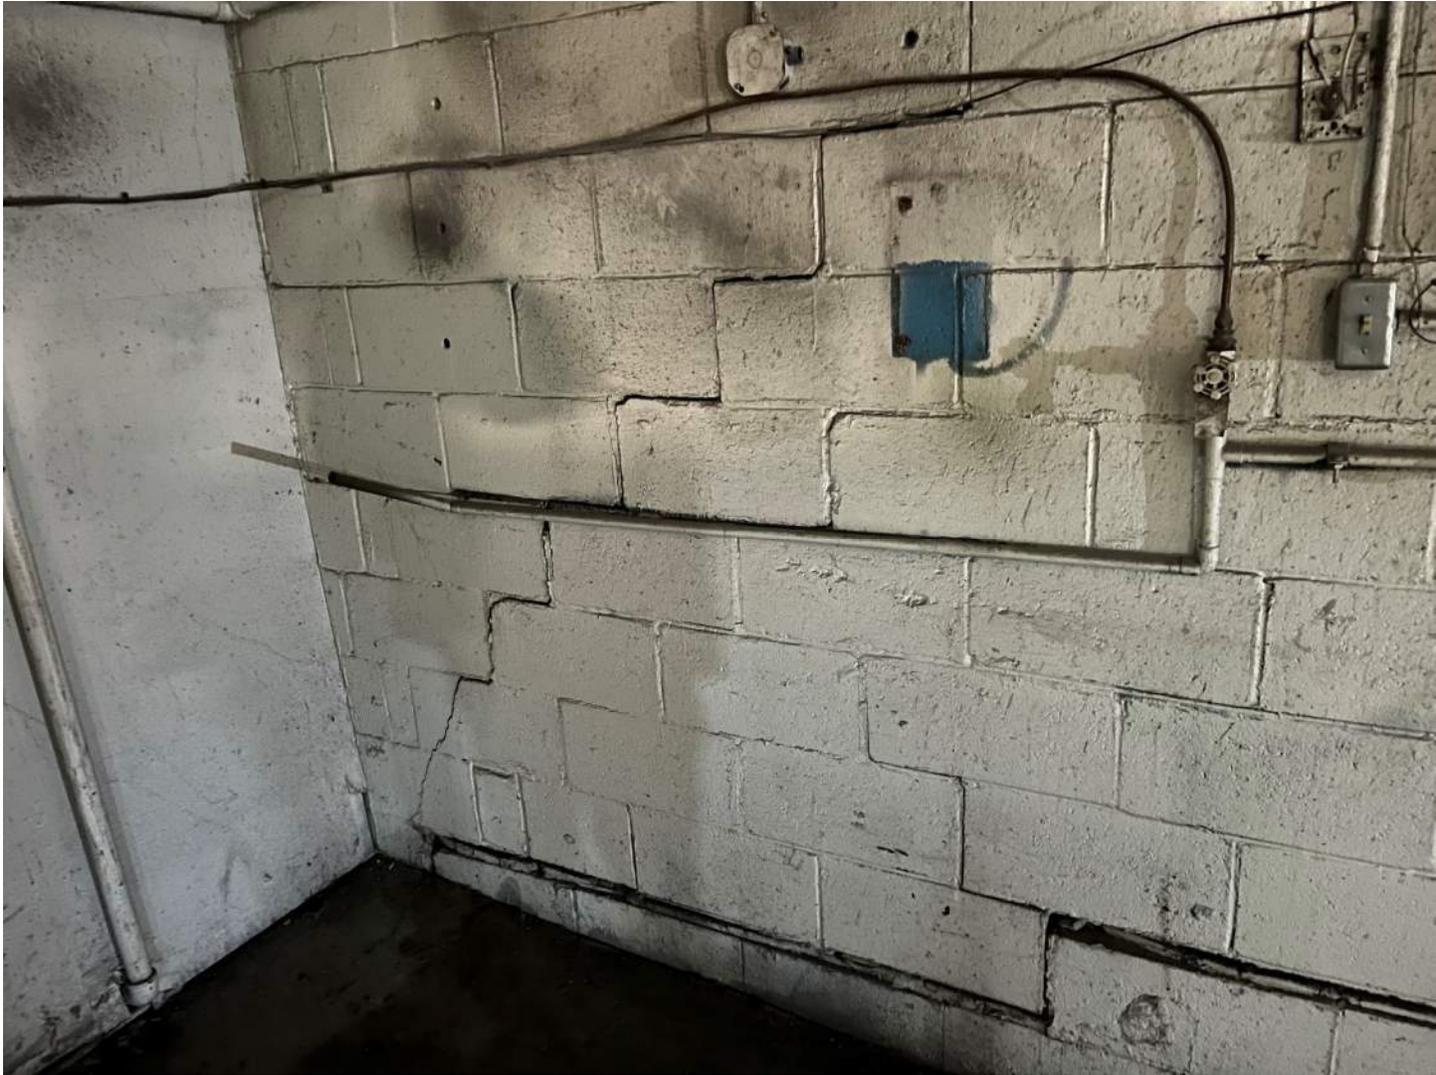
Figure 6. Settlement interior CMU wall.

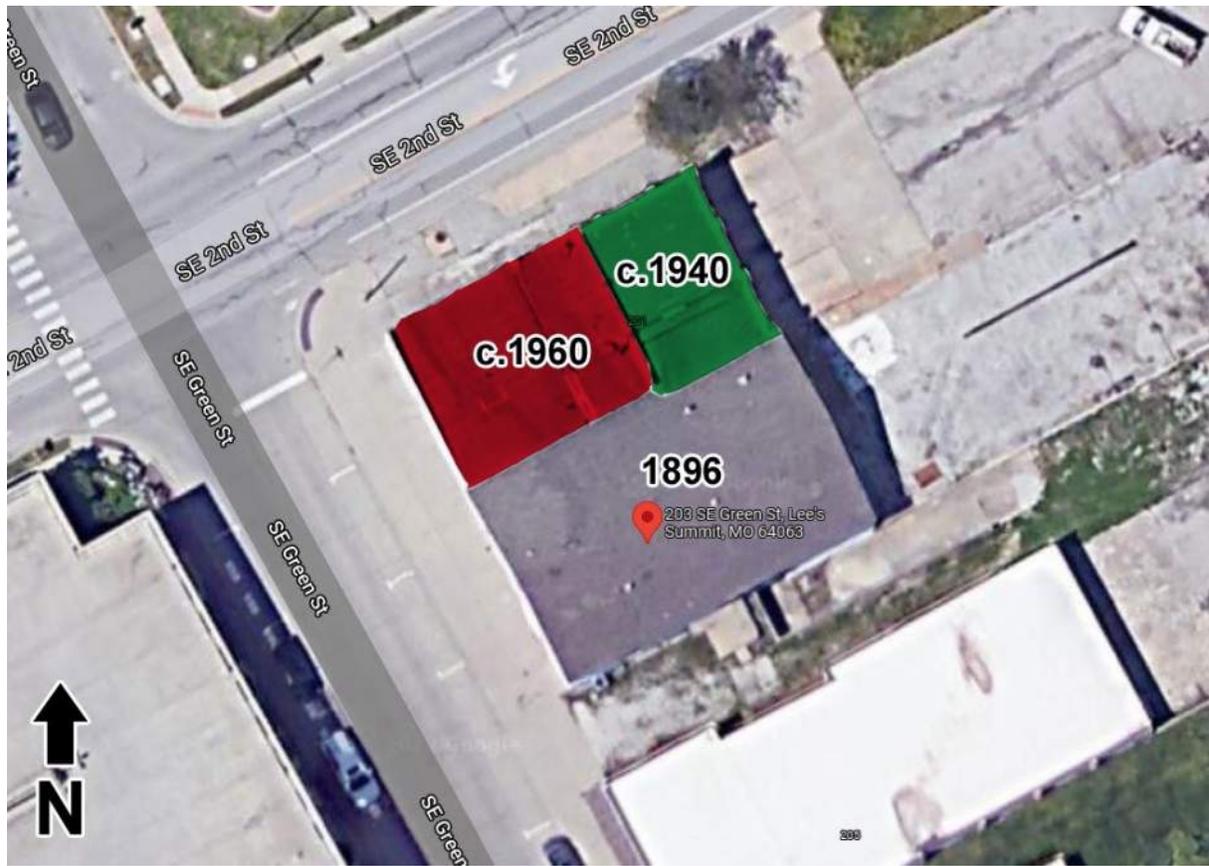
Figure 1. Annotated aerial photograph.

- If the owner were to pursue National Register listing for this building the nomination would require a defined period of significance. The most logical period of significance, based on the history of the building, would begin in 1896 with the construction of the building, and end in c.1960. It is presumed that when the Community Ice Company vacated the building, the new owner constructed the west addition (*Figure 1*). The

- The c.1940 tank room addition (north addition, *Figure 1*) would likely need to be retained. It is too integrated with 1896 building, both physically and contextually. It cannot be removed in such a way that makes the 1896 building intact due to the removal of the stone wall at the northwest corner.

- The c.1960 addition (west addition, *Figure 1*) could be removed, if it is confirmed that Community Ice Company did not construct it. If it is removed, the historic stone north wall could be exposed and restored. The brick wall of the c.1940 tank room addition could be exposed and restored.
