# LEE'S SUMMIT FIRE STATION 1

## FEASIBILITY STUDY

Lee's Summit, MO

May 2024

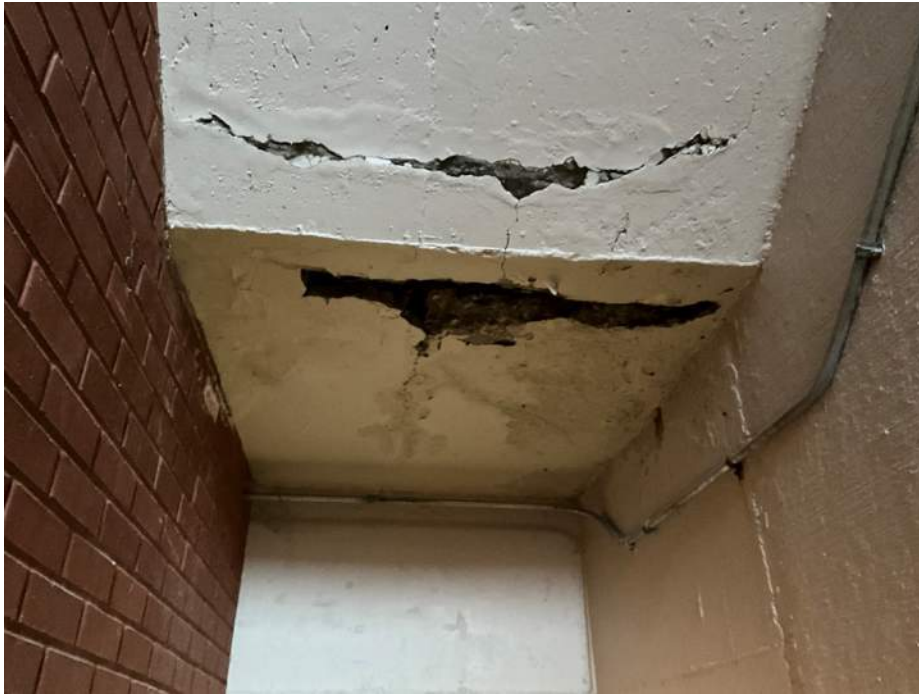
Figure 1: North exit stair concrete spall.
