TOWER INSPECTION REPORT

SITE NAME: 404 NE Woods Chapel Road

FOR: City of Lees Summit MO

DATE: 10/7/2021

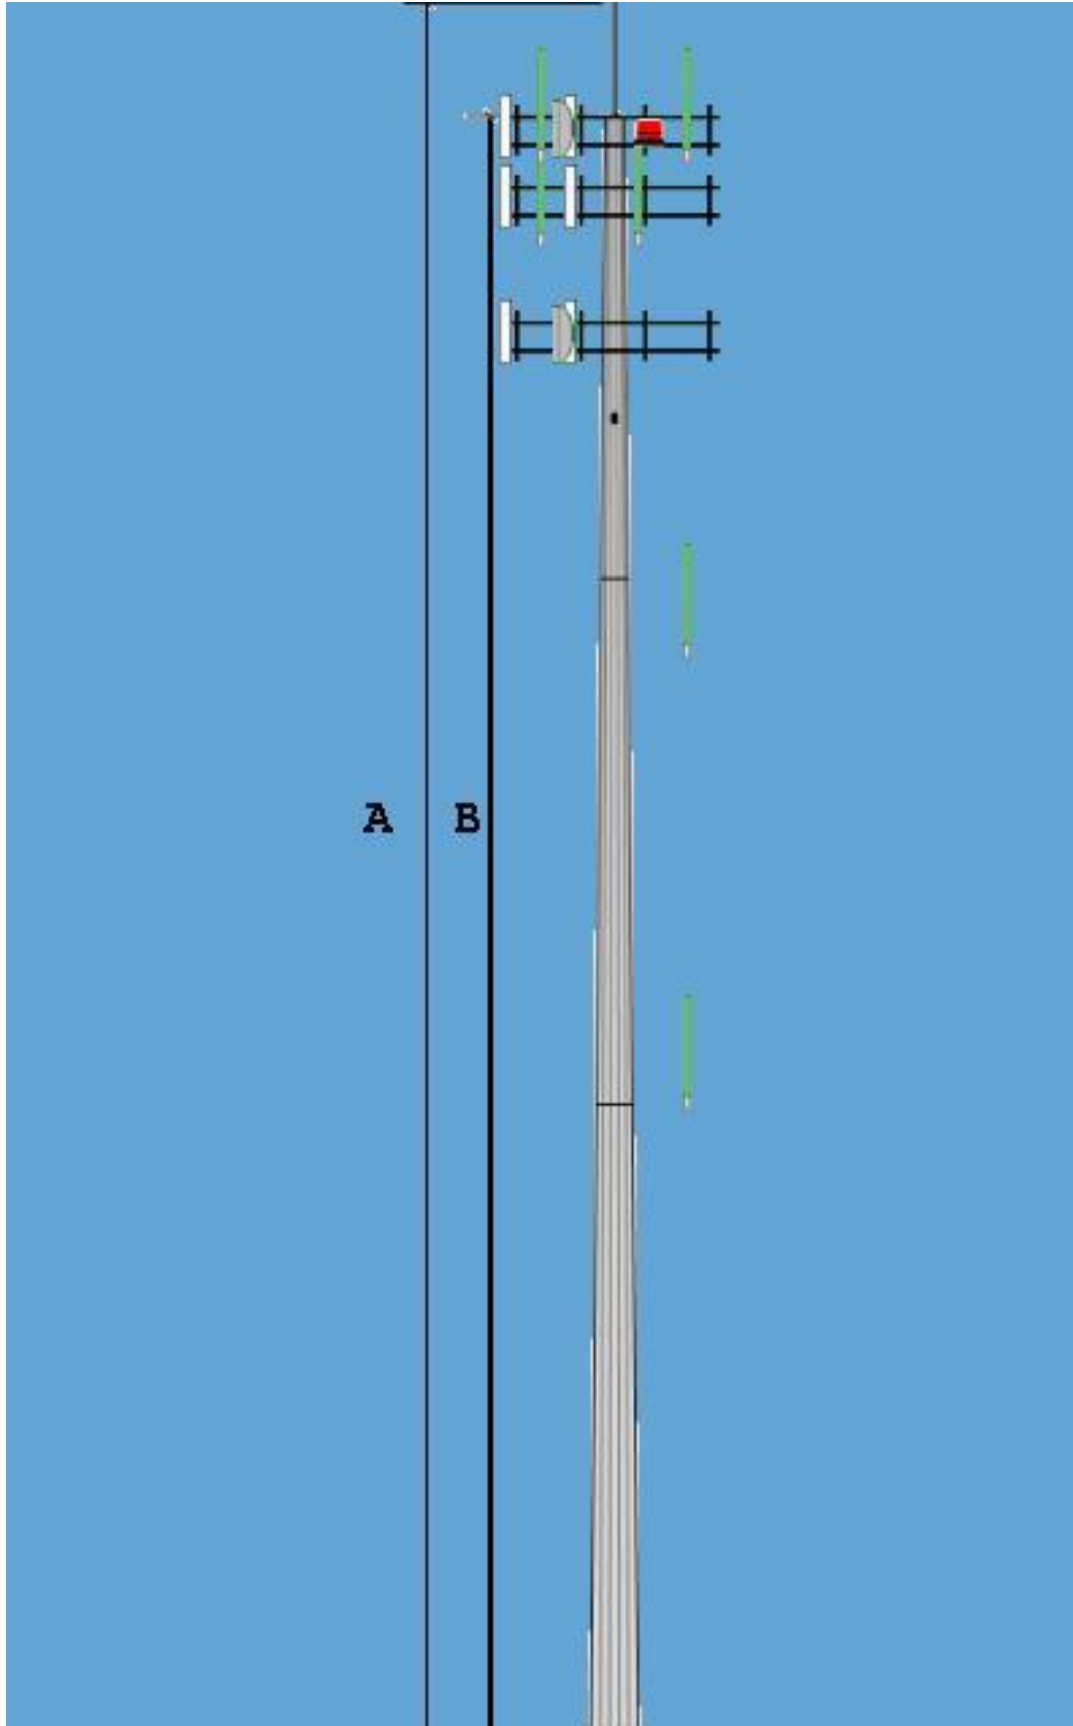
Tower Elevation

Total Height AGL (A) 130
Height of Structure (B) 120
