Before and After

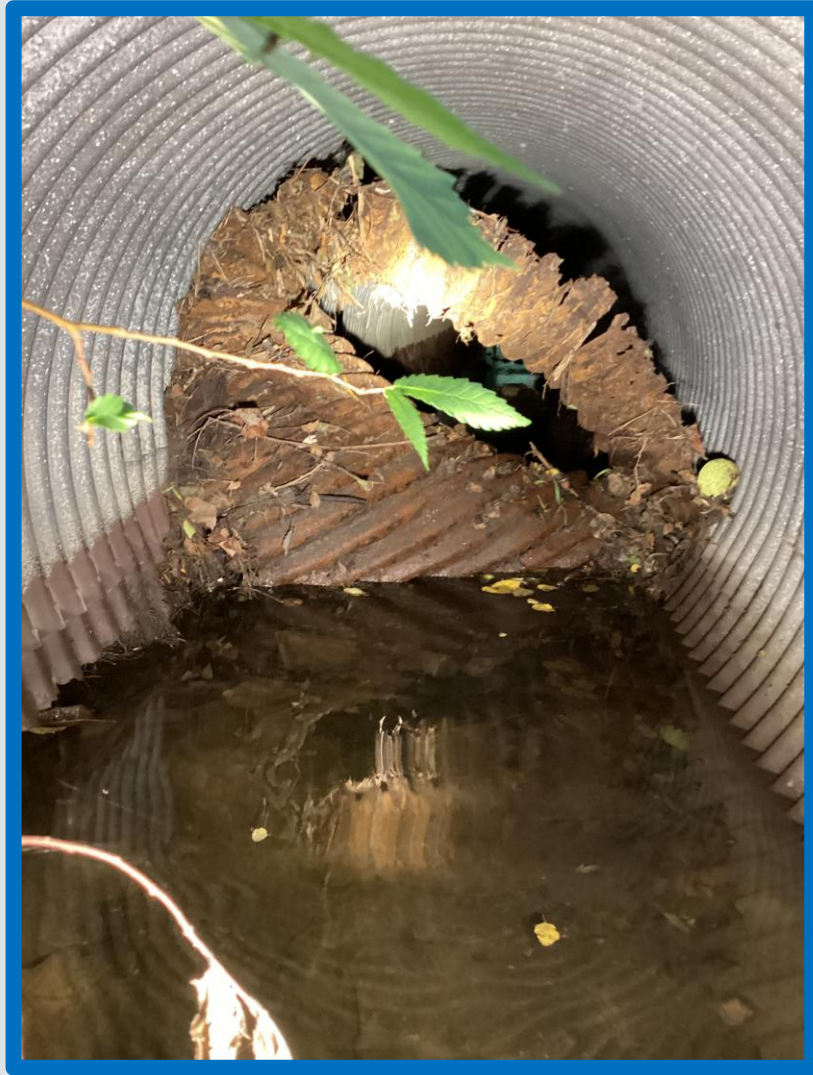
Along this run of pipe, the bottom portion was displaced and rolled up blocking much of the pipe.

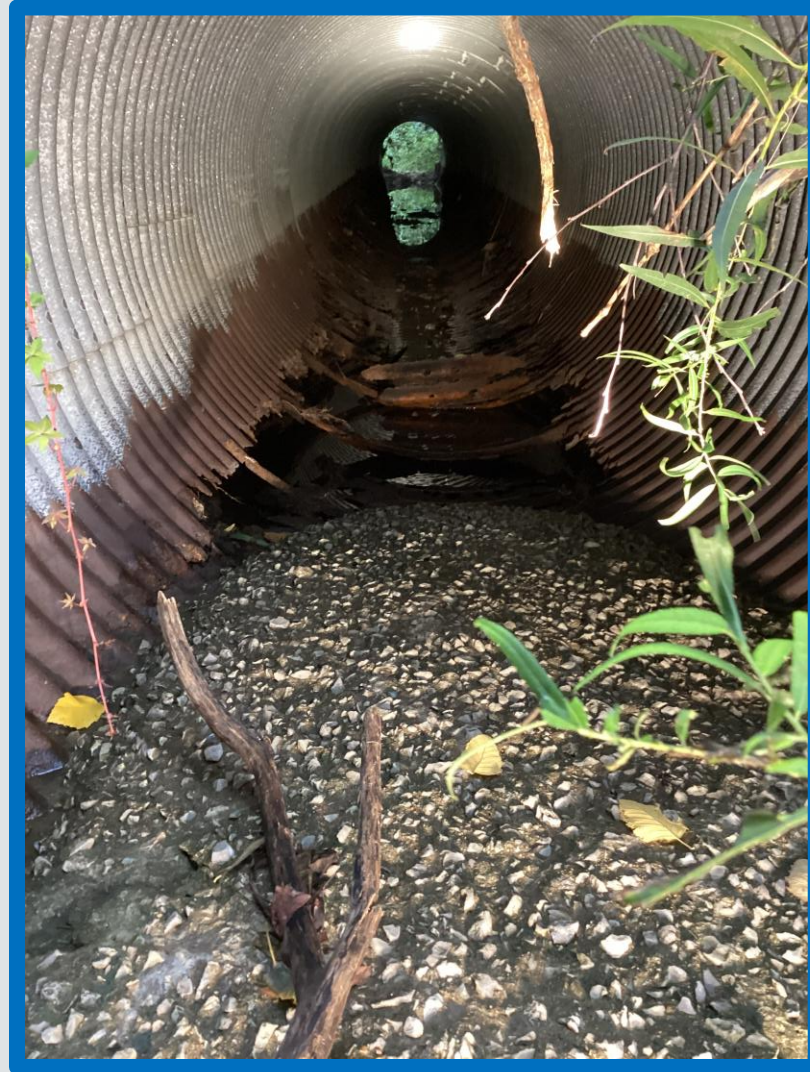
Bottom portion of pipe is completely missing.
