Re: Preliminary Waters of the U.S. Assessment
Weaver Tract
Lee's Summit, Jackson County, Missouri
Terracon Project No. 01217245

Preliminary Waters of the U.S. Assessment

**Weaver Tract
Jackson County, Missouri**

Terracon Project No. 01217245

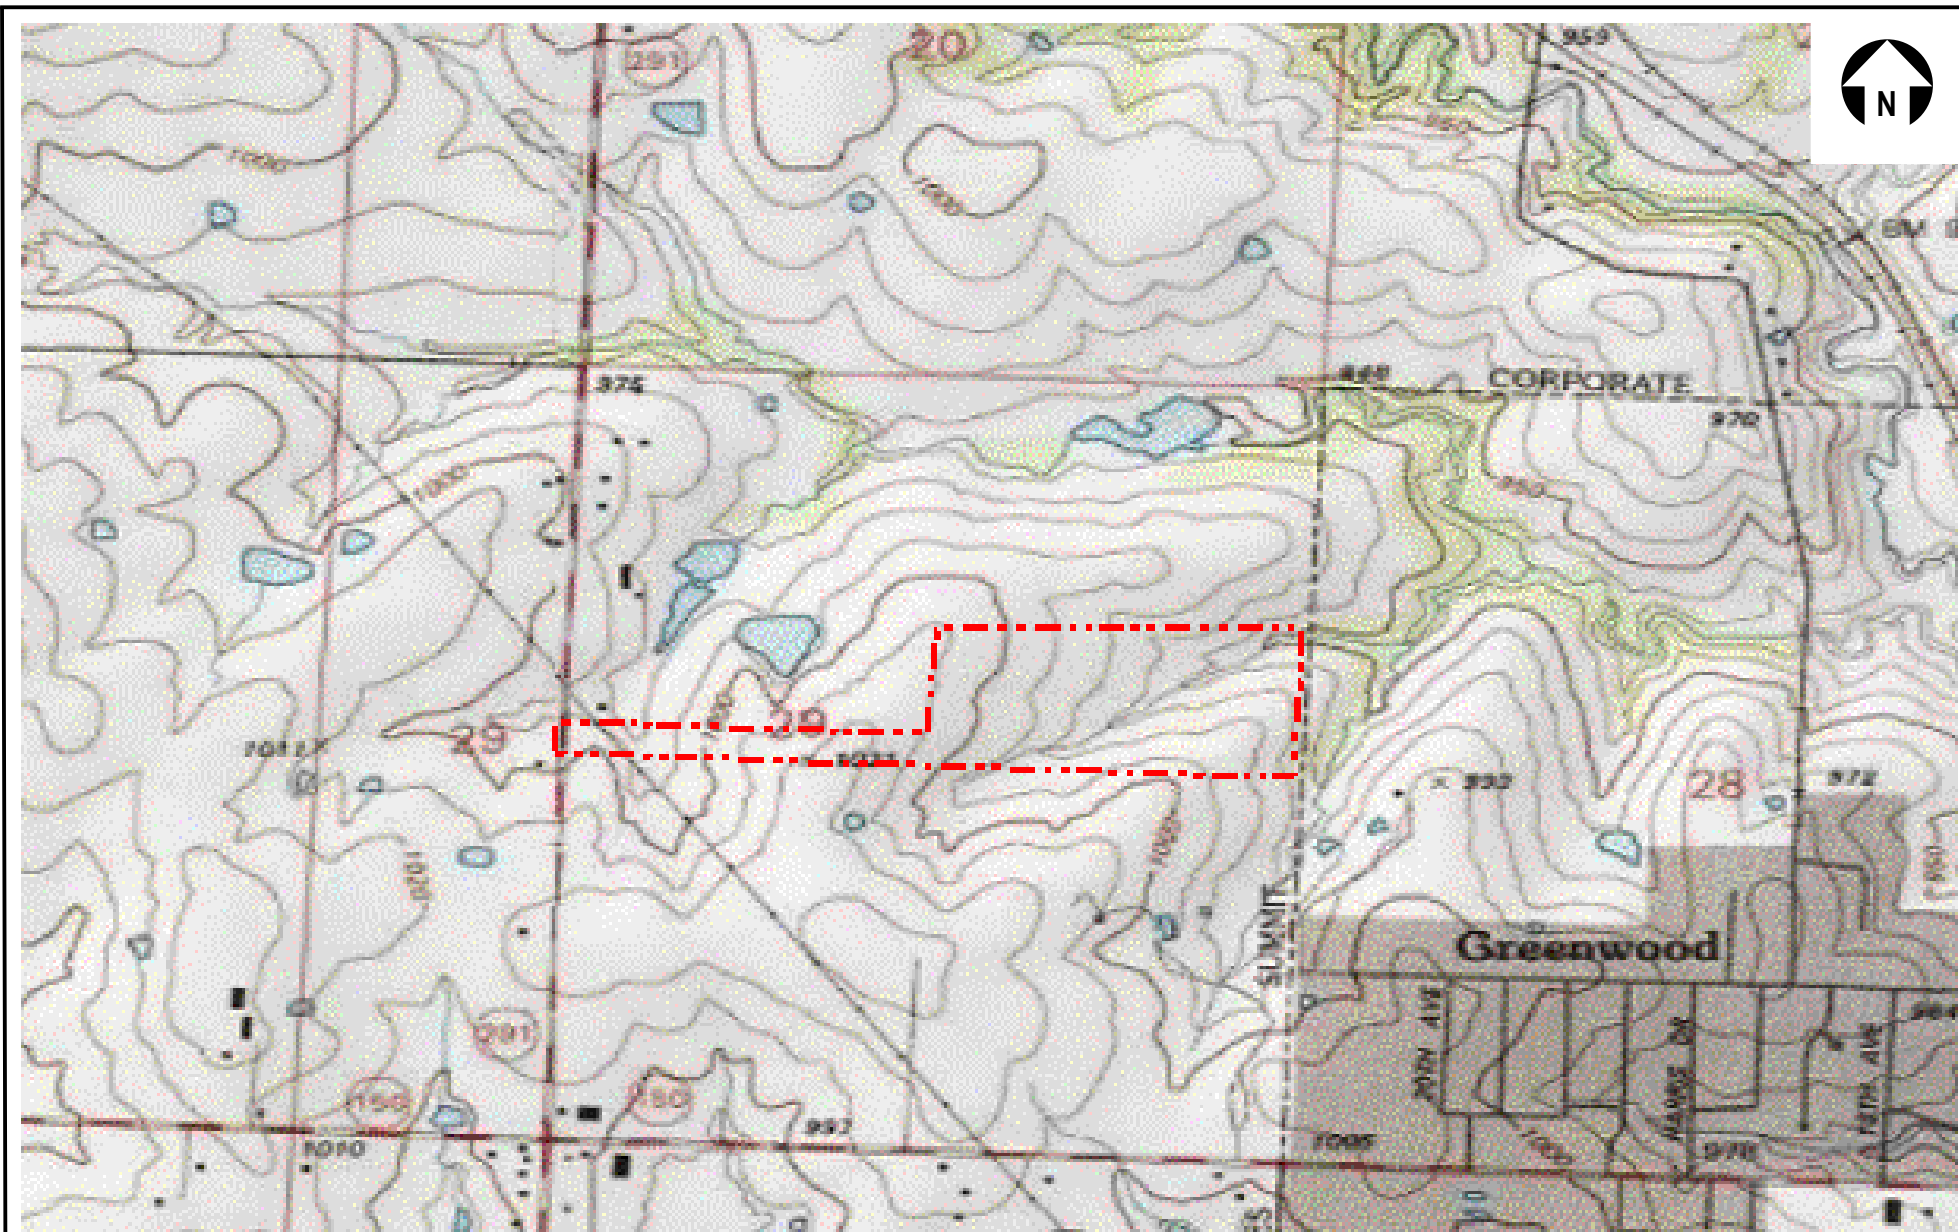
Figure:
1.0

The topographic map depicts generally undeveloped property. An intermittent blue-line stream (Drainage 1) crosses the site from the southwest portion of the site to the northeast corner. The elevation ranges across the site is from approximately 950 to 1,020 feet above mean sea level (msl). The general surface gradient on the eastern portion of the site area is to the northeast and on the western portion of the site is to the north.

Portions of the 1975 Pleasant Hill, Missouri USGS topographic map

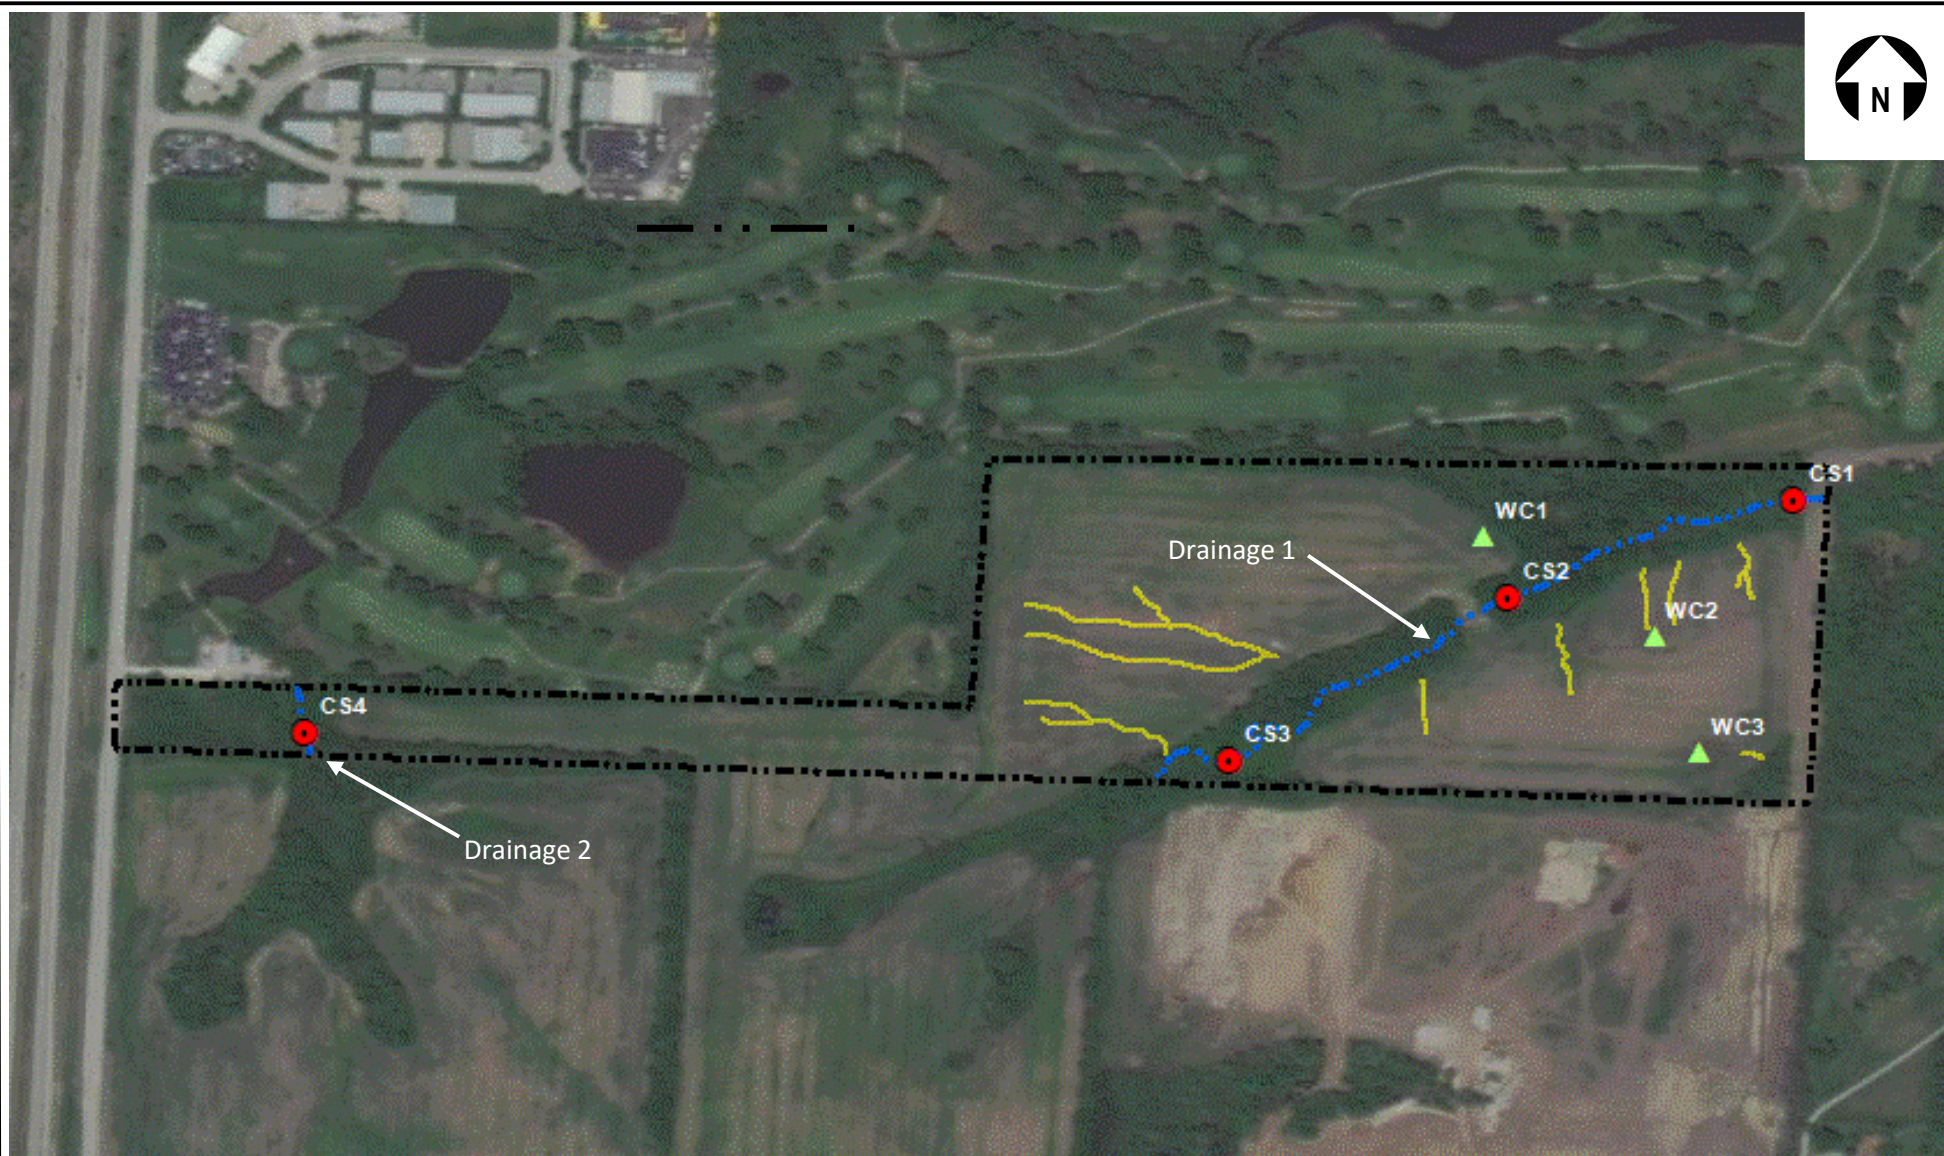
Figure:
2.0

SITE MAP WITH SAMPLE LOCATIONS
WEAVER TRACT
Jackson County, Missouri

Based on some color variations observed on some of the aerial images during the desktop review, suspect areas of potential wetlands were identified in the tilled portions of the site. At the time of the reconnaissance these areas were observed to heavily eroded and generally with apparent drainage. Casual observation did not identify wetland characteristics in these areas. Soils, vegetation and hydrology were recorded at sample plots WC1, WC2 and WC3 to confirm the absence of wetland characteristics. Hydric soils, hydrophytic vegetation or wetland hydrology were not observed at these sample locations. The sample plot locations are depicted on Figure 2.0 in Appendix A. Wetland data sheets for these sample locations are included in Appendix E.

Cross section observations were recorded at three locations on Drainage 1. Cross sections on Drainage1 included upstream location, central location and downstream location (sample locations CS1, CS2 and CS3 respectively). A single cross section location was recorded for Drainage 2 (sample location CS4). Datasheets with details of the cross-section characteristics for the four sample locations are included in Appendix F.

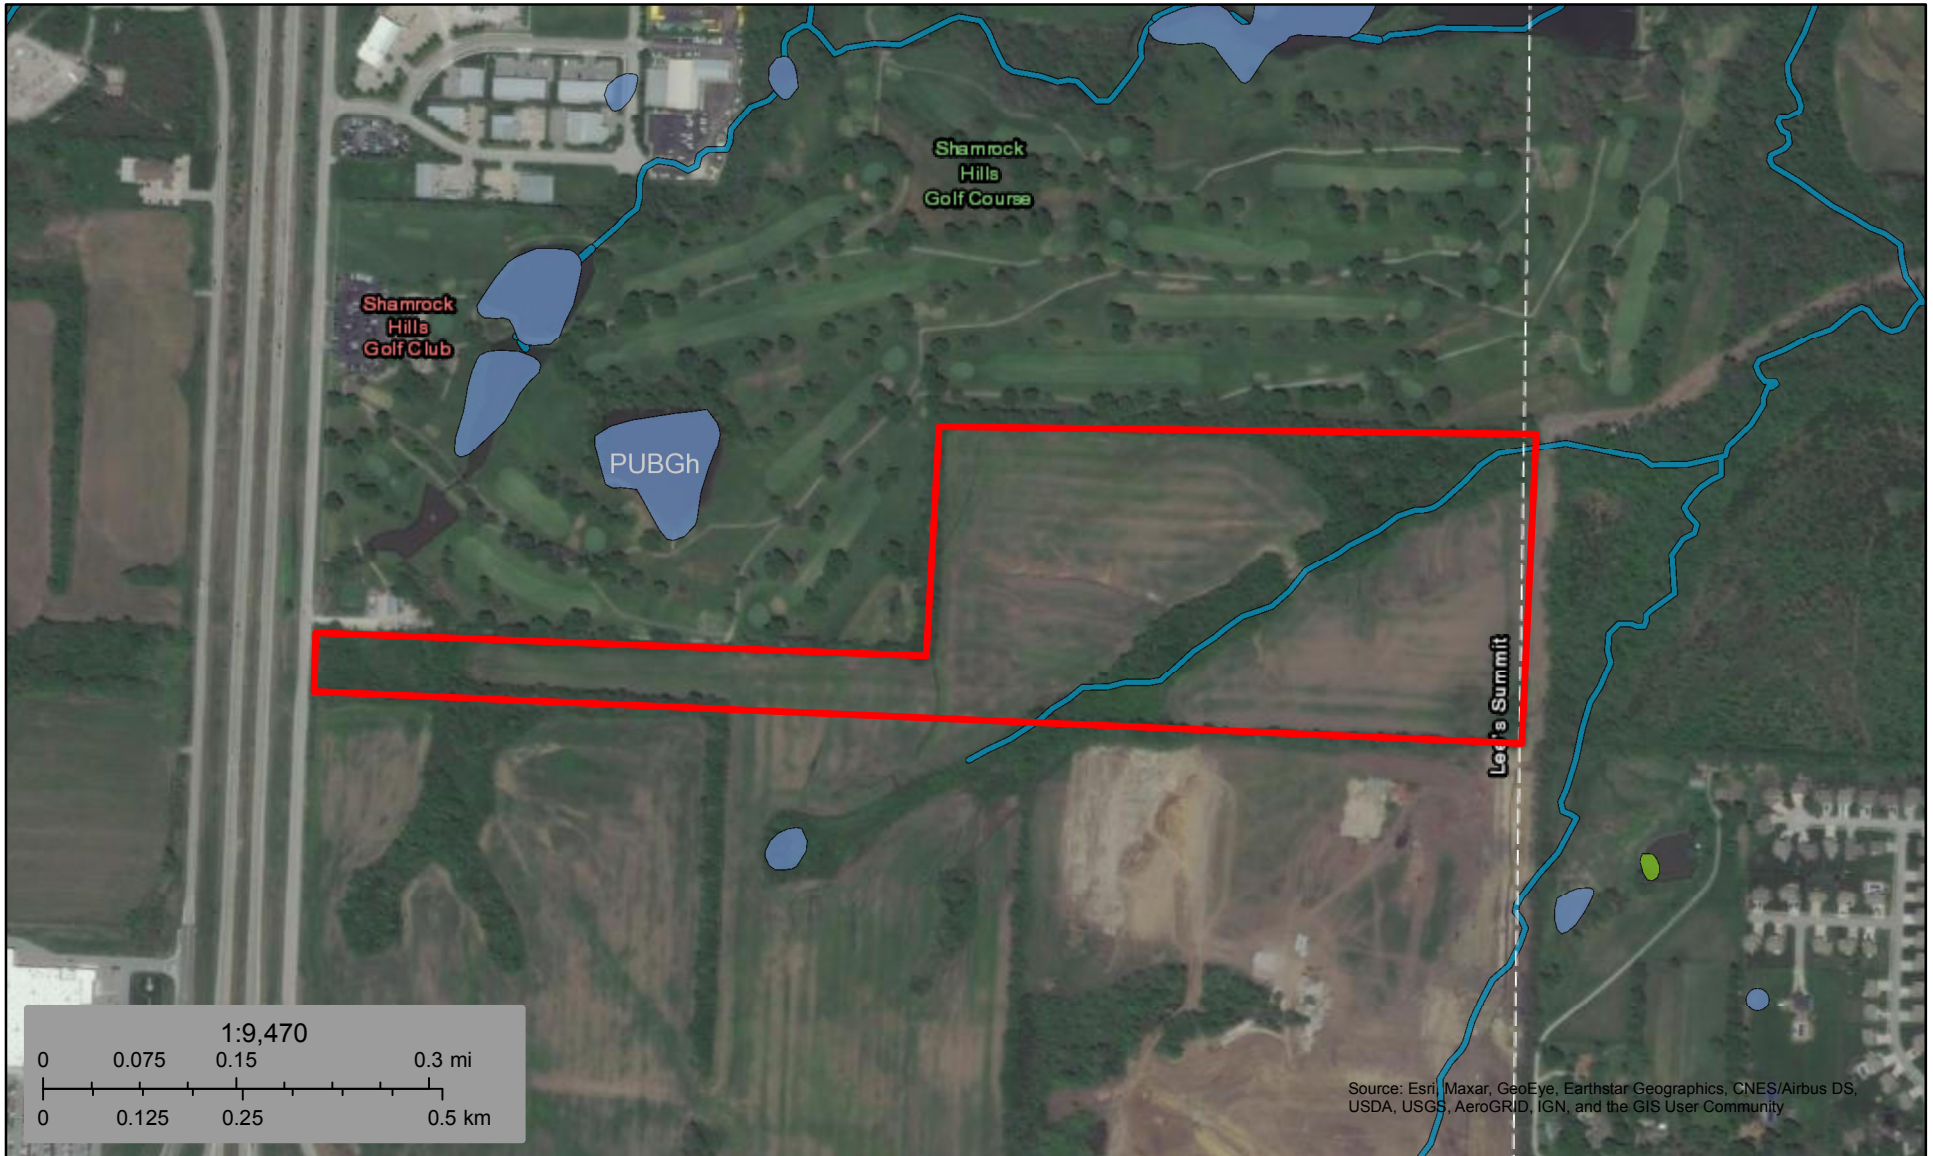
National Wetland Inventory Map

These wetland class associated with Drainage 1 appear generally consistent with the review of other historic data (topographic maps and aerial images). A copy of the NWI map downloaded from the USFWS website is included in Appendix B.

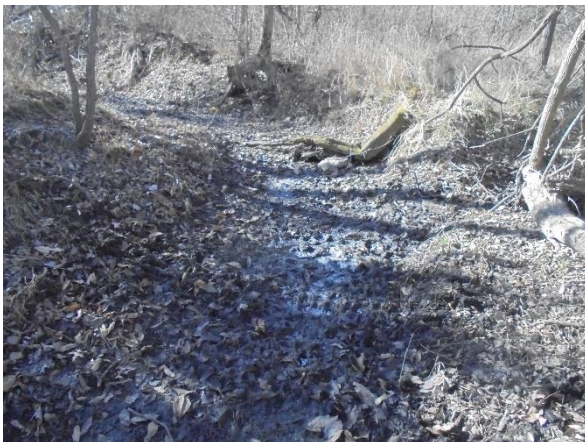
Photo #5 .View looking upstream near Cross Section CS1 on Drainage 1

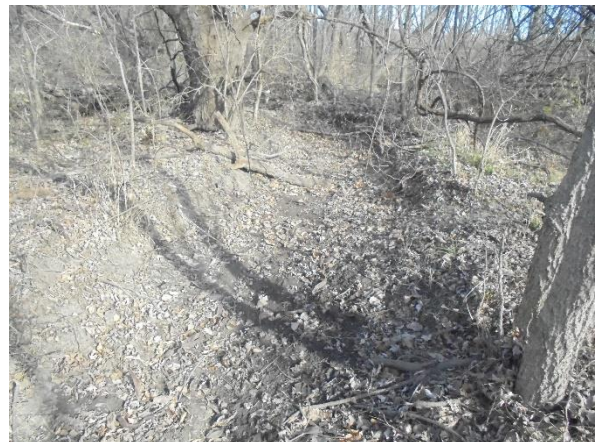
Photo #6 View looking downstream near Cross Section CS-2 on Drainage 1.

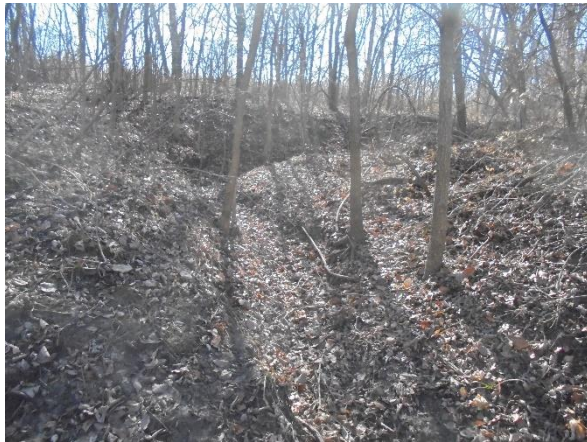
Photo #7 View looking upstream near Cross Section CS3 on Drainage 1.

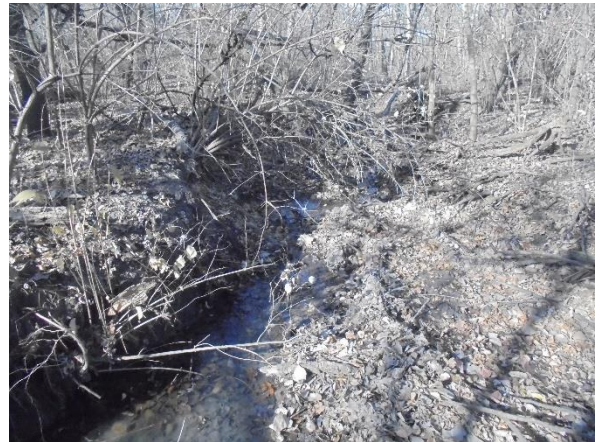
Photo #8 View looking downstream near Cross Section CS4 on Drainage 2.

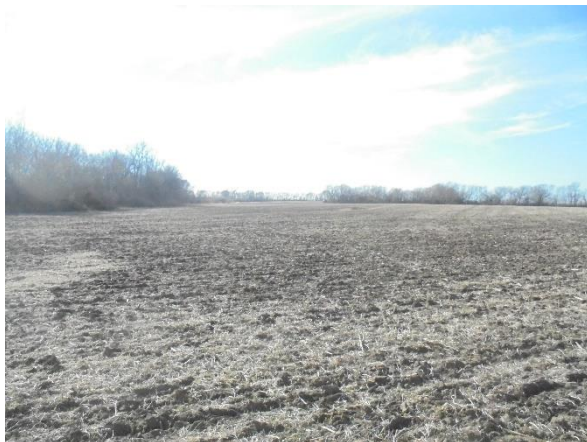
Photo #9 View looking at area where Sample Plot WC1 was collected.

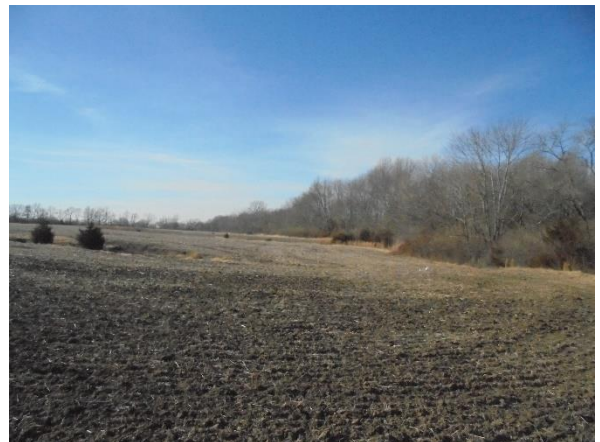
Photo #10 View looking across area where Sample Plot WC1 was collected (near erosion with cedars in back ground).

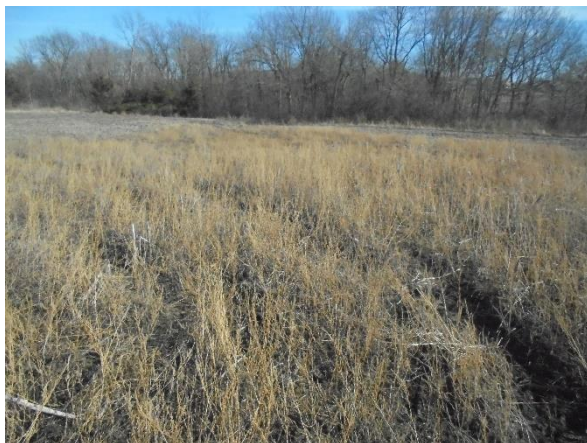
Photo #11 View looking at area where Sample Plot WC3 was collected.

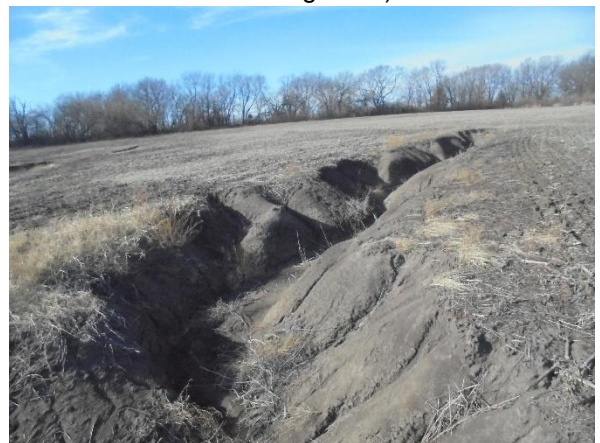
The site property consisted of tilled cropland on most of the acres. At the time of the reconnaissance the site did not appear to be planted to a crop (no emergent crop) and had recently been tilled. Channels consistent with Drainage 1 and Drainage 2 observed during the desktop review were observed and were consistent in location and appearance as what was viewed during the review of the aerial images. Both Drainage 1 and 2 had a wooded riparian buffer on both banks that was generally mixed deciduous trees and shrubs with limited herbaceous undergrowth. A wooded area was also observed on the northeast portion of the site and was similar in vegetative composition to the riparian areas. Multiple erosional features were observed in the tilled cropland areas and in some of these areas the erosional cut is over 4 feet deep and 8 to 10 feet wide (see Photograph 12 in Appendix D).

Photo #12 View of erosional feature on the central portion of the site.

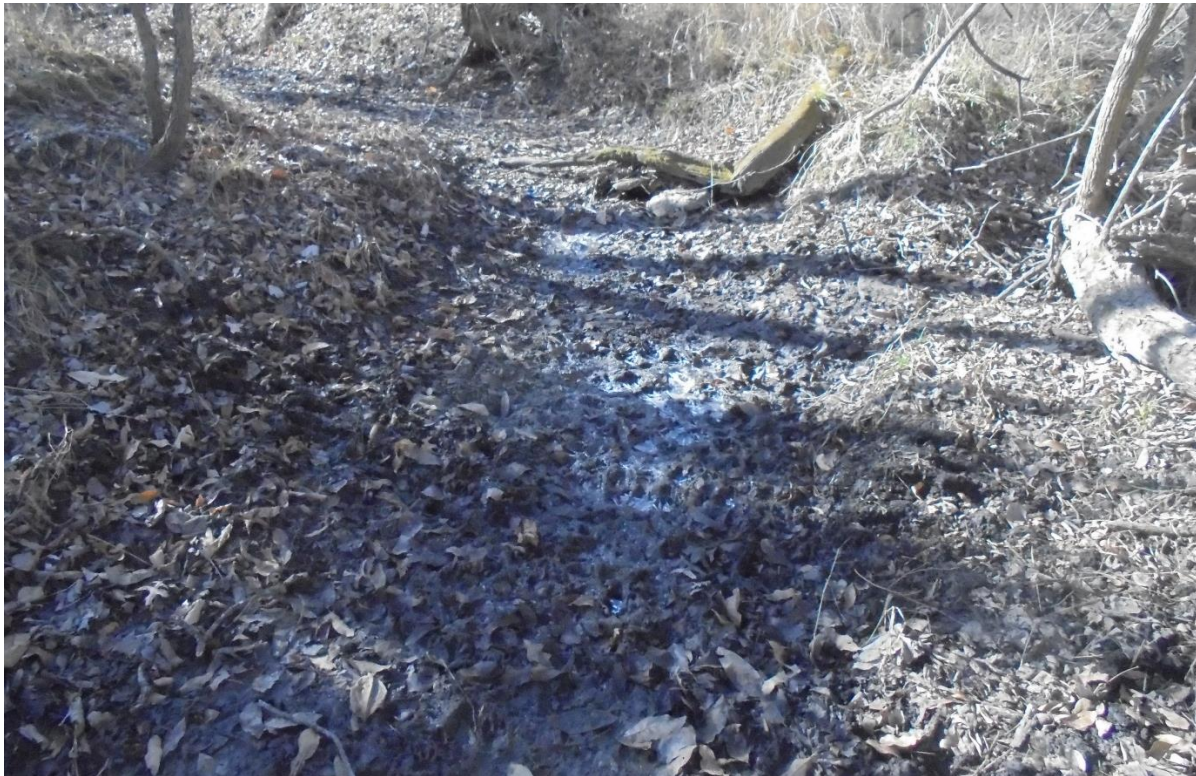
CROSS SECTION ID: CS1
DRAIANGE 1

Coordinates	Lat-Long: 38.861878°, -94.360987°
Flow Characteristics	Intermittent
Ordinary High Water Mark (OHWM)	Yes
Channel Width Across OHWM	14'
Channel Width Across Bottom	5'
Bank Height at OHWM	2'
Approximate Bank Slope (left)	35°
Approximate Bank Slope (right)	35°
Bank Substrate	Silty clay
Bed Substrate	Silty clay over rock
Riparian Corridor	Wooded

Photograph of CS1 looking upstream.

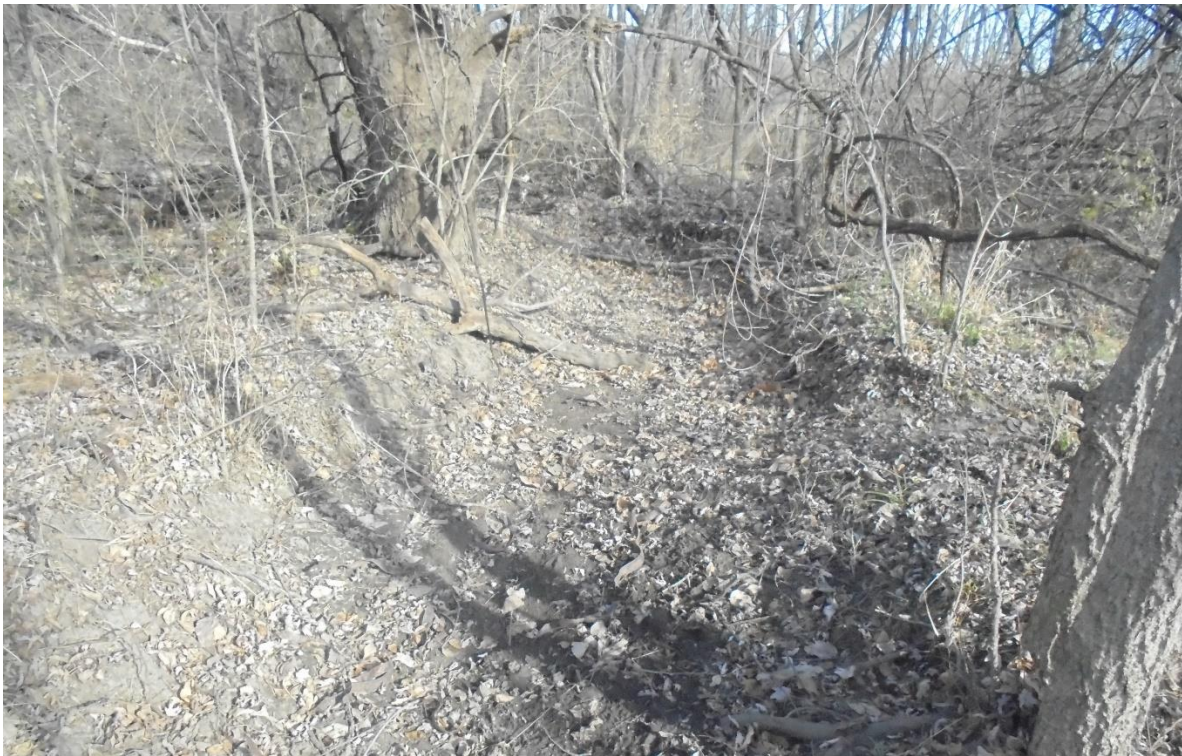
CROSS SECTION ID: CS2
DRAINAGE 1

Coordinates	Lat-Long: 38.861077°, -94.363322°
Flow Characteristics	Intermittent
Ordinary High Water Mark (OHWM)	Yes
Channel Width Across OHWM	12'
Channel Width Across Bottom	5'
Bank Height	18"
Approximate Bank Slope (left)	40°
Approximate Bank Slope (right)	40°
Bank Substrate	Silty clay
Bed Substrate	Silty clay
Riparian Corridor	Wooded

Photograph of CS2 looking downstream.

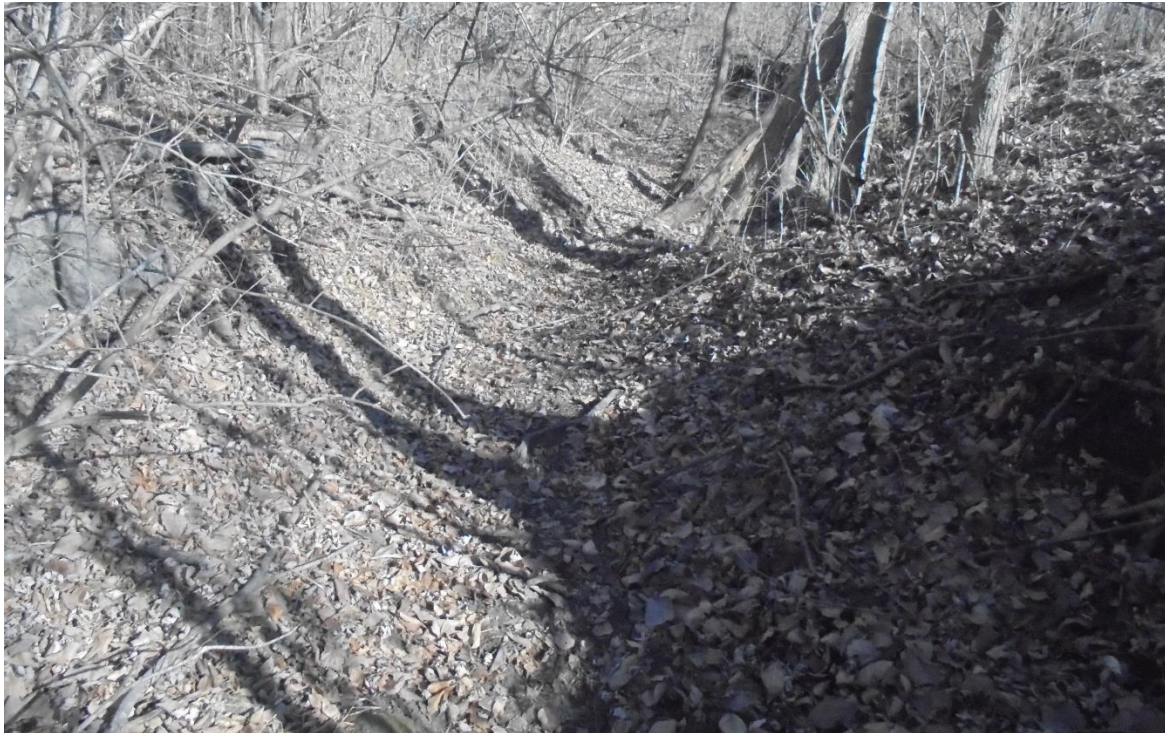
CROSS SECTION ID: CS3
DRAINAGE 1

Coordinates	Lat-Long: 38.859746°, -94.365613°
Flow Characteristics	Intermittent
Ordinary High Water Mark (OHWM)	Yes
Channel Width Across OHWM	16'
Channel Width Across Bottom	4'
Bank Height at OHWM	3"
Approximate Bank Slope (left)	45°
Approximate Bank Slope (right)	45°
Bank Substrate	Silty clay
Bed Substrate	Silty clay
Riparian Corridor	Wooded

Photograph of CS3 looking downstream.

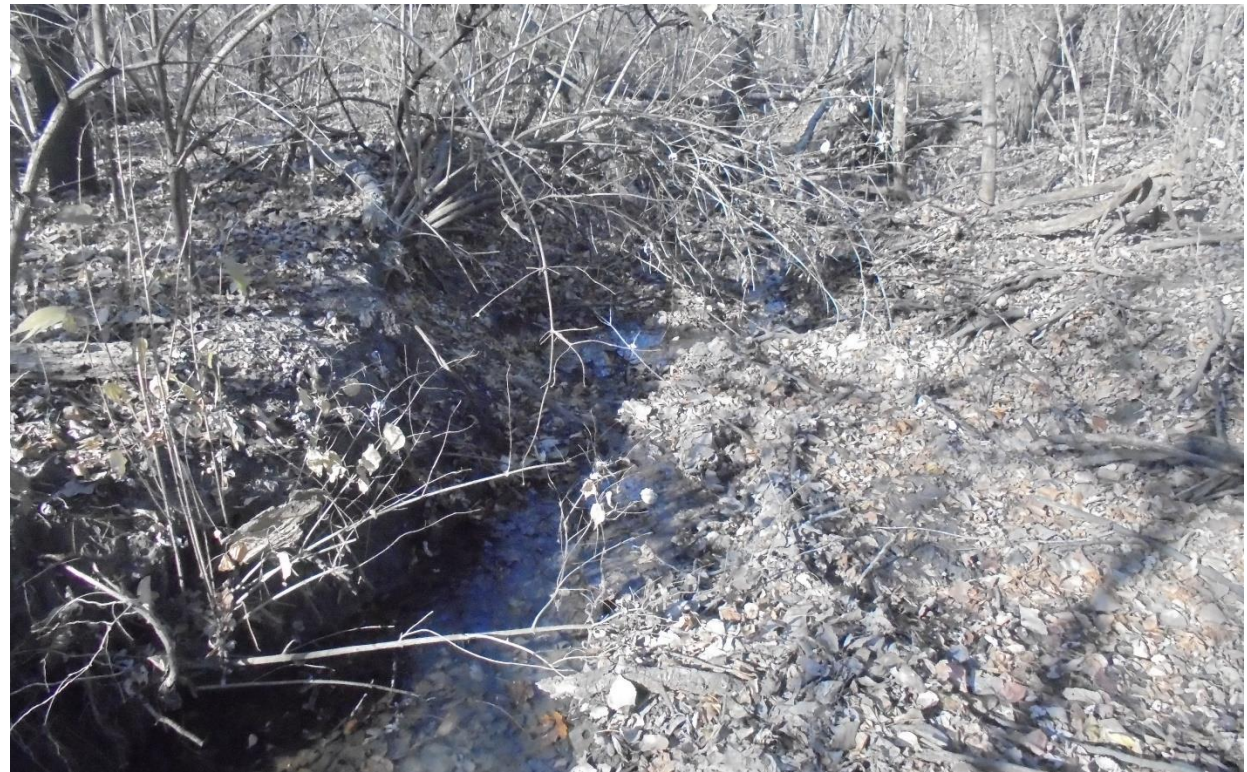
CROSS SECTION ID: CS4
DRAINAGE 2

Coordinates	Lat-Long: 38.859961°, -94.373192°
Flow Characteristics	Ephemeral
Ordinary High Water Mark (OHWM)	Yes
Channel Width Across OHWM	12'
Channel Width Across Bottom	4'
Bank Height at OHWM	2'
Approximate Bank Slope (left)	60°
Approximate Bank Slope (right)	35°
Bank Substrate	Silty clay
Bed Substrate	Silty clay
Riparian Corridor	Wooded

Photograph of CS4 looking downstream.
