Pavement Management Program

Public Works Committee

July 11, 2022

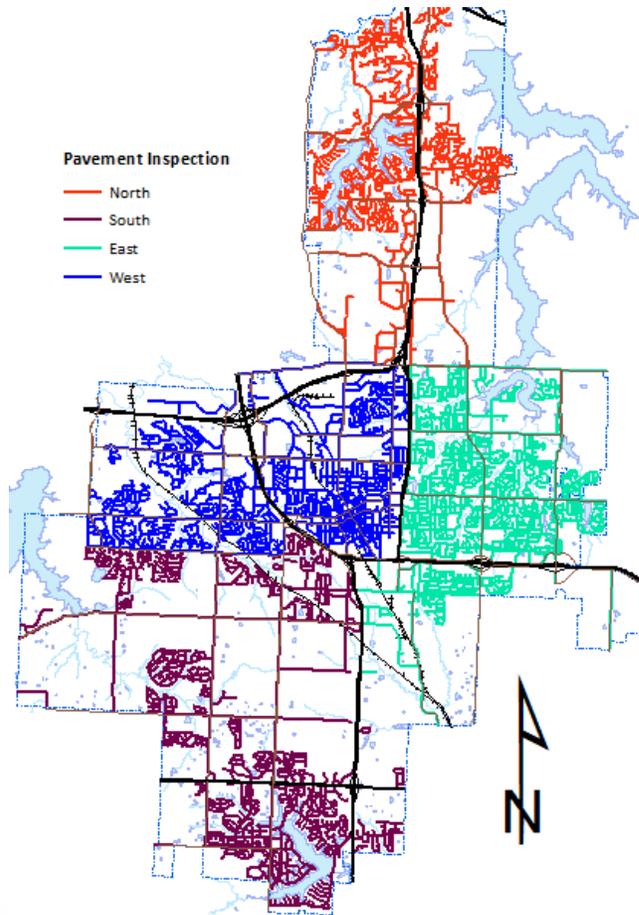
PCI Based on Pavement Inspections

Pavements are on a 4-year rotating inspection schedule

Defects
Block Cracking
Fatigue Cracking
Joint Cracking
Patching
Potholes
Raveling
Rutting
Bumps/Sags

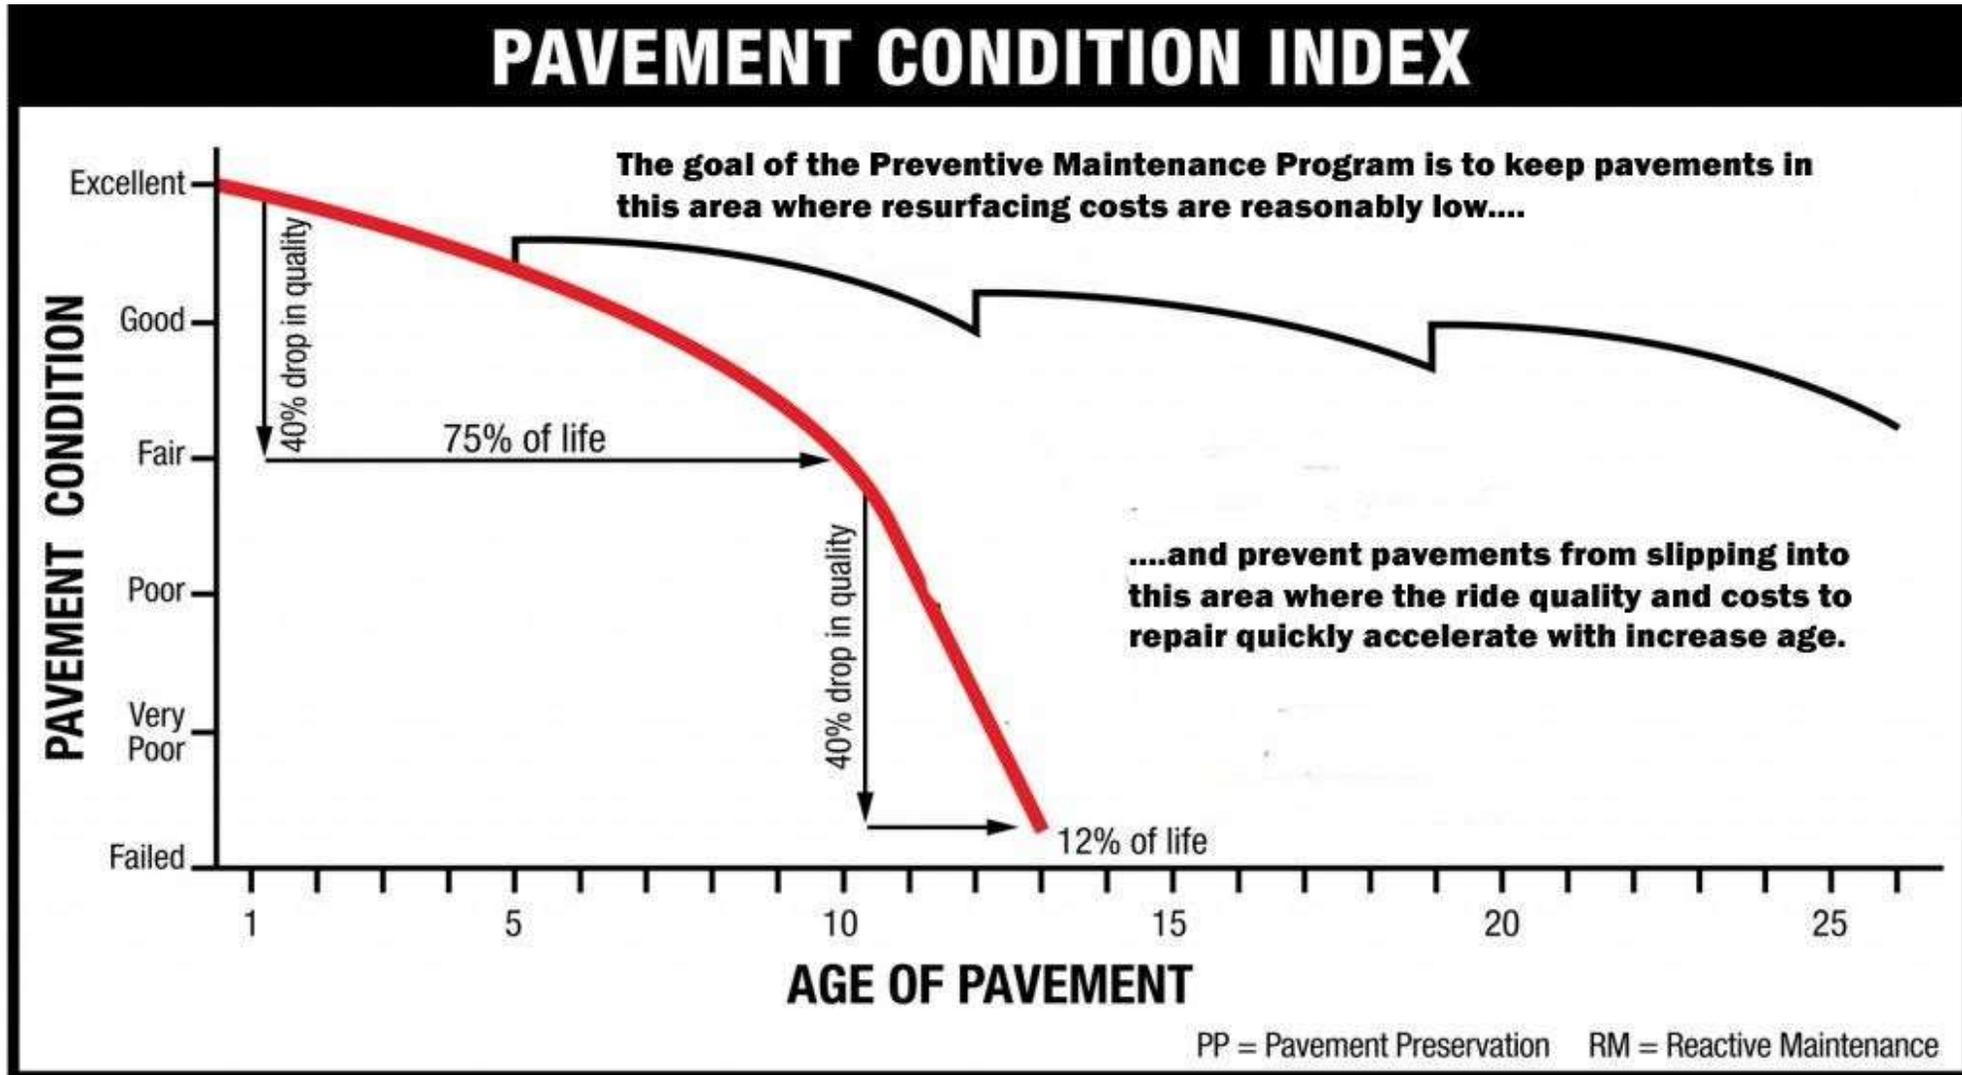
Keeping the Good Pavements in Good Condition

PCI Rating Scale

Red = Poor/Very Poor condition

Yellow = Fair condition

Green = Good/Excellent condition

PAVER (PCI)	Pavement Condition	Corrective Action
24 and Below	Very Poor	Overlay – Consider Rebuild
25 - 59	Poor	Overlay
60 - 74	Fair	Surface Seal/Overlay
75 - 89	Good	Surface Seal/Crack Seal
90 and Above	Excellent	Very Unlikely/Crack Seal

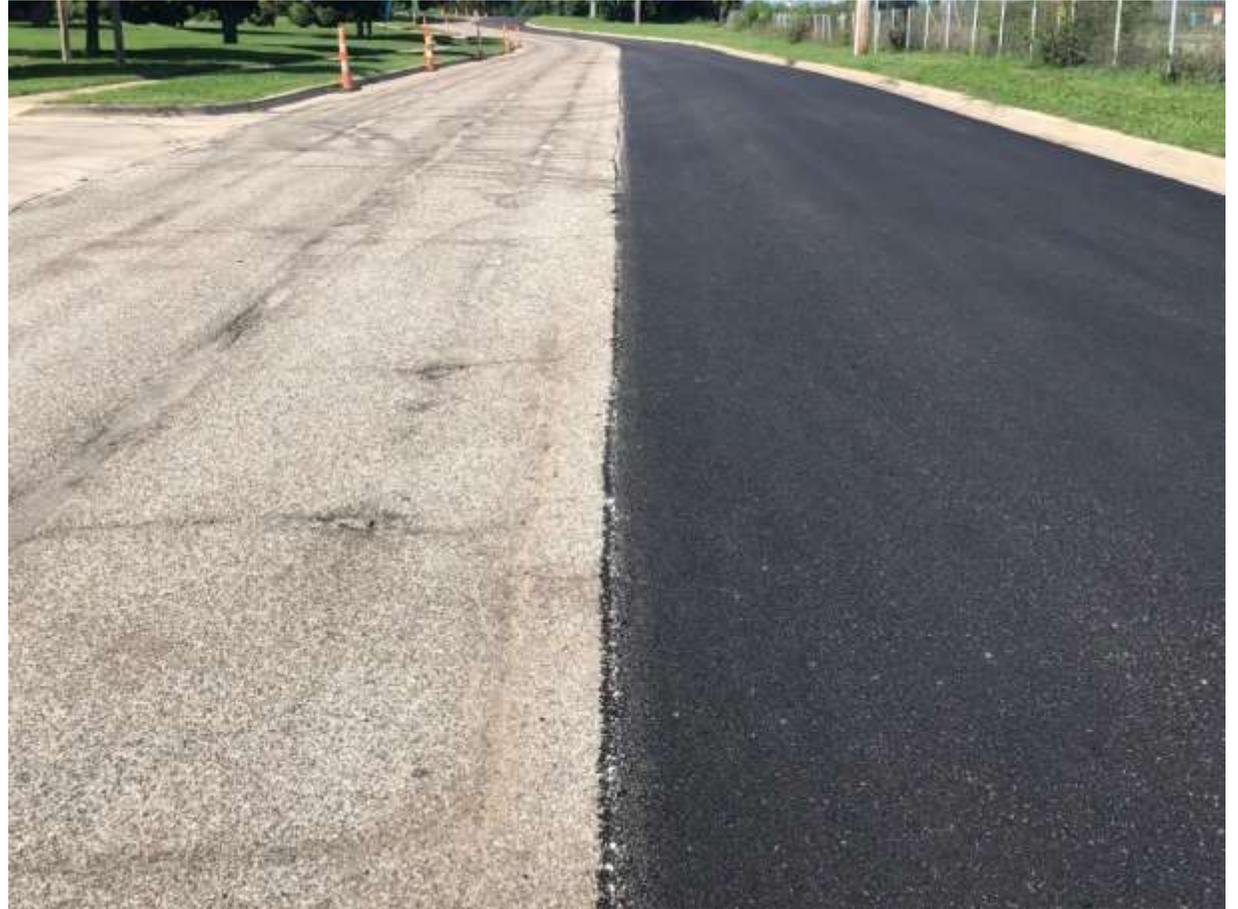
Mill and Overlay Construction

- Average \$128,000/LM
- Remove top 2" of street surface
 - make any repairs (patching)
 - replace asphalt
- Restore road close to initial construction
- Improved ride quality

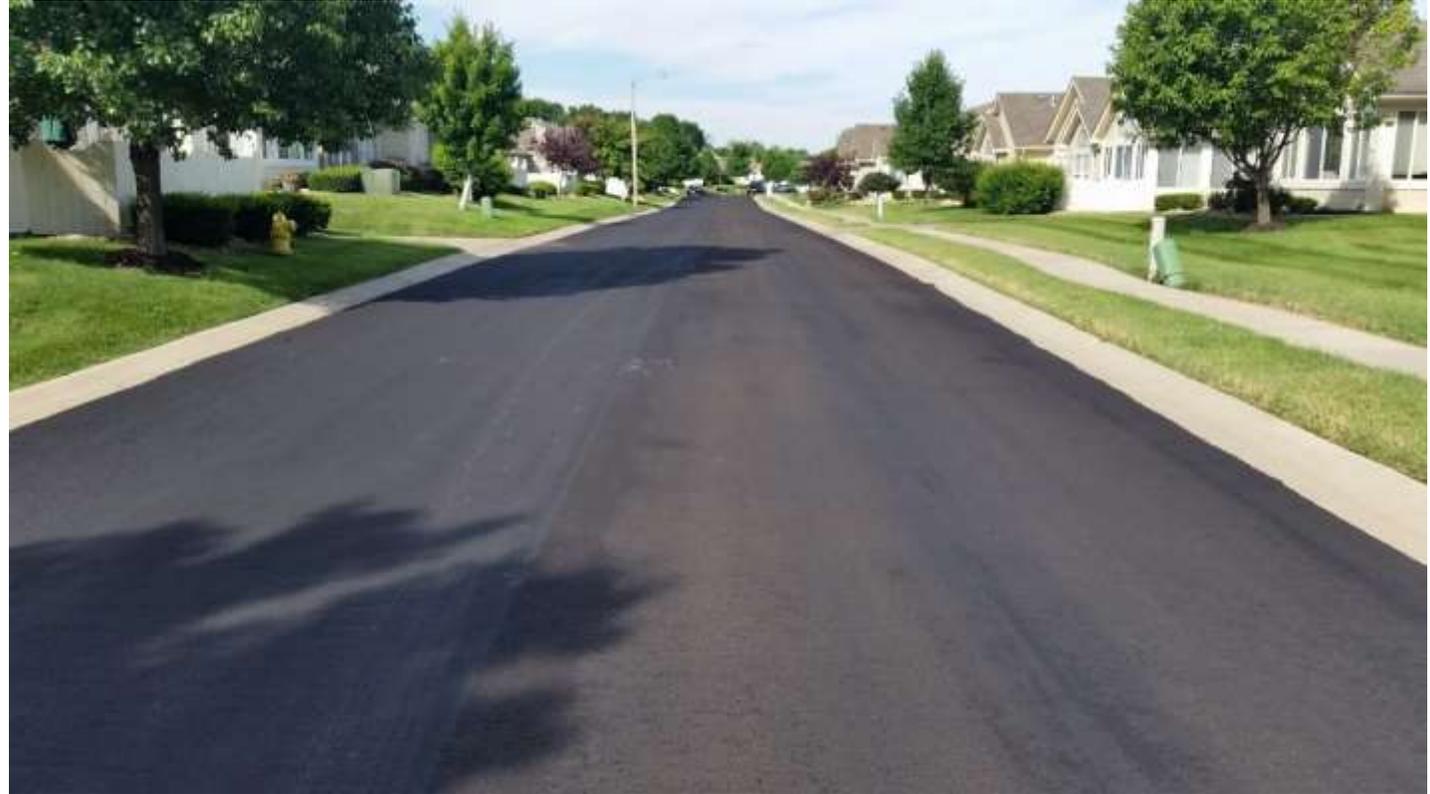
Micro Surfacing Construction

- Average \$30,000/LM
- Add 1/4" - 3/8" asphalt/polymer/aggregate slurry material to the road surface
- Does not add structural strength to pavement
- Protects Asphalt from UV degradation
- Does not improve ride quality
- Cracks sealed, but visible
- Streets closed for at least 4 hours

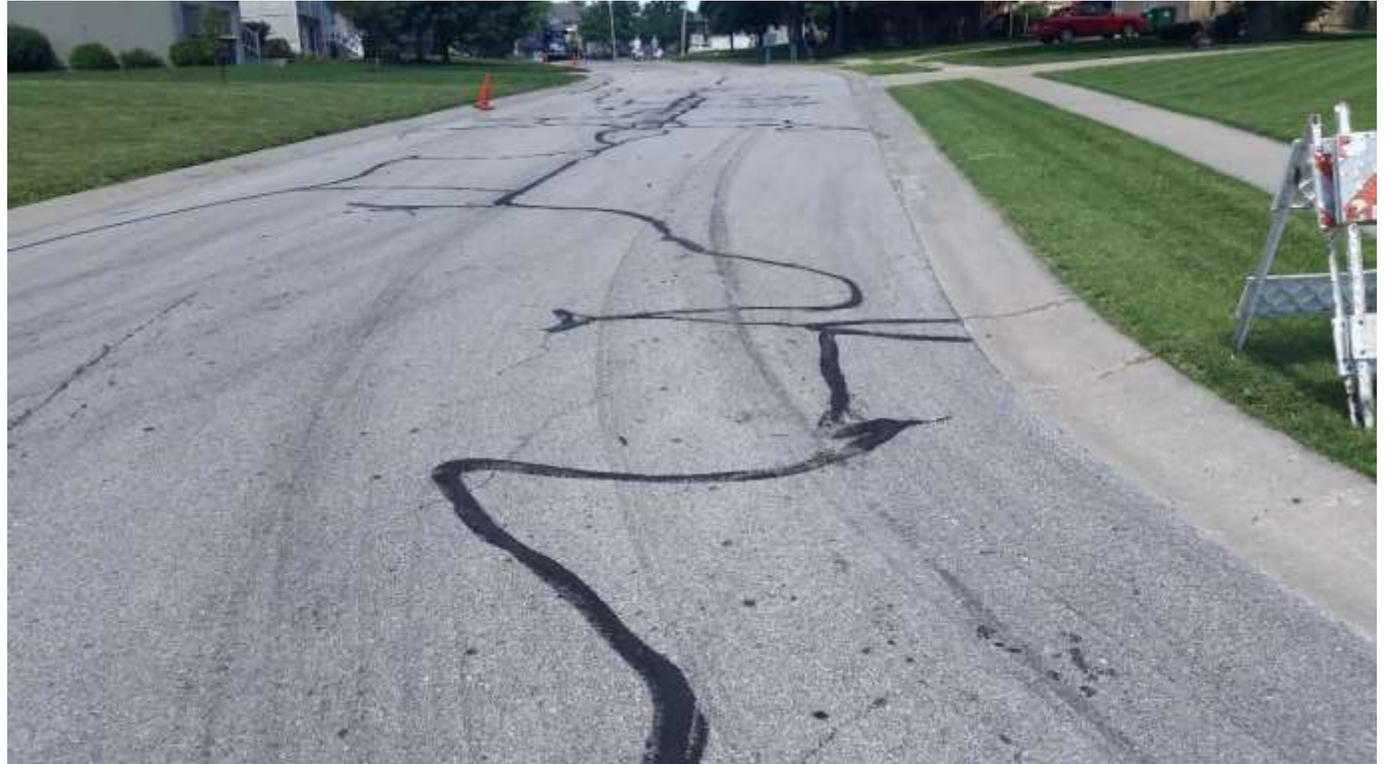
Construction

- Average \$5,100/LM
- Cracks blown out & refilled with rubberized asphalt
- Seals water from subgrade:
Slows pothole formation
- Not Pretty
- 3 to 4 years following overlay
- 6 to 9 years following new construction

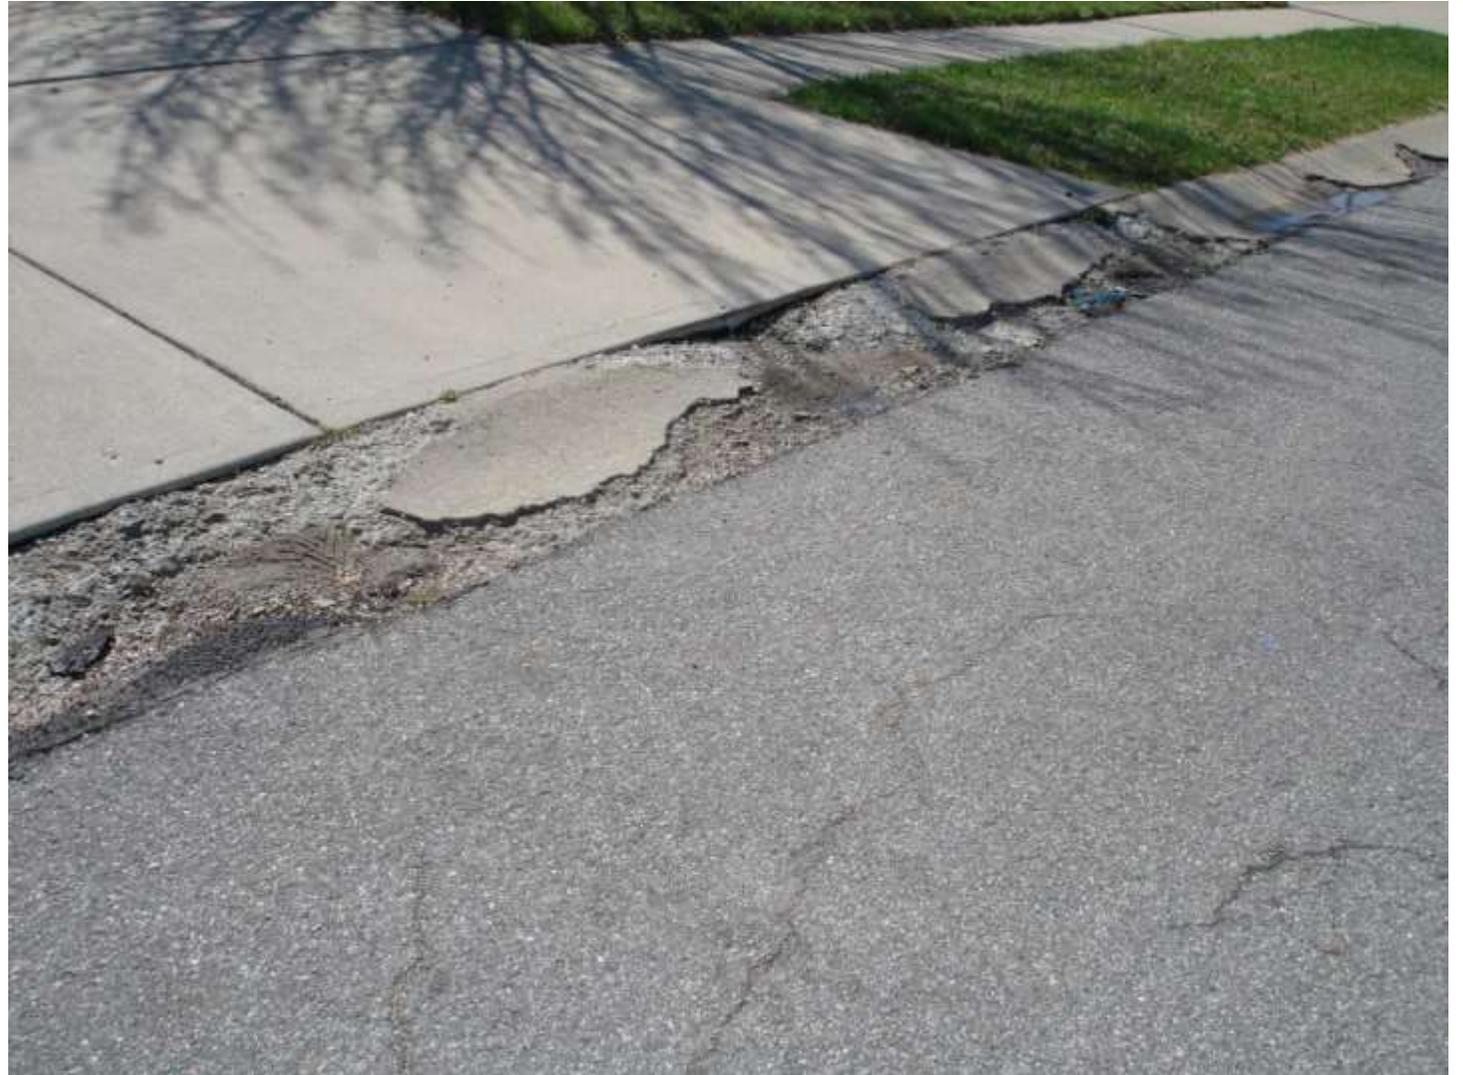
Construction

- Average \$165,400/mile
- Replaces damaged & deteriorated curb ahead of Overlay
- Sidewalk ramps are reconstructed to current ADA specifications

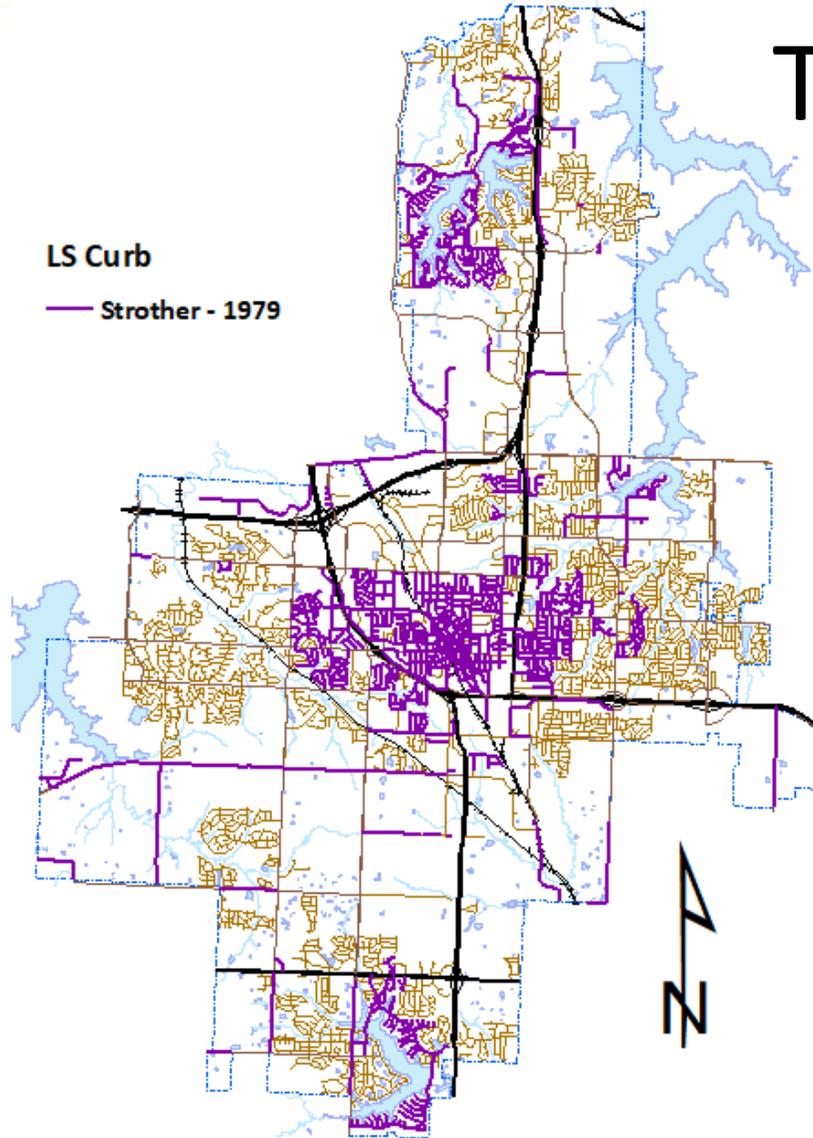
Town of Strother - 1979

- 208 miles of curb (22%)
- Good Condition
- Issues:
 - Alignment
 - Overlaid
 - Design
 - Aesthetics
 - New areas replaced

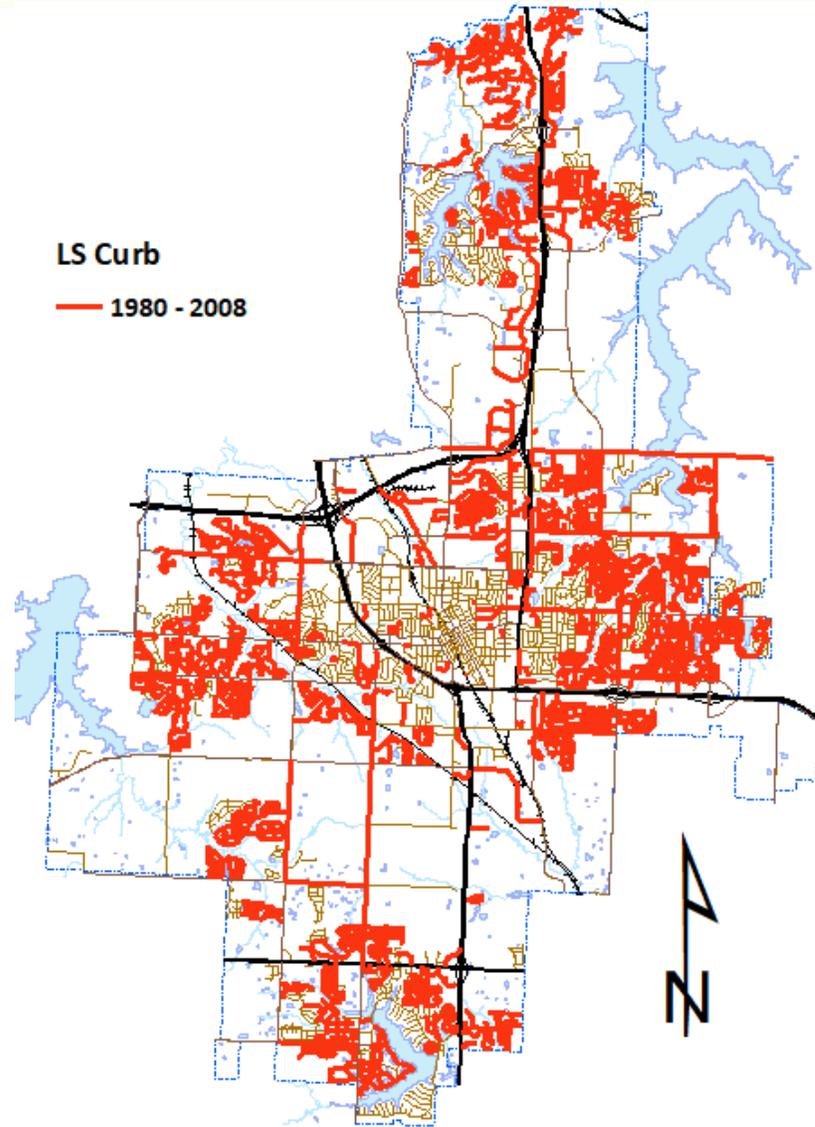
1980-2007

- 623 miles of curb (65%)
- OK – Poor Condition
- Issues: (same +)
 - Total Delamination
 - Cost to rebuild
 - 623 miles
 - \$165,400/mile
 - **\$103,044,200**

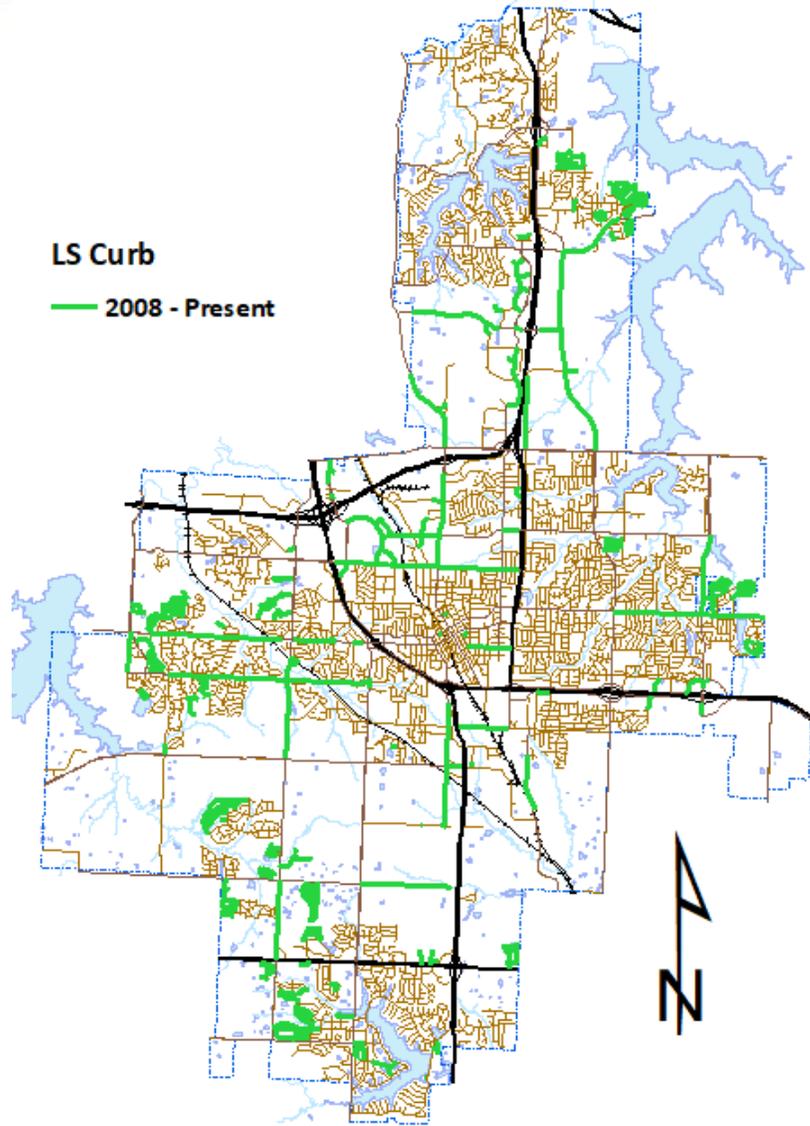
2008-Present

- 128 miles of curb (13%)
- Good Condition
- Issues:
 - Minor offsets

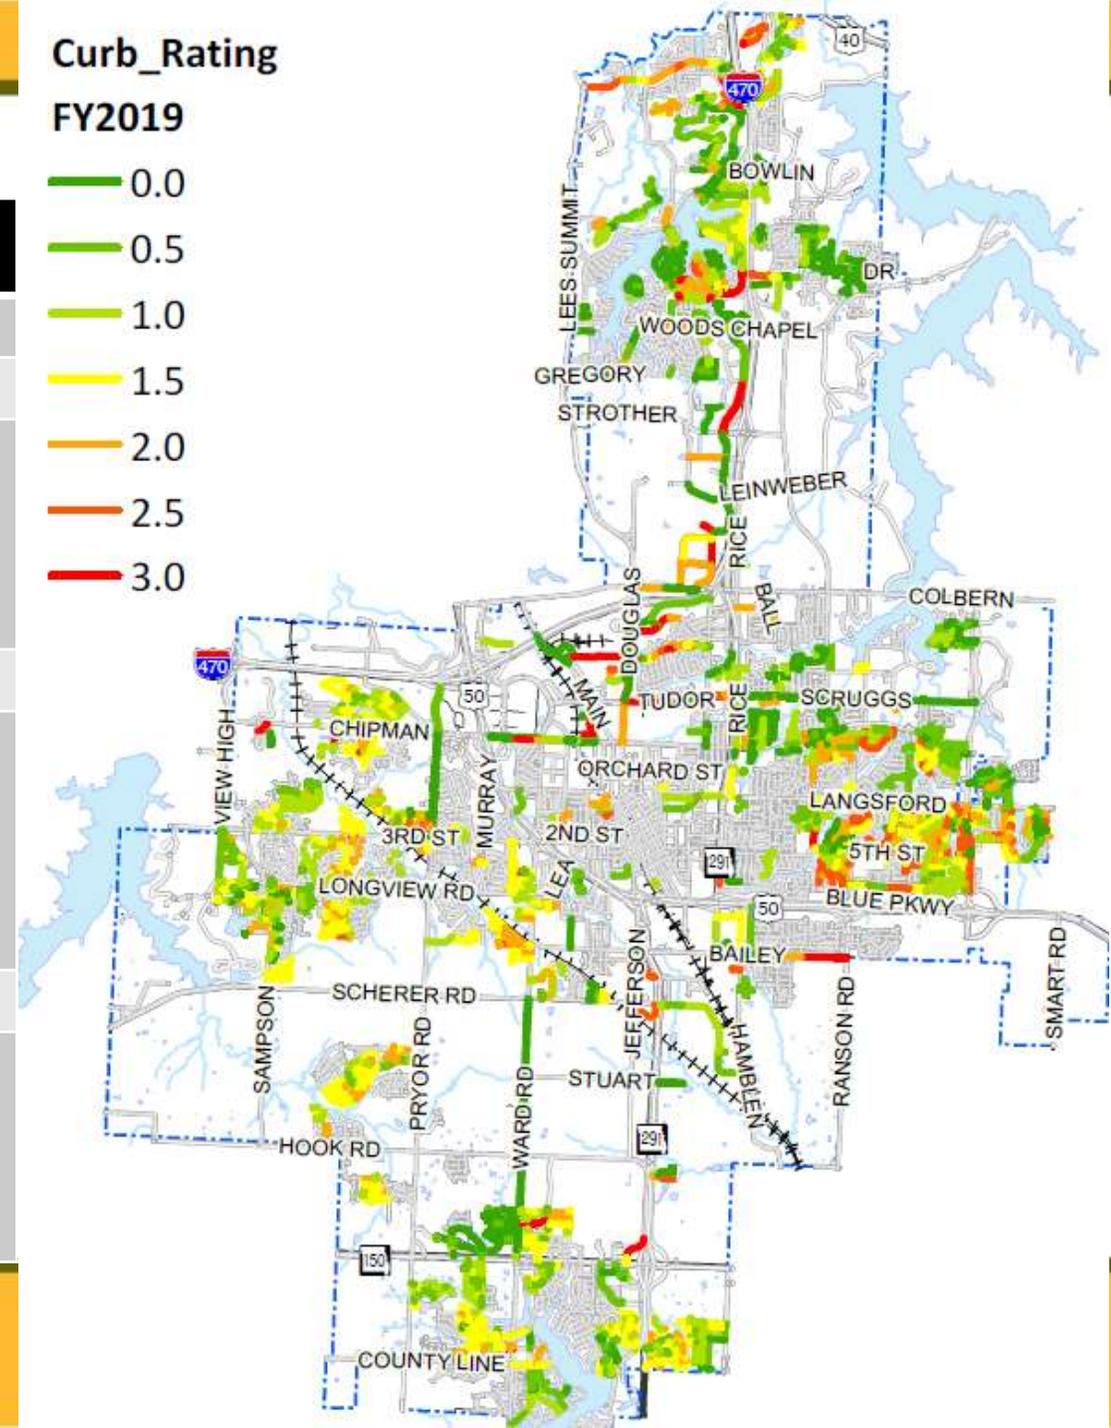
Curb_Rating

Rating	Type of Deterioration	Extent	Description
0	None Observed	None/Minimal	Don't mess with
0.5			
1	Looks good: very early stages noticed, but not developed (may last)	Intermittent	Should stay together a few years
1.5			
2	D-cracking or Potholes at every joint (15-foot intervals)	Large pieces, but not continuous failure	Should be replaced but may not be evident. Replace large sections; but not all
2.5			
3	Turning to gravel; potholes; asphalt patching	Along entire length of curb for large area (GLOBAL)	"No Brainer" "Global Failure" ASAP

Rating	Type of Deterioration	Extent	Corrective Action
0	None Observed	None/Minimal	No Action
0.5			
1	Looks good: very early stages noticed, but not developed (may last)	Intermittent	No immediate action; possible replacement or spot patching in several years
1.5			
2	D-cracking or Potholes at every joint (15-foot intervals)	Large pieces, but not continuous failure	Should be replaced but may not be evident; Replace large segments; Patch with asphalt
2.5			
3	Turning to gravel; potholes; asphalt patching	Along entire length of curb for large area (GLOBAL)	“Very obvious, global failure (gravel)” Replace ASAP

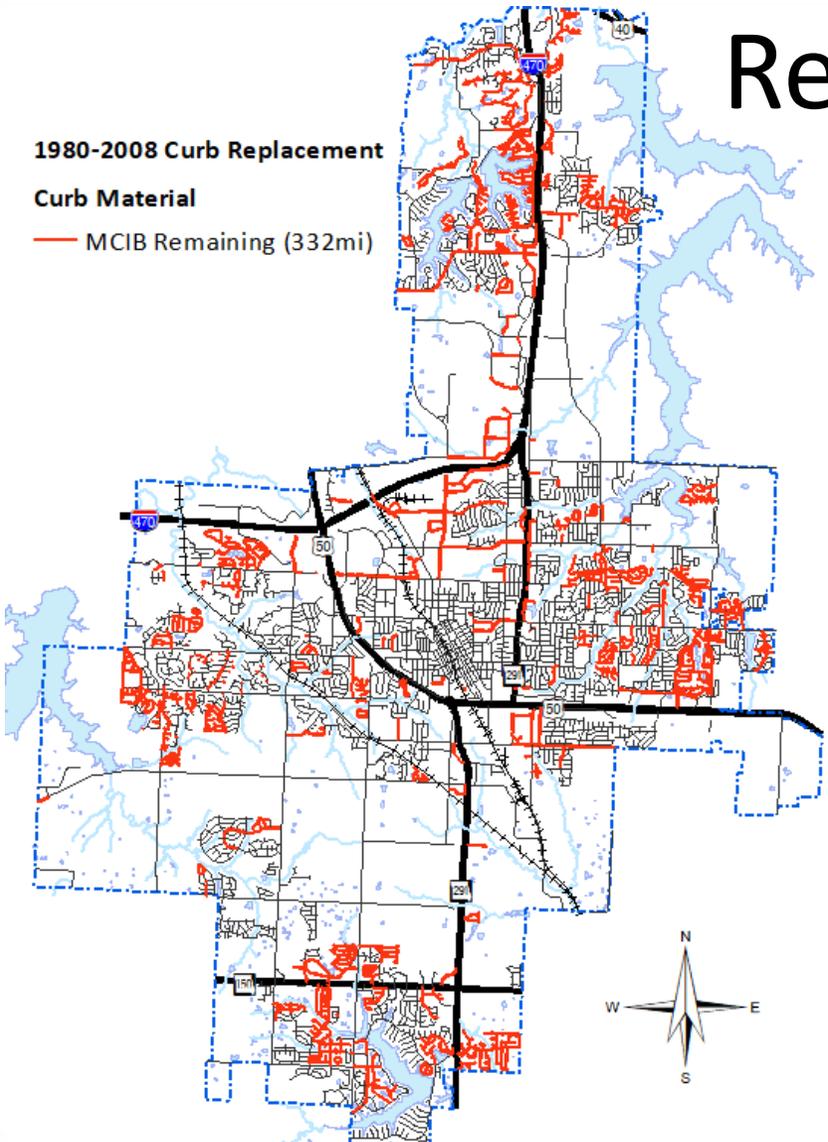
1980-2008 Curb Replacement
Curb Material
— MCIB Remaining (332mi)

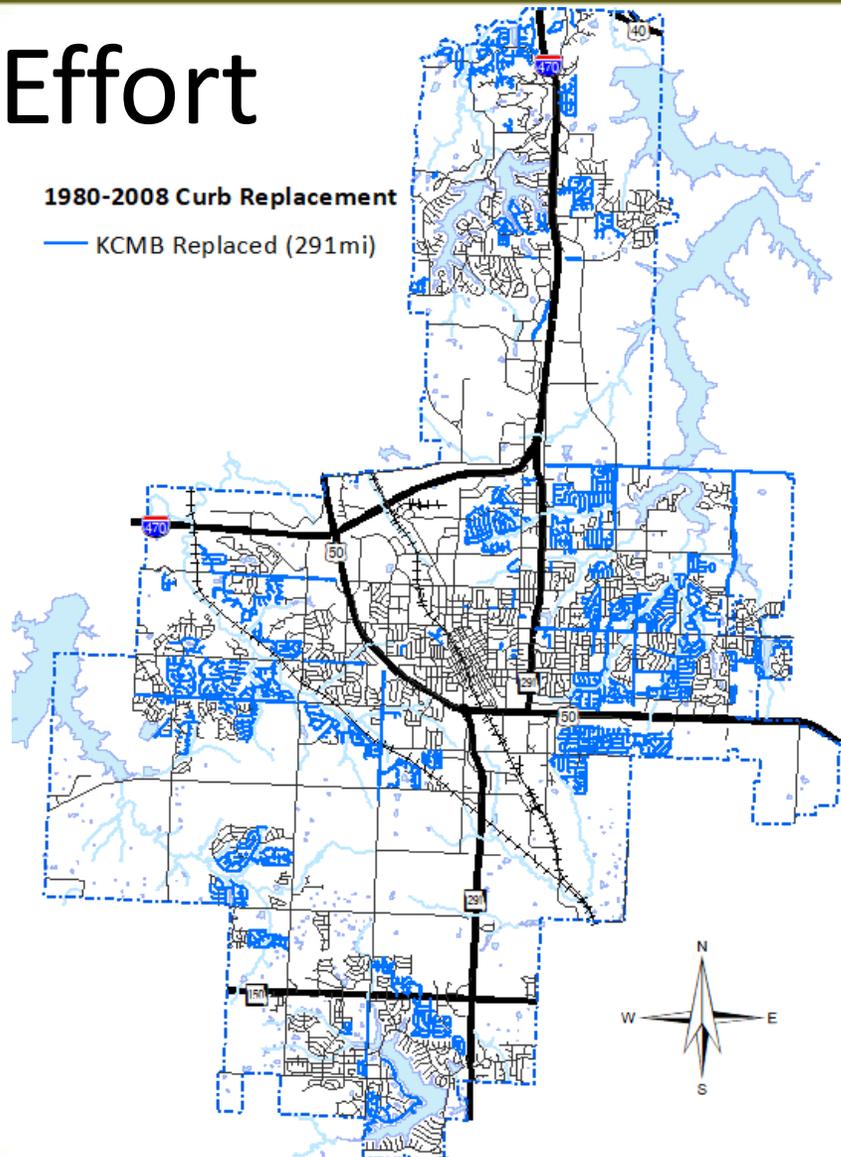
1980-2008 Curb Replacement
— KCMB Replaced (291mi)

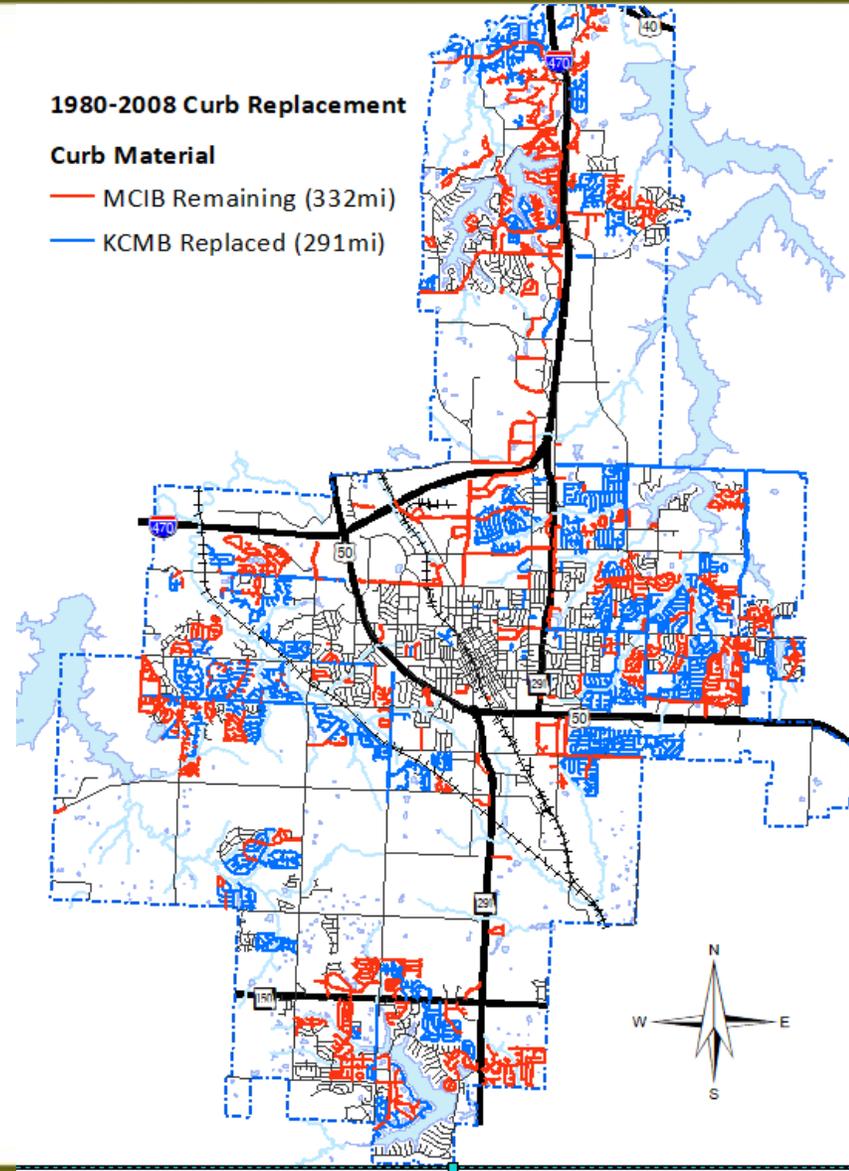
1980-2008 Curb Replacement

Curb Material

- MCIB Remaining (332mi)
- KCMB Replaced (291mi)

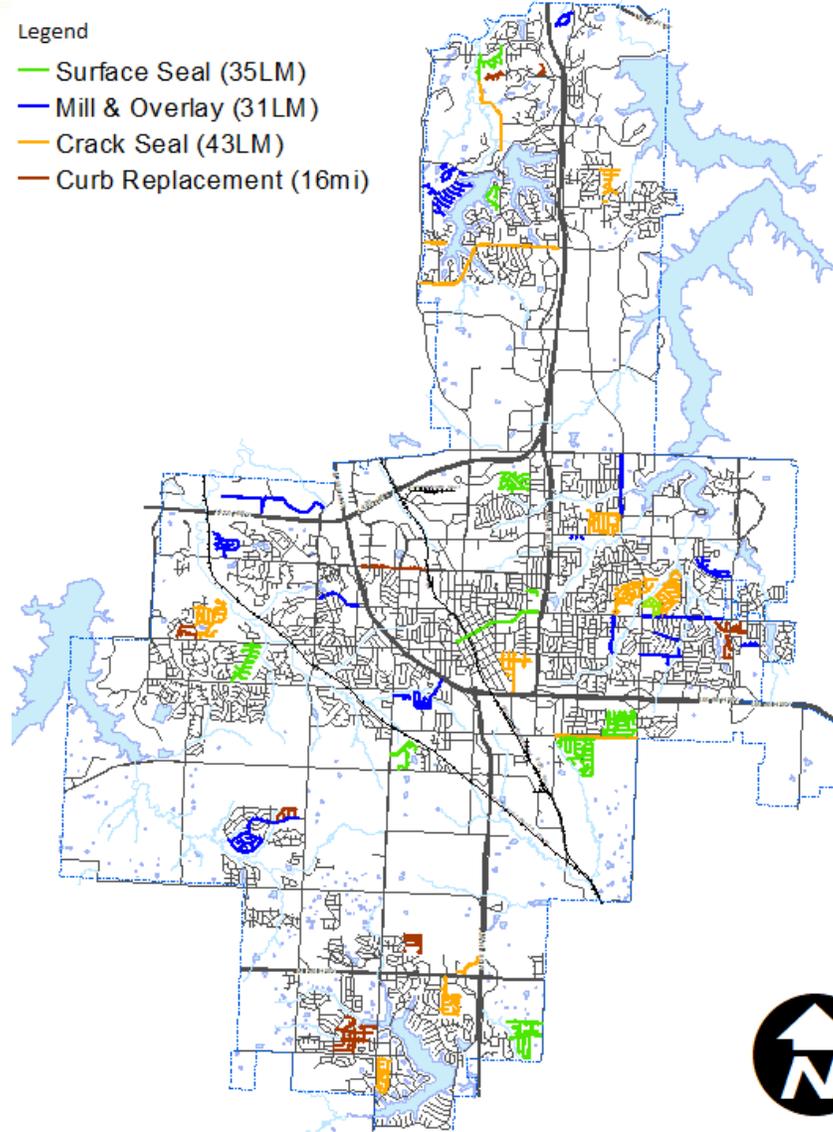
- Surface Seal (35LM)
- Mill & Overlay (31LM)
- Crack Seal (43LM)
- Curb Replacement (16mi)
