**SOUTHSIDE PLAZA
COMMUNITY IMPROVEMENT DISTRICT**

PETITION TO ESTABLISH
THE DISTRICT

LEE'S SUMMIT, JACKSON COUNTY, MISSOURI

March 5, 2020

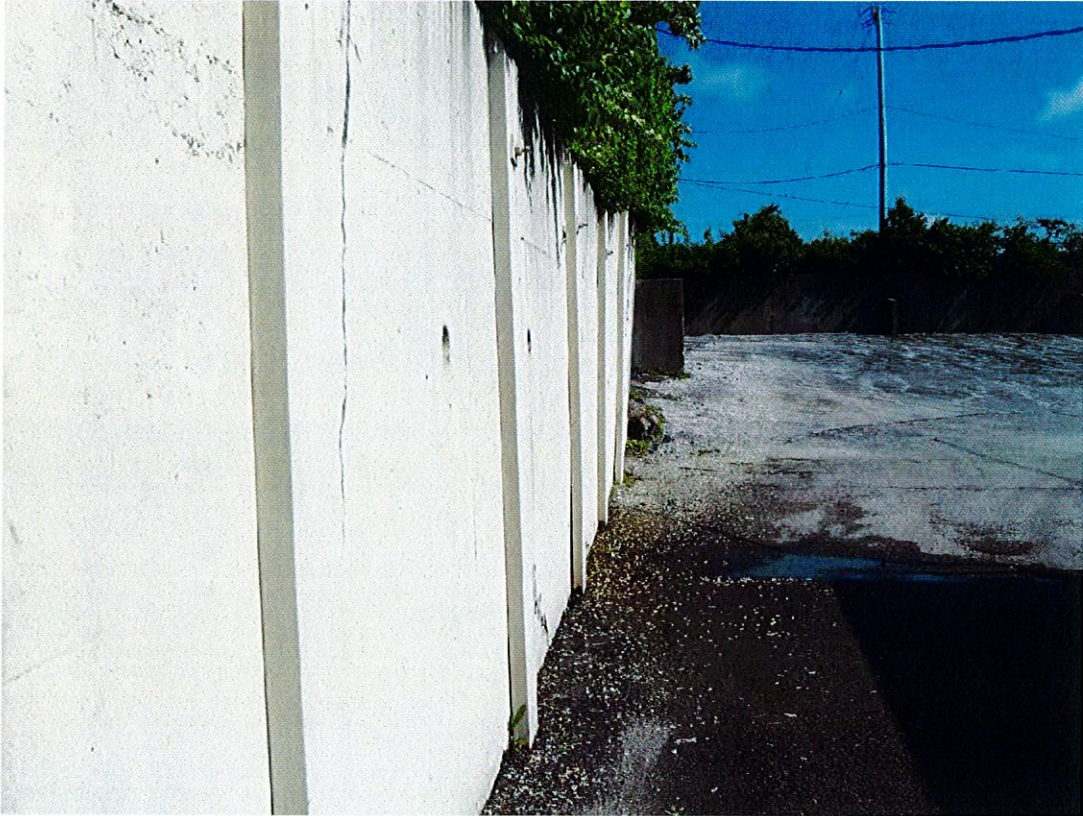
Photo 16 – Deteriorated/compromised retaining wall.

Upon inspection, it was noted that the west and north retaining wall exhibited significant structure deterioration. Deflection in the retaining wall can be noted in this photo.

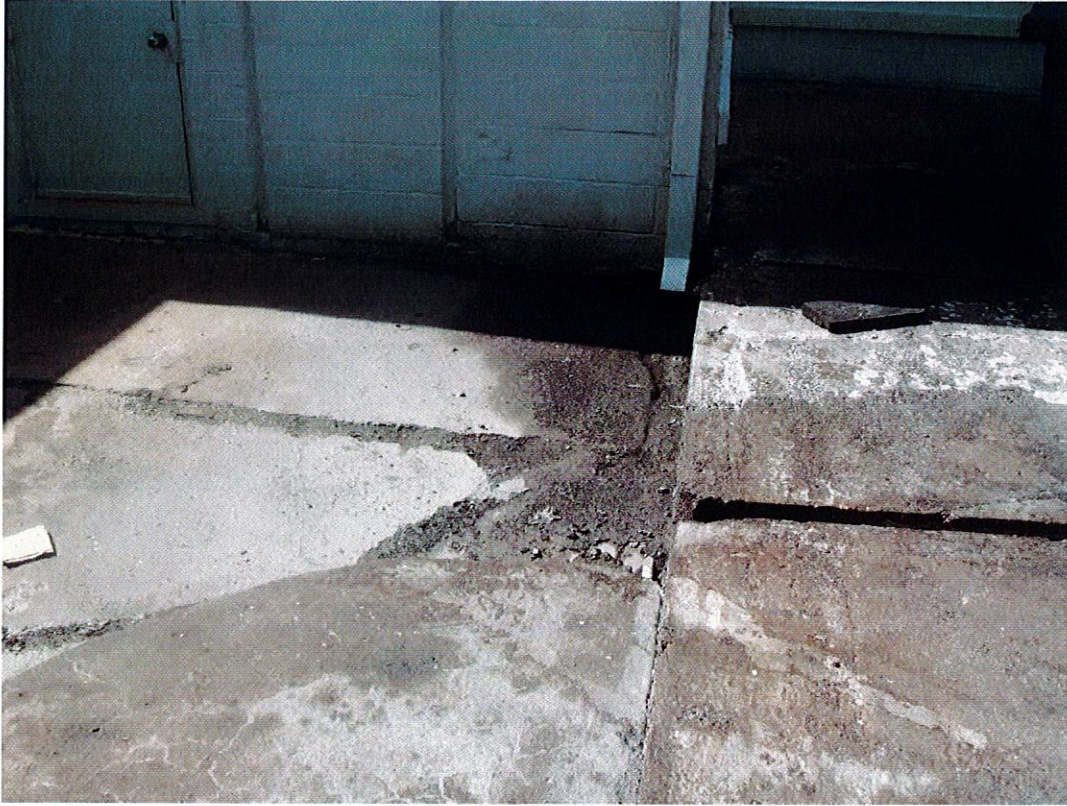
Photo 20 – Inadequate drainage.

Along the northern portion of the shopping center, several locations were noted where roof downspouts were inadequately drained. This can lead to possible water infiltration into the structure of the building.

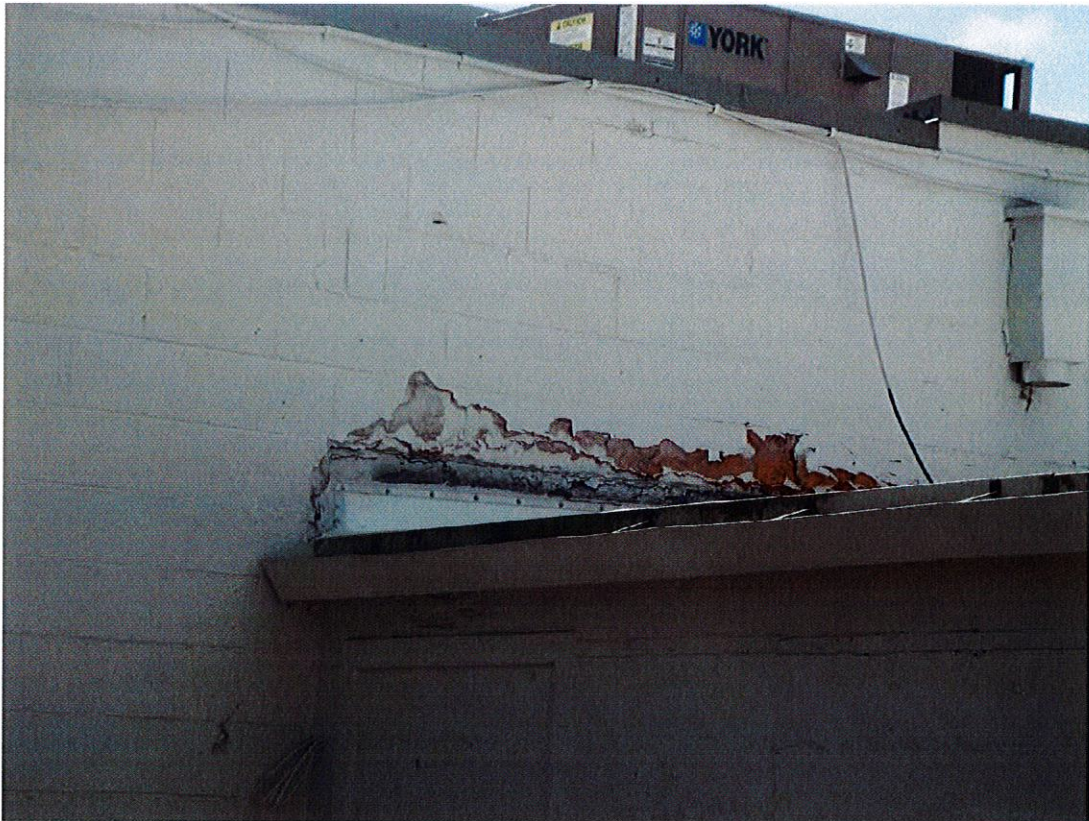
Photo 21 – Deteriorated flashing material.

Also not rainwater gutter system is inadequate and not properly installed.

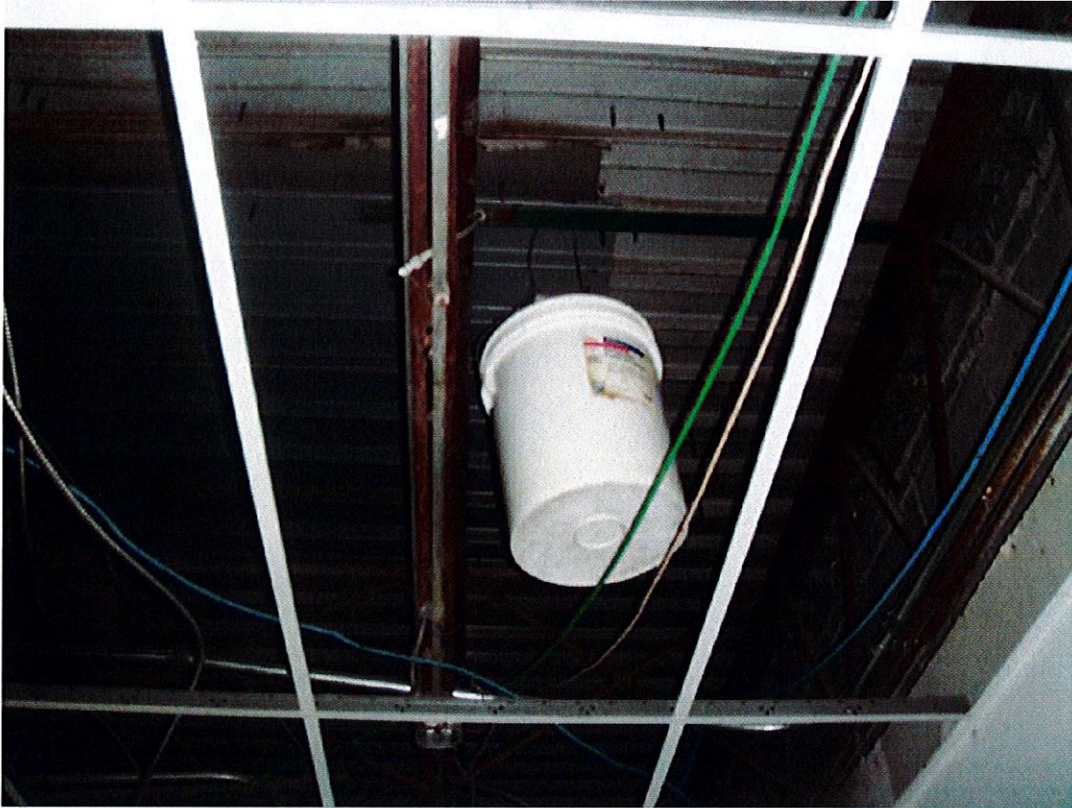
Photo 27 – Roof structure deterioration.

Several locations were observed with deteriorated or damaged roof structures. Deteriorated roof structures can lead to water infiltration and further damage to interior finishes. This images shows a temporary water catchment system.

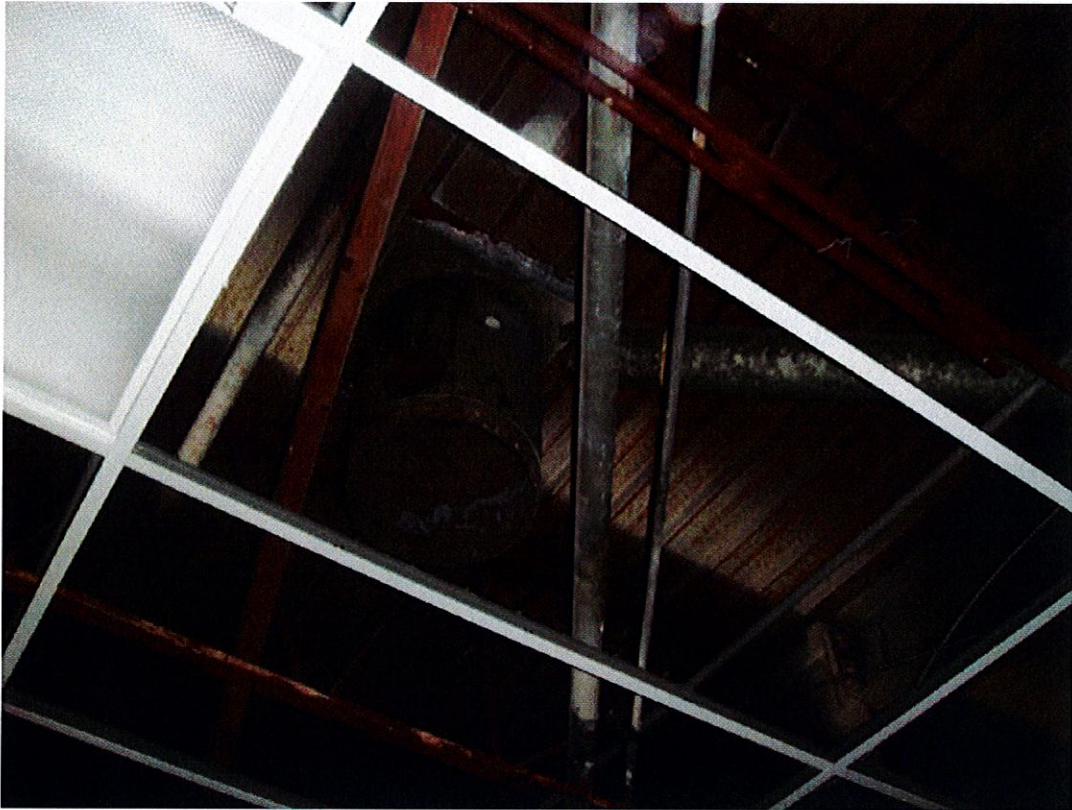
Photo 28 – Roof structure deterioration.

Several locations were observed with deteriorated or damaged roof structures. Deteriorated roof structures can lead to water infiltration and further damage to interior finishes. This image appears to be abandoned roof service vents. Access to the roof was unavailable, so conditions above this location were not observed.

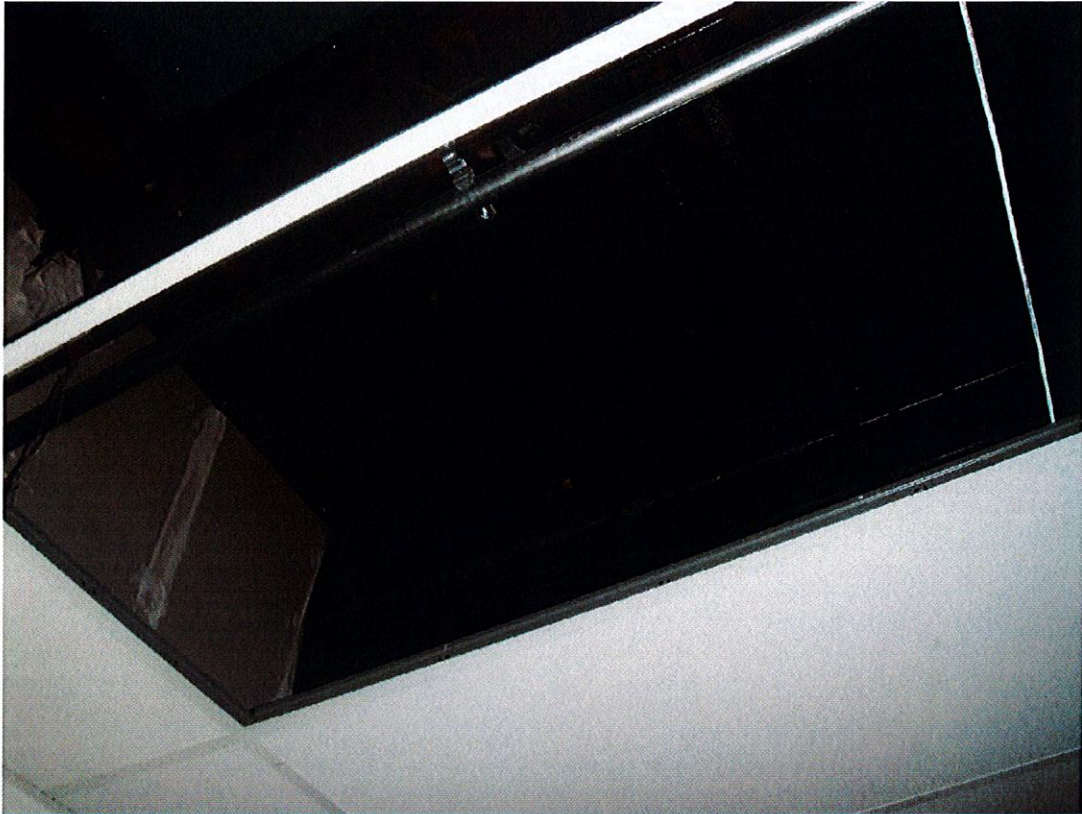
Photo 33 – Roof structure condensation.

Upon inspection, several locations were noted which significant condensation was observed on the underside of the roof structure. This was significant enough that it was dripping and falling onto the ceiling and floor below.

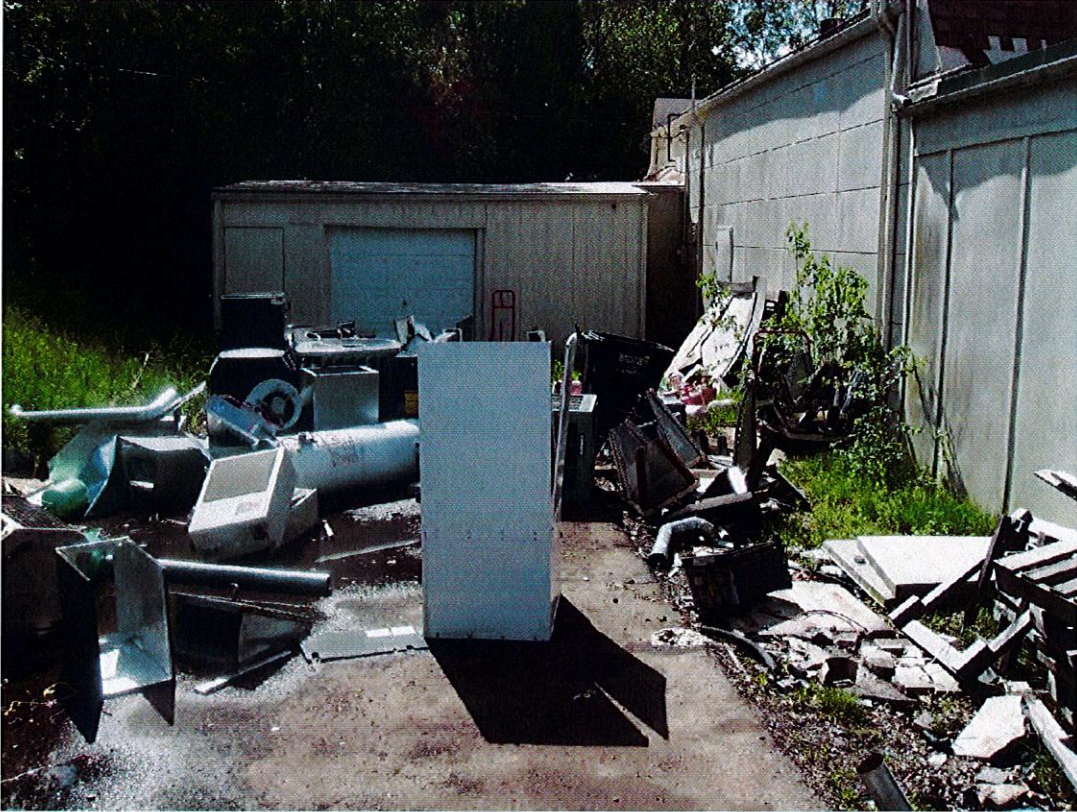
Photo 39 – Excessive exterior storage.

One location within the District exhibited excessive exterior storage. Much of the materials appear to be scrap materials or trash. It should be noted that the area was fenced and screened, but was still readily observable.
