Solicitation Title: **Abatement and Demolition of MSHP Troop A Campus**

ACM, LBP, LCM, UHW Survey Report
Former Missouri Highway Patrol Campus
Lee's Summit, Missouri

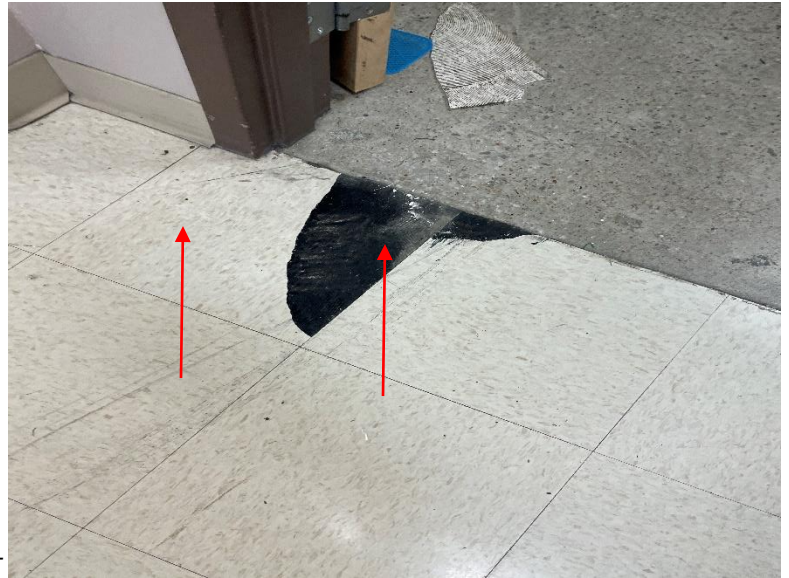
Photo #2

Description: Asbestos-containing 12" x 12" white floor tile and black mastic in the second-floor main building lobby. *Main Building Sample: 504-2-2-4*

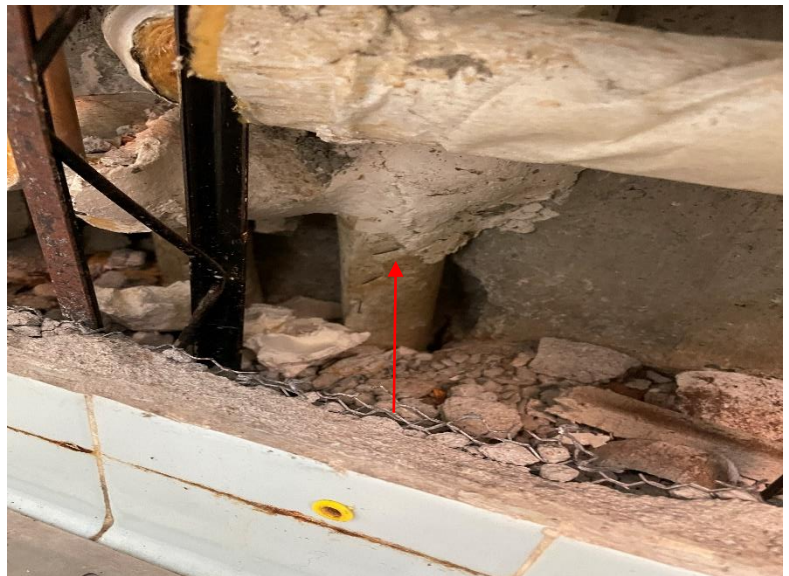
Photo #3

Description: Asbestos-containing mudded fitting in the second-floor main building men's restroom. *Main Building Sample: 504-14-2-40*

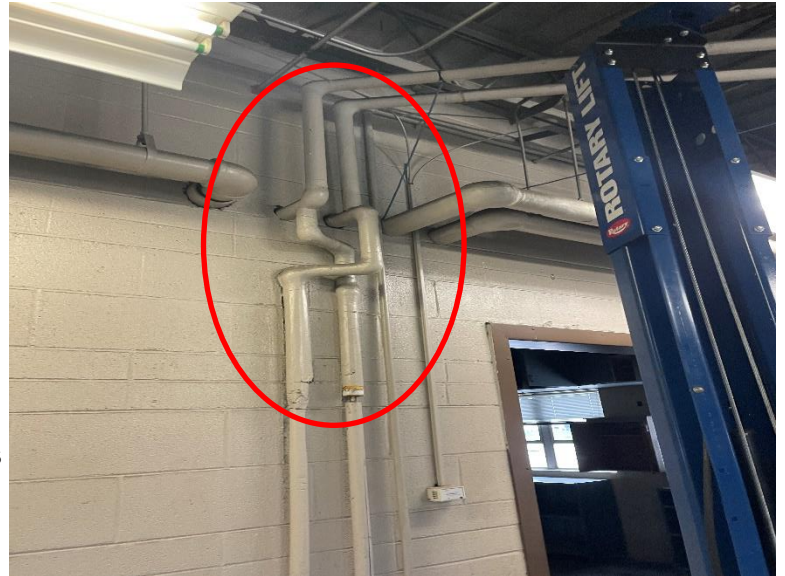
Photo #5

Description: Asbestos-containing mudded fittings on the main building garage south wall.

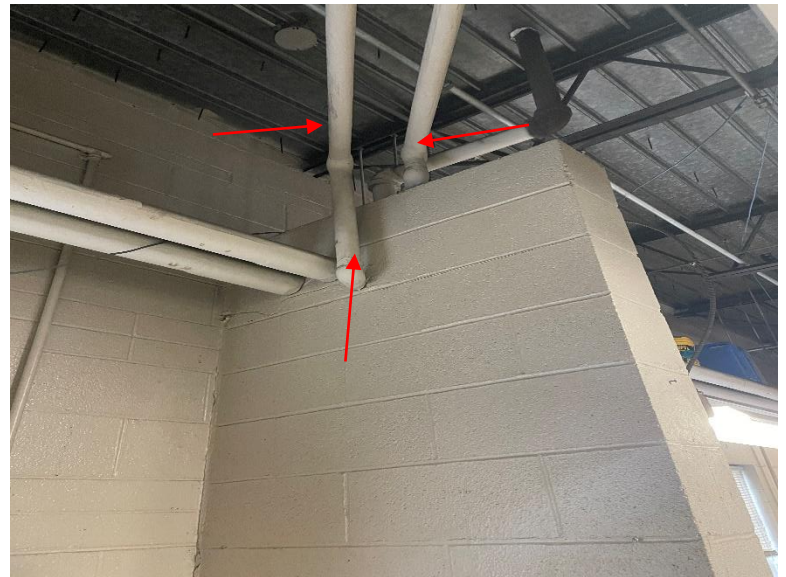
Photo #6

Description: Asbestos-containing mudded fittings on the main building garage center wall.

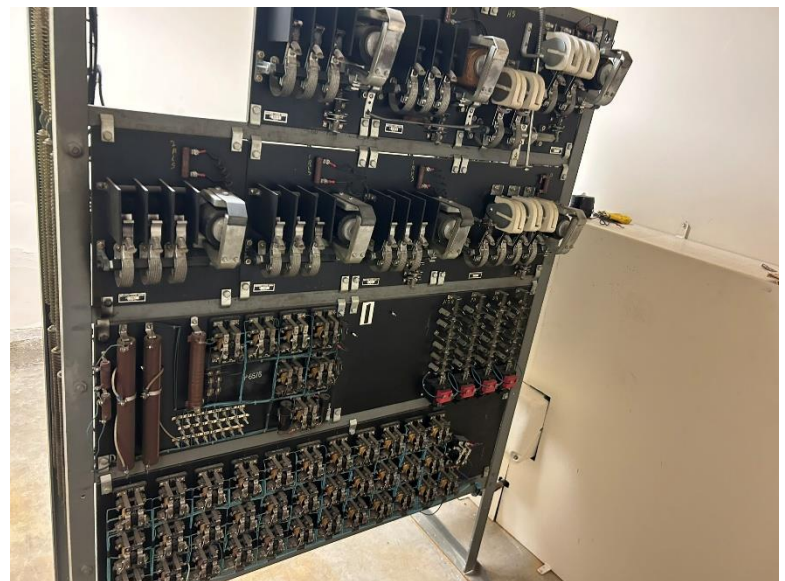
Photo #7

Description: Assumed asbestos-containing electrical components located inside elevator electrical room.

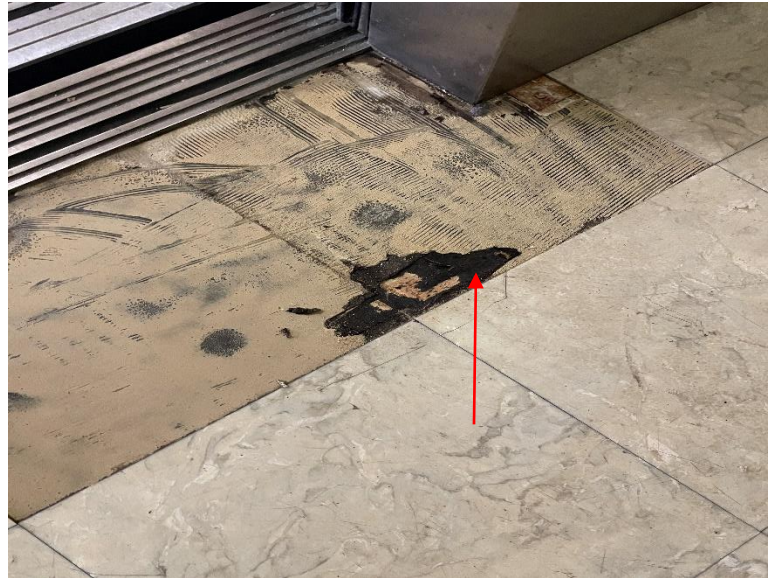
Photo #8

Description: Trace asbestos-containing black mastic underneath the main building second floor elevator 12" x 12" tiles. *Main Building Sample: 504-12-2-34*

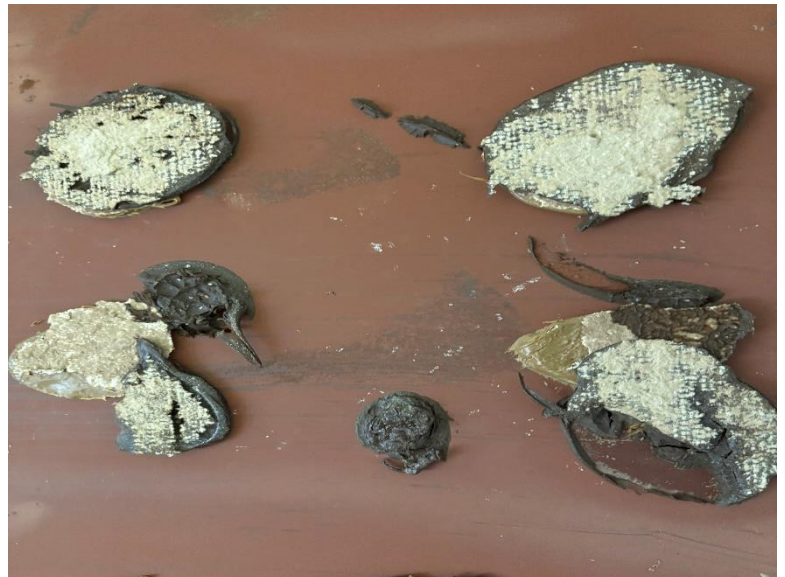
Photo #9

Description: Asbestos-containing brown glue dot mastic above firing range firing line. *Firing Range Sample: 504-8-1-22*

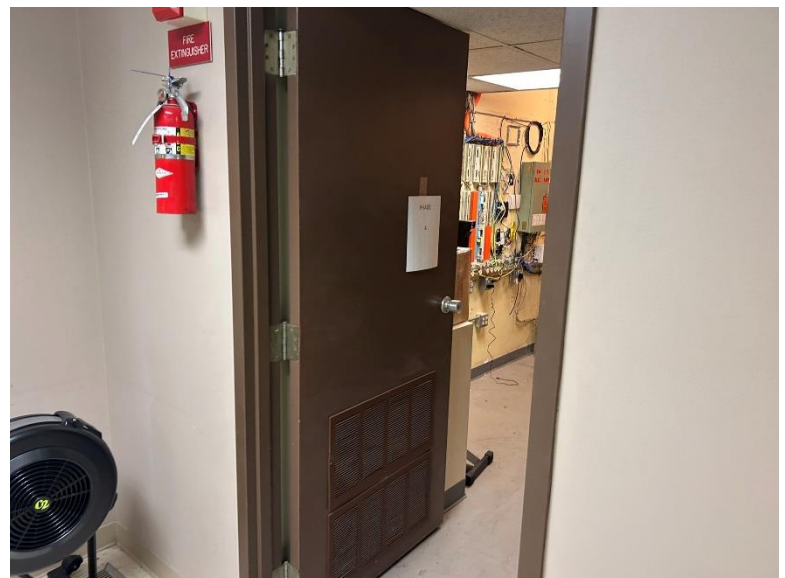
Photo #10

Description: Typical assumed asbestos-containing fire metal door located inside Main Building.

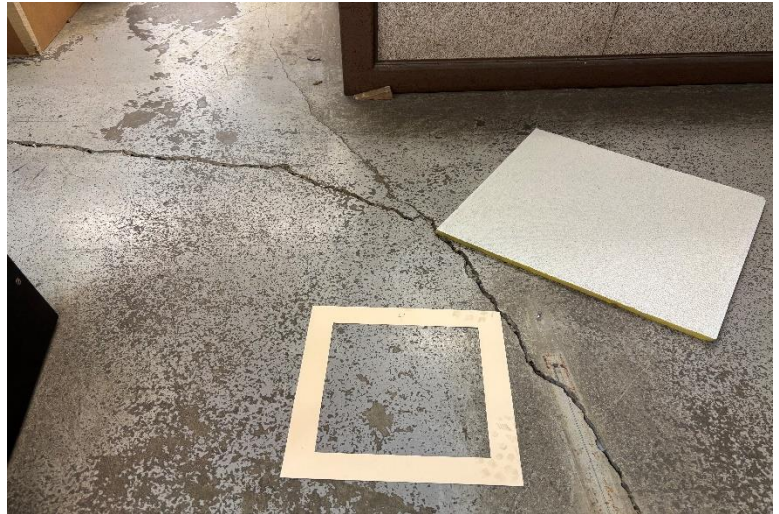
Direction (facing): South

Description: Lead Dust Wipe sample location on firing line floor. *Firing Range Lead Dust Sample #4*

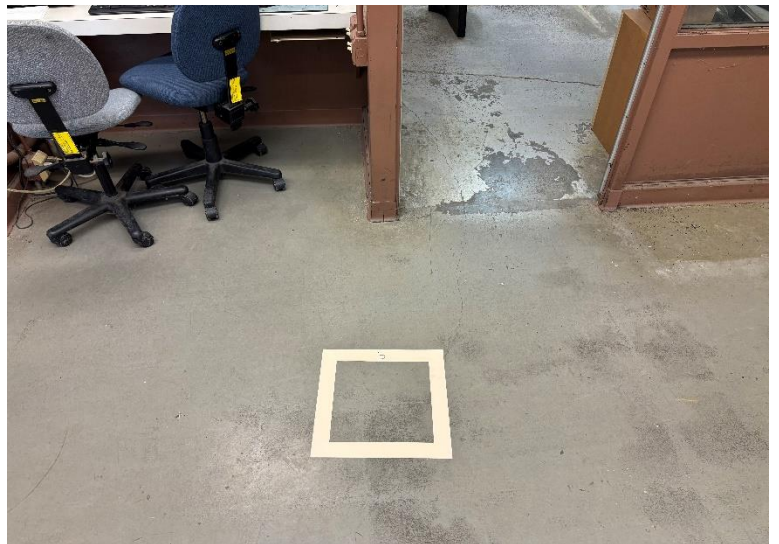
Photo #14

Direction (facing): North

Description: Lead Dust Wipe sample location on firing range office floor. *Firing Range Lead Dust Sample #5*

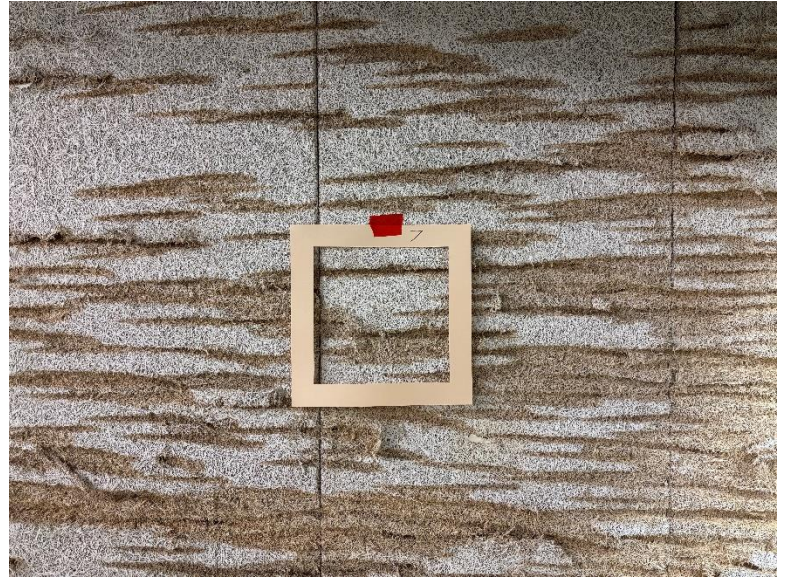
Direction (facing): West

Description: Lead Dust Wipe sample location on west acoustical wall panel. *Firing Range Lead Dust Sample #7*

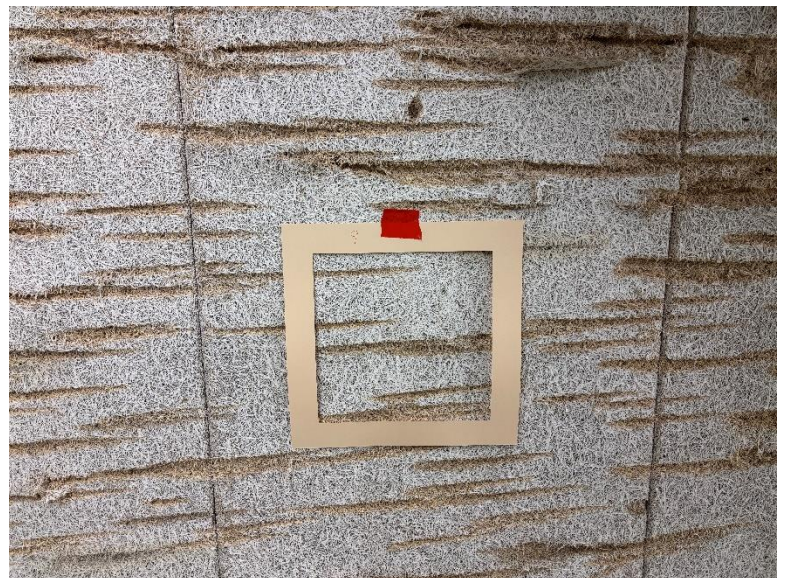
Direction (facing): East

Description: 1 SF Lead Dust Wipe sample location on east acoustical wall panel. *Firing Range Lead Dust Sample #9*

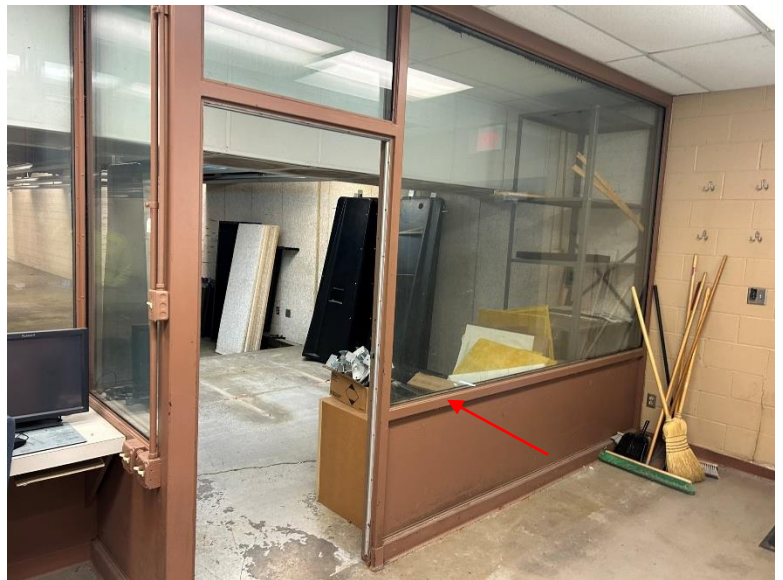
Photo #21

Description: Brown lead-based paint on metal window and door framing located inside firing range building. *XRF Reading No.: LBP-7*

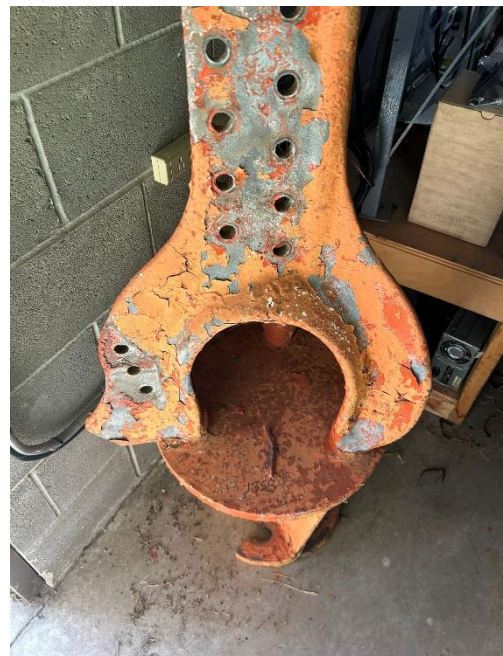
Photo #22

Description: Orange lead-based paint on former radio tower cable anchor located inside Communications Building. *XRF Reading No.: LBP-38*

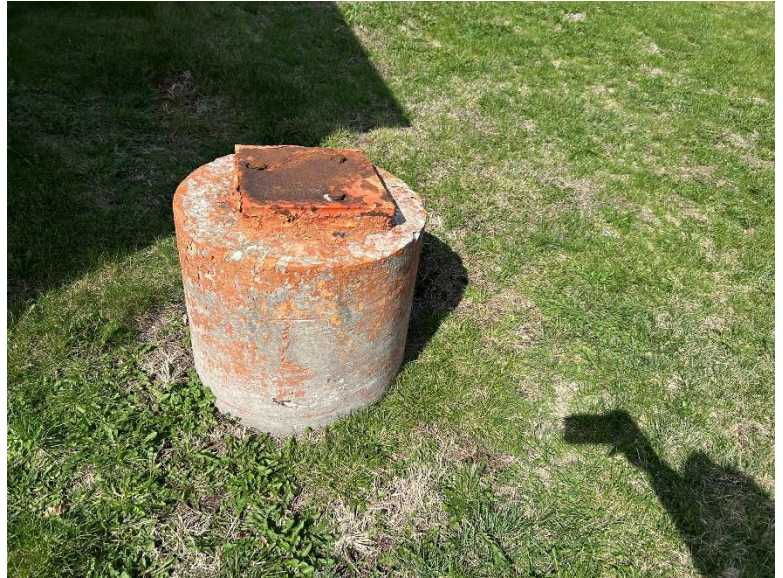
Photo #23

Description: Orange lead-based paint on former
radio tower pier. *XRF Reading No.: LBP-39*

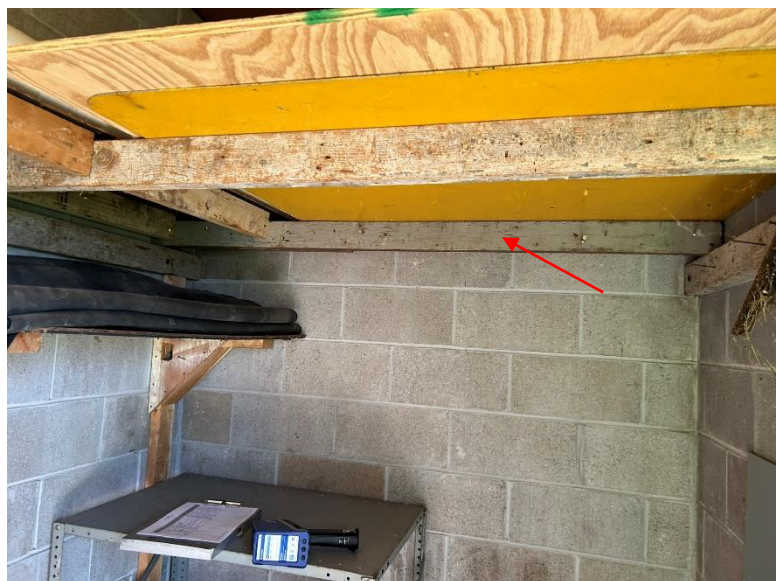
Photo #25

Description: Silver lead-based paint on wood
framing inside storage room of the
Communications Building.
XRF Reading No.: LBP-47

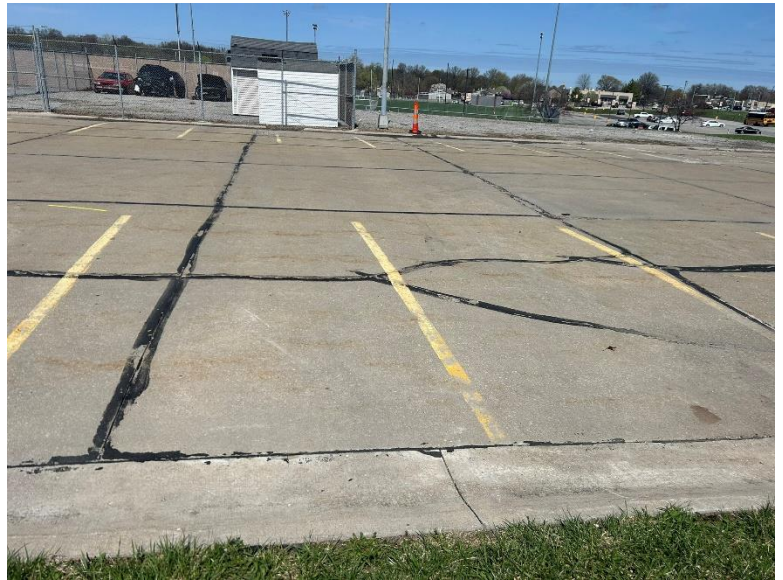
Photo #26

Description: Yellow lead-based paint parking lot
striping. *XRF Reading No.: LBP-47*

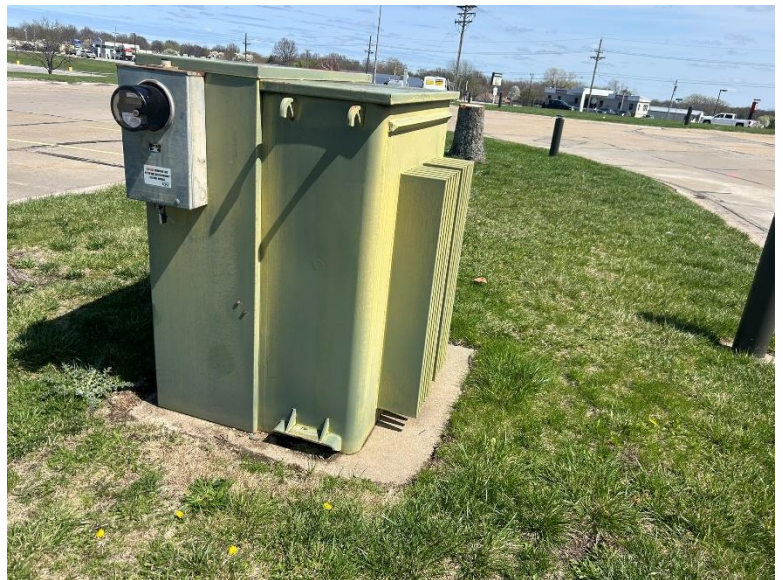
Photo #27

Description: Green lead-based paint on
transformer. *XRF Reading No.: LBP-49*

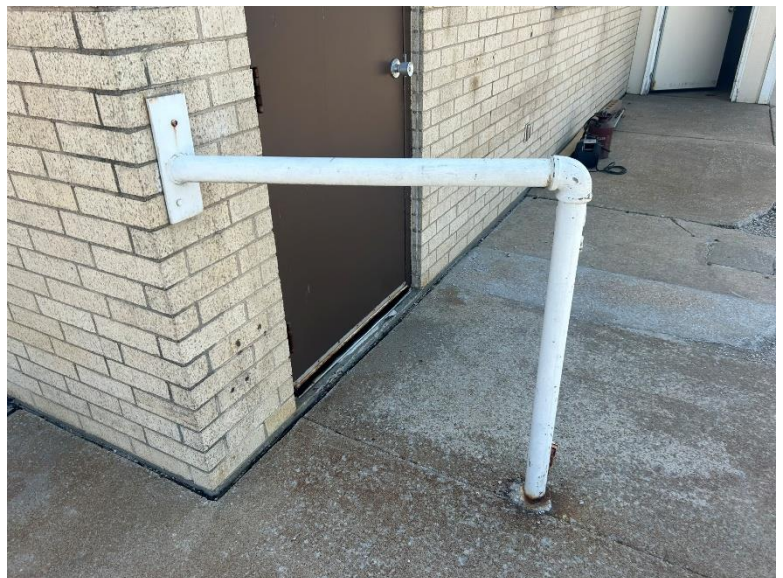
Photo #28

Description: White lead-based paint on handrail
located at the northeast corner of the service
repair garage. *XRF Reading No.: LBP-66*

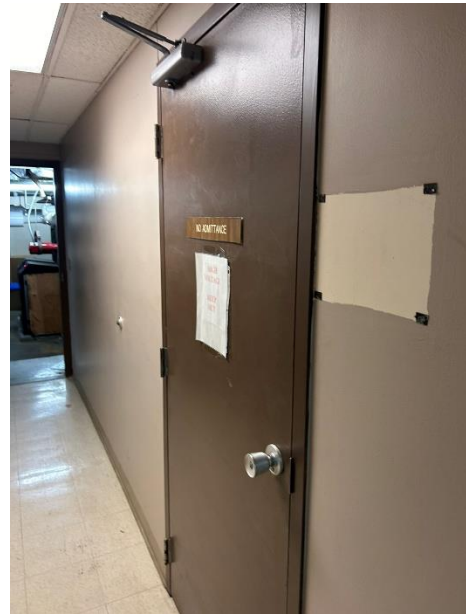
Photo #29

Description: Typical door inside the Main Building with lead-based paint.
XRF Reading No.: LBP-119, 100, and 105

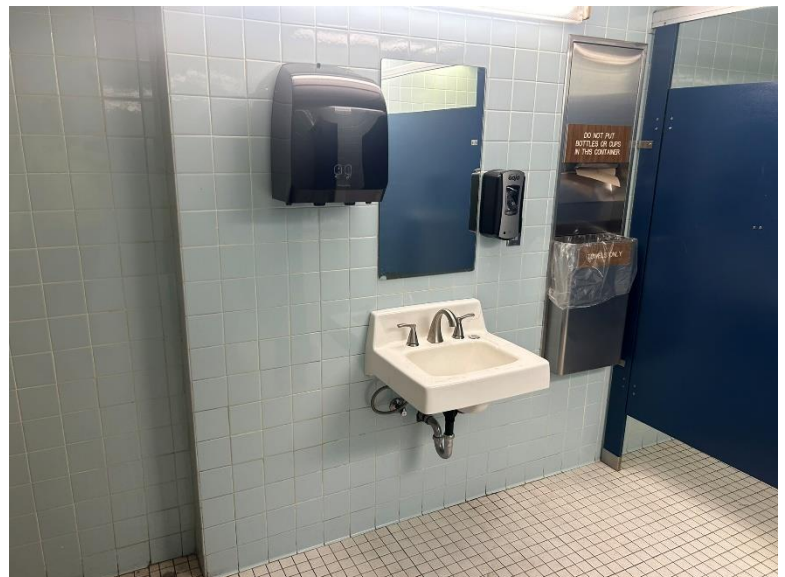
Photo #31

Description: Lead glazing on men's restroom floor and wall tiles, sink, and toilet inside the Main Building. *XRF Reading No.: LBP-108, 109, 112, and 113.*

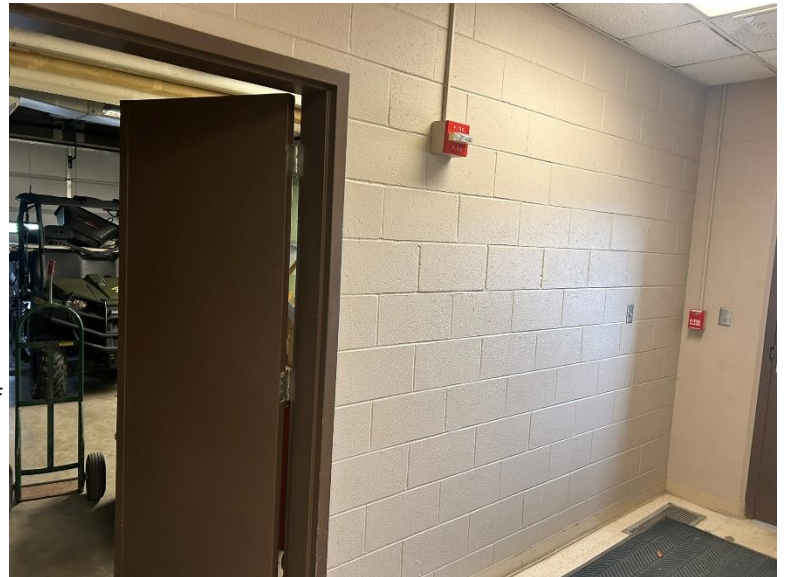
Photo #33

Description: Tan lead-based paint on west wall of the first floor northwest hallway of the Main Building. *XRF Reading No.: LBP-119*

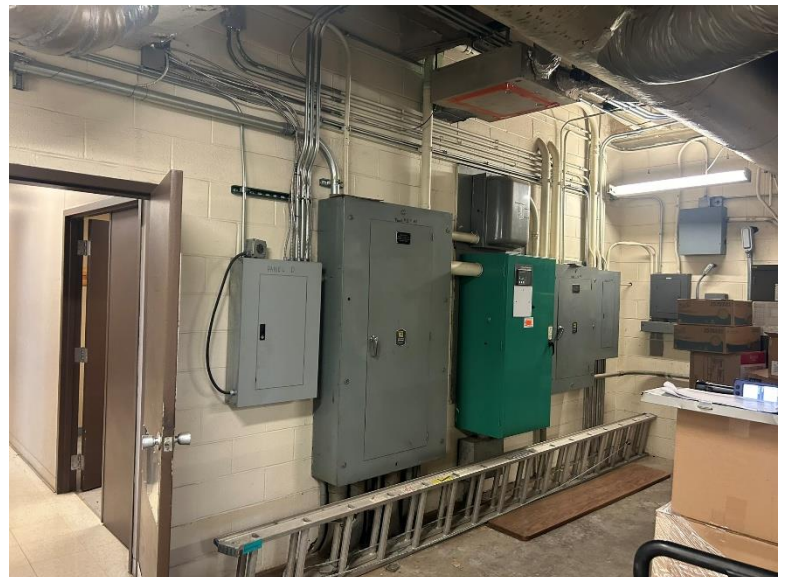
Description: White/green lead-based paint on east and south walls of the first floor northwest mechanical room of the Main Building. *XRF Reading No.: LBP-123 and 125.*
