**SOUTHSIDE PLAZA  
COMMUNITY IMPROVEMENT DISTRICT**

PETITION TO AMEND THE PETITION TO  
ESTABLISH THE SOUTHSIDE PLAZA  
COMMUNITY IMPROVEMENT DISTRICT

LEE'S SUMMIT, JACKSON COUNTY, MISSOURI

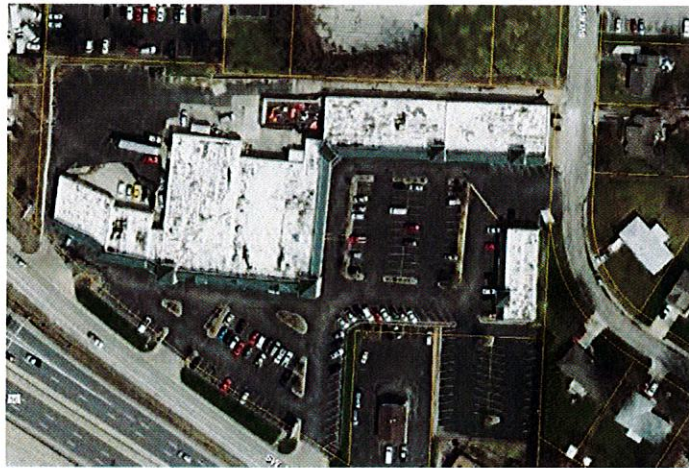
Figure 9 - Before Picture Roof Condition: Year 2010.

From evaluating aerial photographs, it appears that the roof was replaced between 2010 and 2012. Below shows the before and after of the roof replacement. No roof access was available at time of inspection.

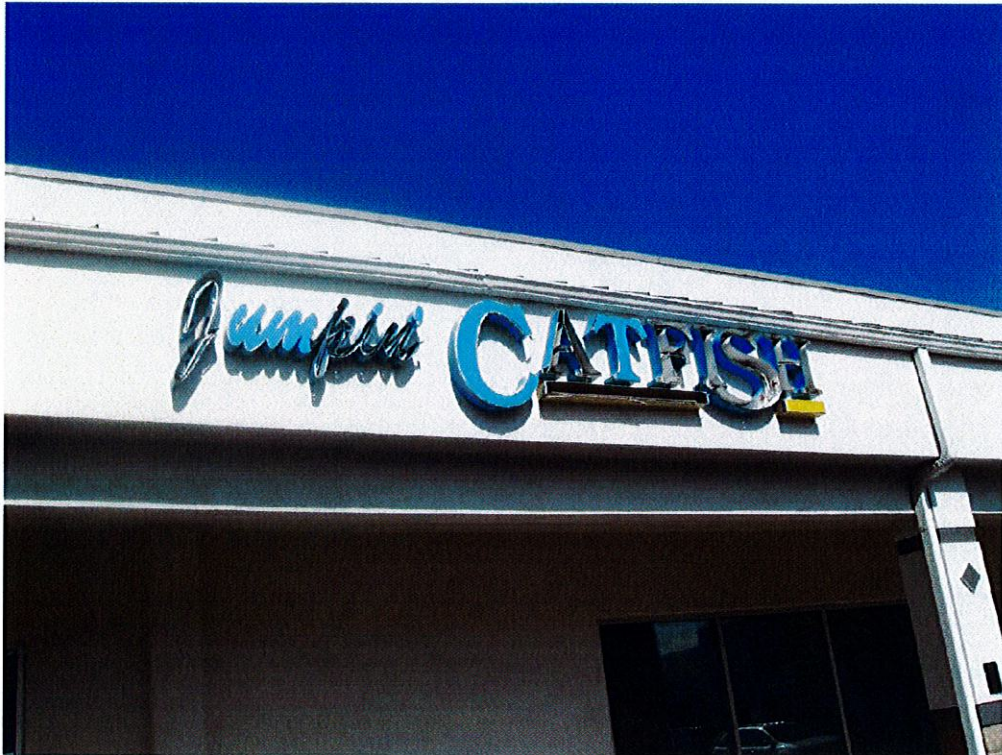
Photo 4 – Deteriorated/damaged tenant signage.

Numerous tenant signs throughout the District were observed to be deteriorated or damaged. This is an indication of deteriorated conditions and a sign of lack of general maintenance.

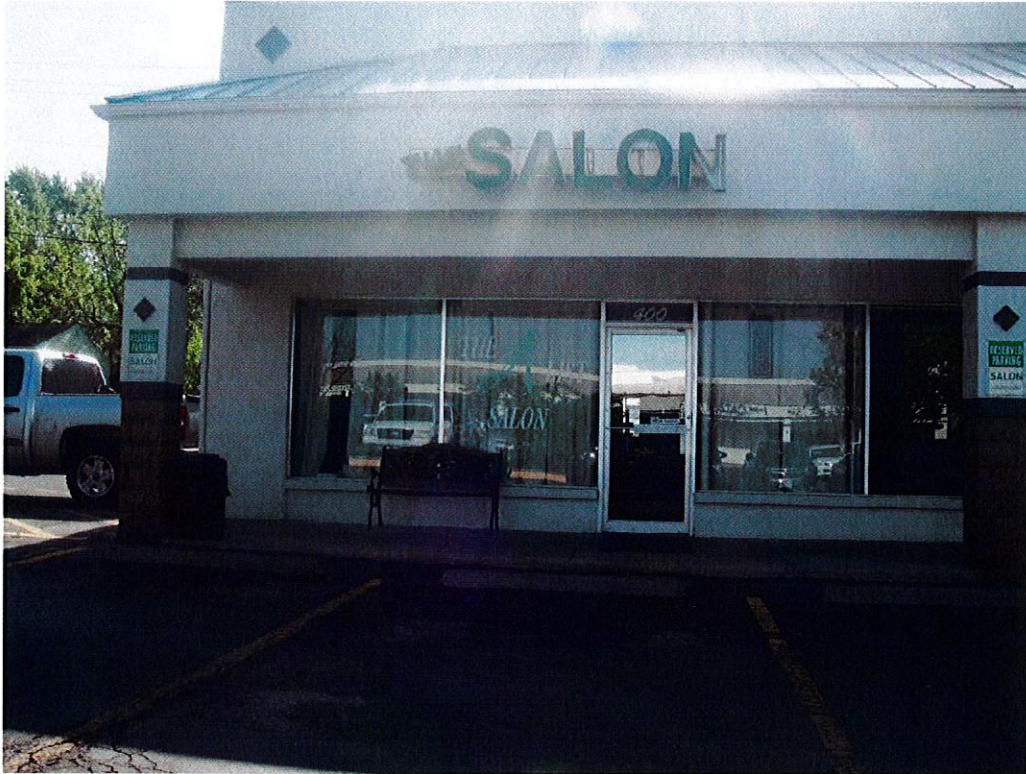
Photo 5 – Deteriorated/damaged tenant signage.

Numerous tenant signs throughout the District were observed to be deteriorated or damaged. This is an indication of deteriorated conditions and a sign of lack of general maintenance.

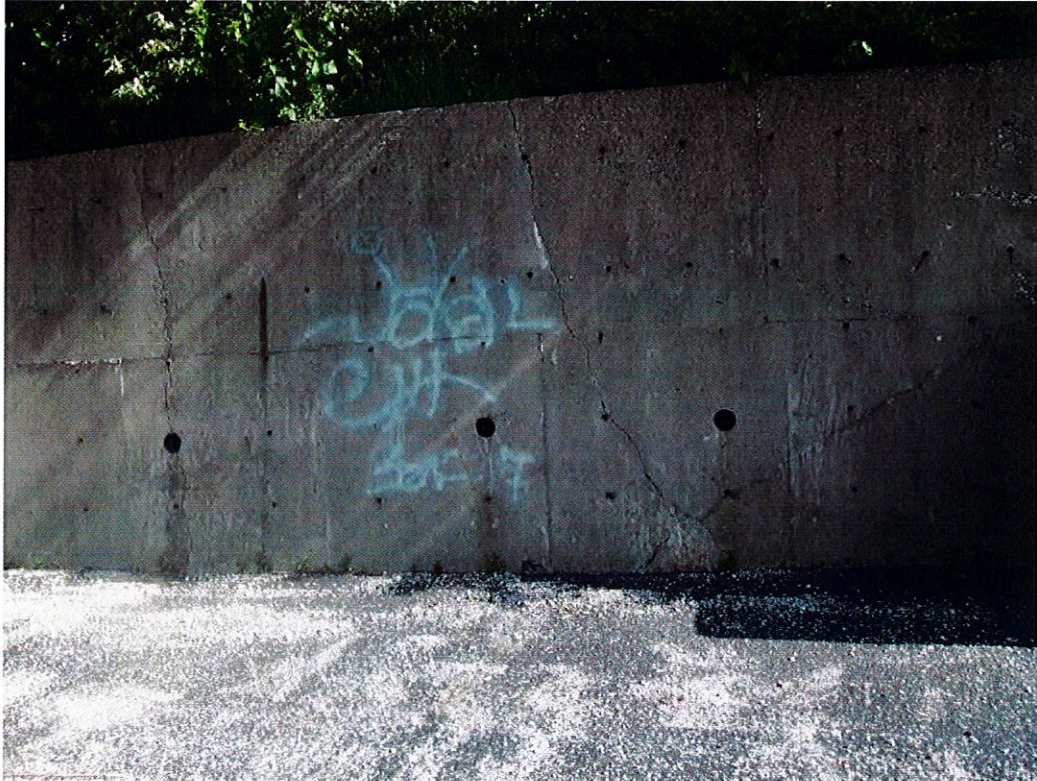
Photo 6 – Graffiti along west and north retaining wall.

Upon inspection, it was noted that graffiti was present in scattered locations throughout the west and northern portion of the District. Graffiti was observed on the west and north retaining walls. This can be an indication of illegal trespassing and vagrancy. Graffiti also can contribute to a social liability of a property or area in that it is unsightly and a sign of illegal activity.

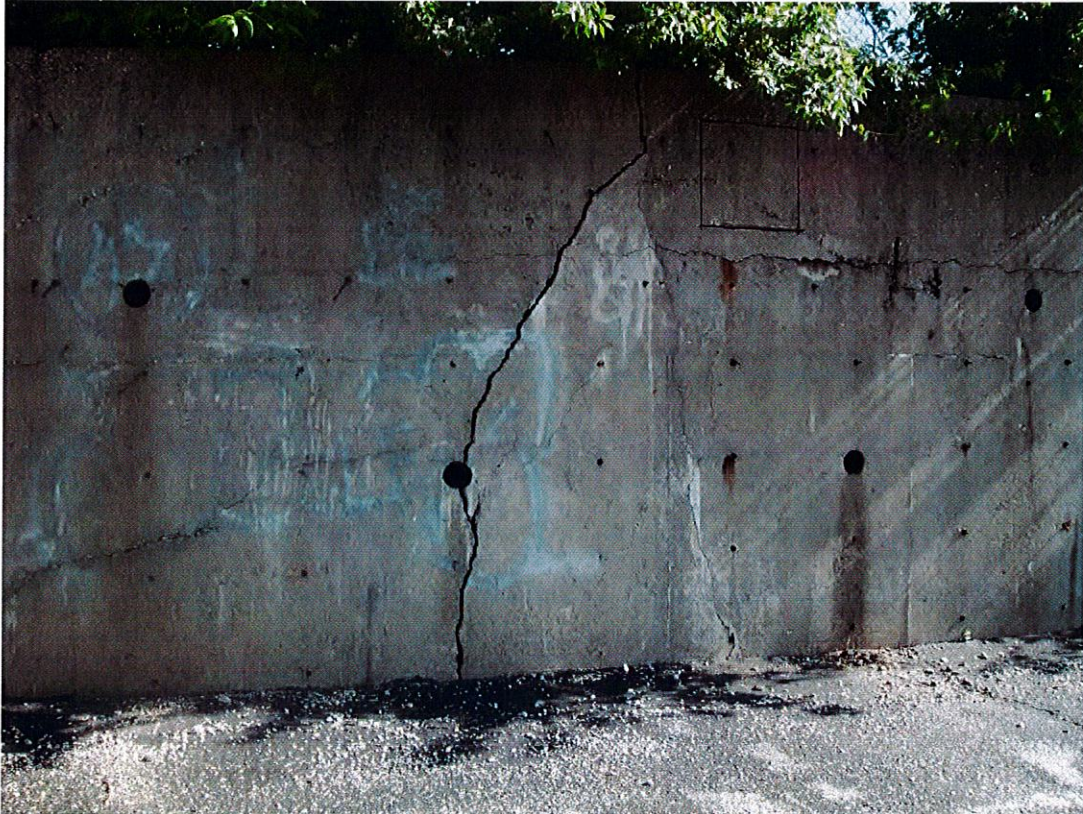
Photo 7 – Graffiti along west and north retaining wall.

Also note the significant vertical crack in the retaining wall, an indication of potential structural failure at this location.

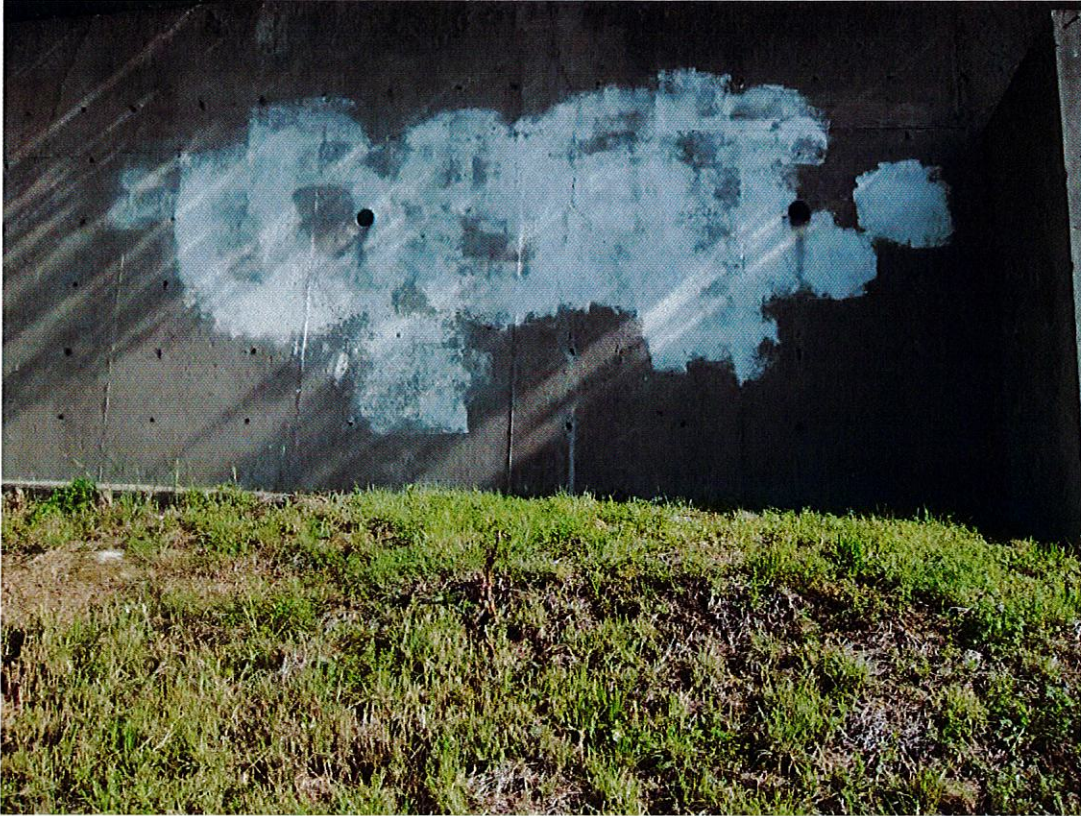
Photo 8 – Graffiti along west and north retaining wall.

Upon inspection, it was noted that graffiti was present in scattered locations throughout the west and northern portion of the District. Graffiti was observed on the west and north retaining walls. This can be an indication of illegal trespassing and vagrancy. Graffiti also can contribute to a social liability of a property or area in that it is unsightly and a sign of illegal activity.

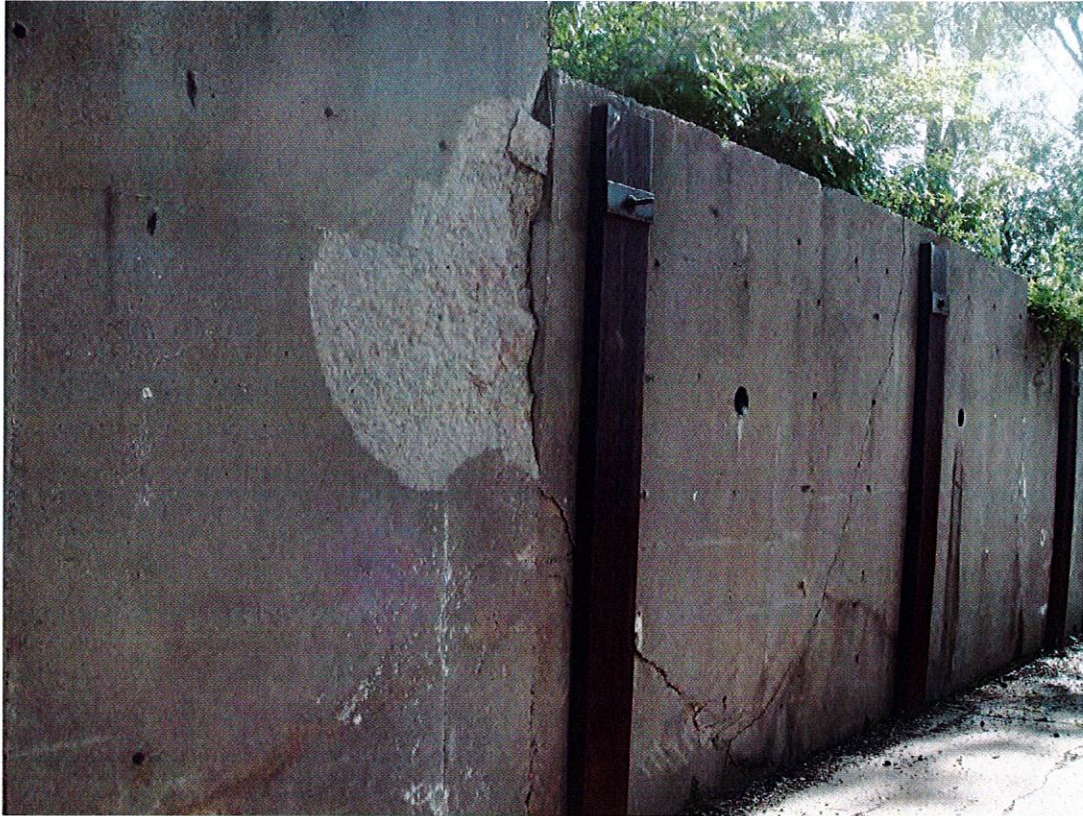
Photo 9 – Deteriorated/compromised retaining wall.

Upon inspection, it was noted that the west and north retaining wall exhibited significant structure deterioration. The photo above shows previous remediation efforts to strengthen and prevent the wall from collapsing, but these efforts appear to have failed. Note significant cracking and concrete spalling, a possible indication that water infiltration has occurred and the drainage system has failed.

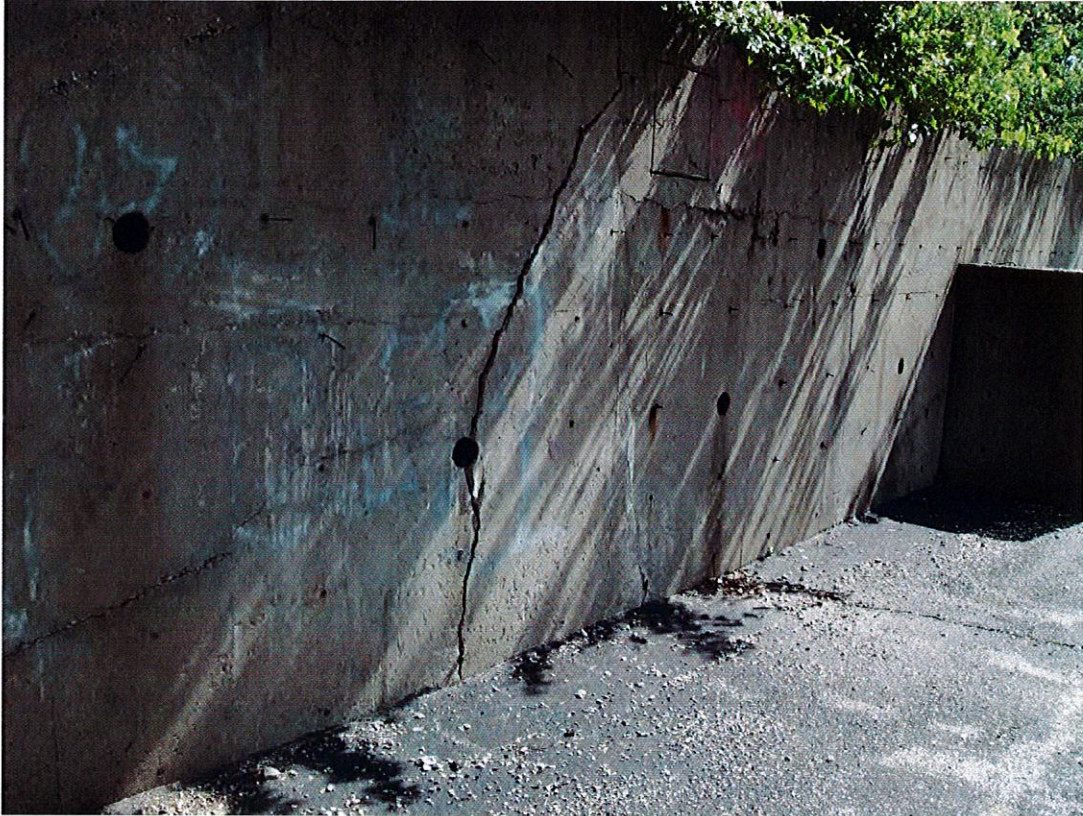
Photo 10 – Deteriorated/compromised retaining wall.

Upon inspection, it was noted that the west and north retaining wall exhibited significant structure deterioration. The photo above shows previous remediation efforts in the form of tie-backs utilized to strengthen and prevent the wall from collapsing, but these efforts appear to have failed. Note significant cracking and concrete spalling, a possible indication that water infiltration has occurred and the drainage system has failed.

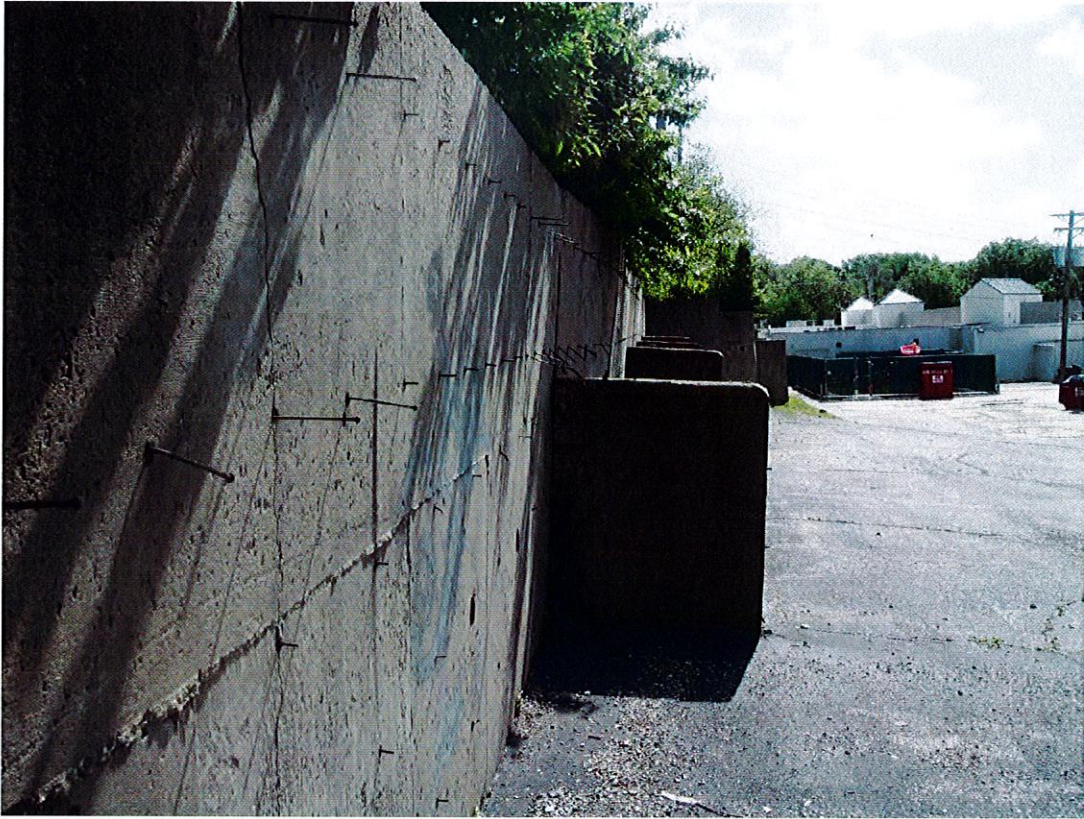
Photo 11 – Deteriorated/compromised retaining wall.

Upon inspection, it was noted that the west and north retaining wall exhibited significant structure deterioration. The photo above shows previous remediation efforts in the form of tie-backs utilized to strengthen and prevent the wall from collapsing, but these efforts appear to have failed. This image also shows buttressing in certain locations to also reinforce the wall.

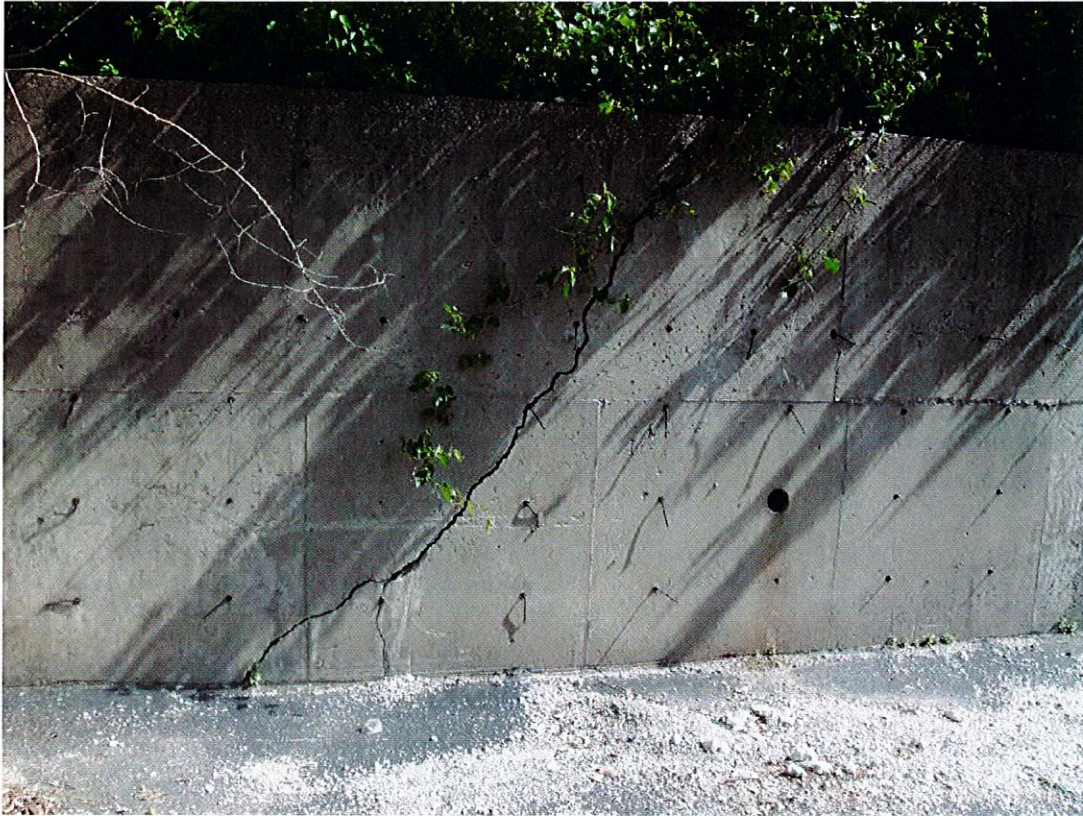
Photo 12 – Deteriorated/compromised retaining wall.

Upon inspection, it was noted that the west and north retaining wall exhibited significant structure deterioration.

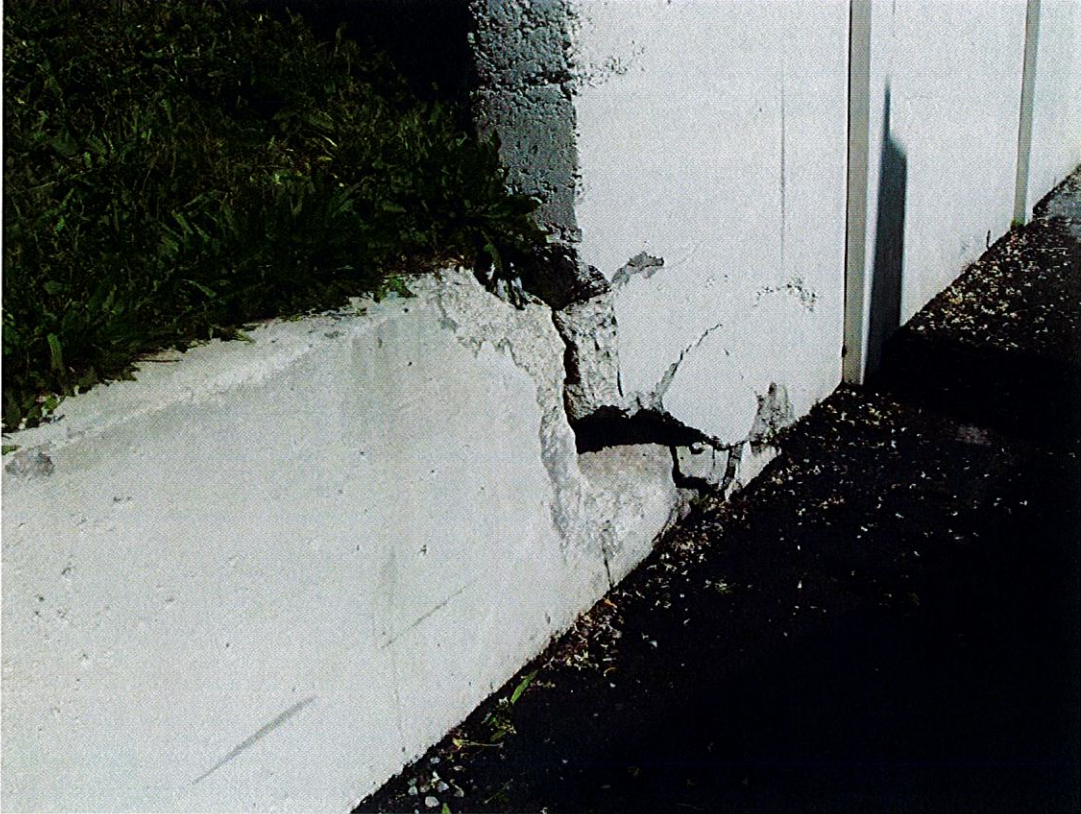
Photo 15 – Deteriorated/compromised retaining wall.

Upon inspection, it was noted that the west and north retaining wall exhibited significant structure deterioration.

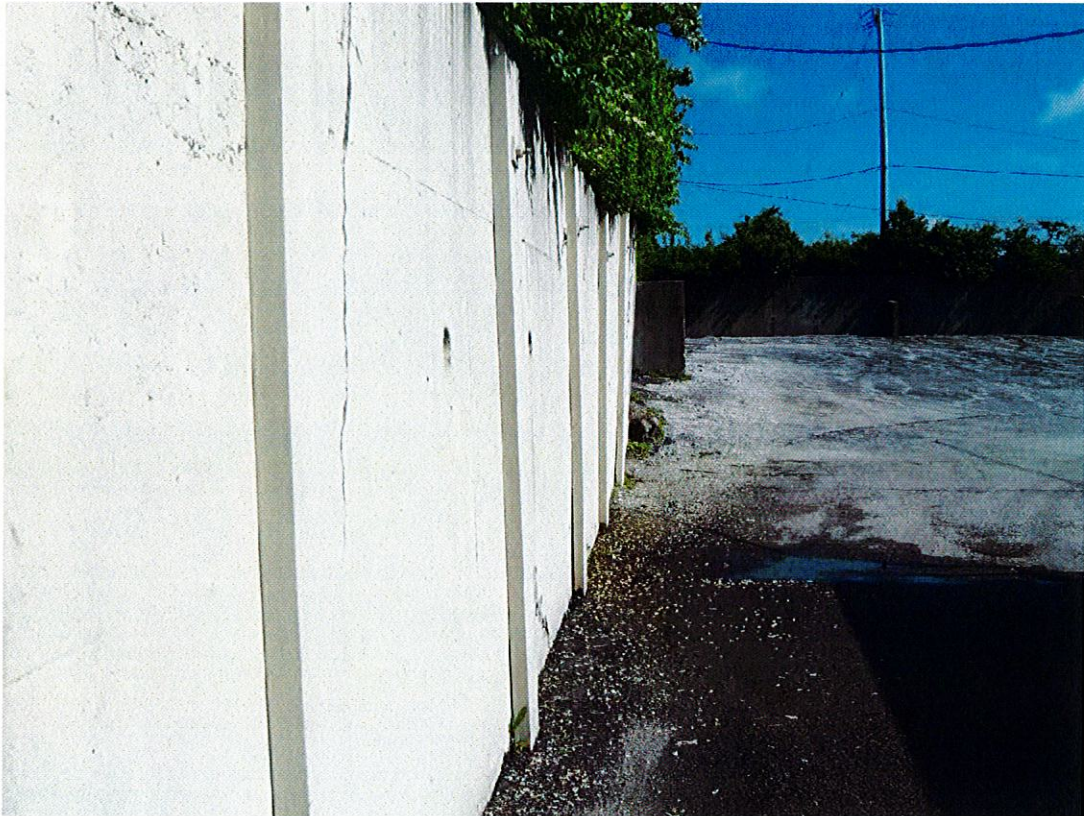
Photo 16 – Deteriorated/compromised retaining wall.

Upon inspection, it was noted that the west and north retaining wall exhibited significant structure deterioration. Deflection in the retaining wall can be noted in this photo.

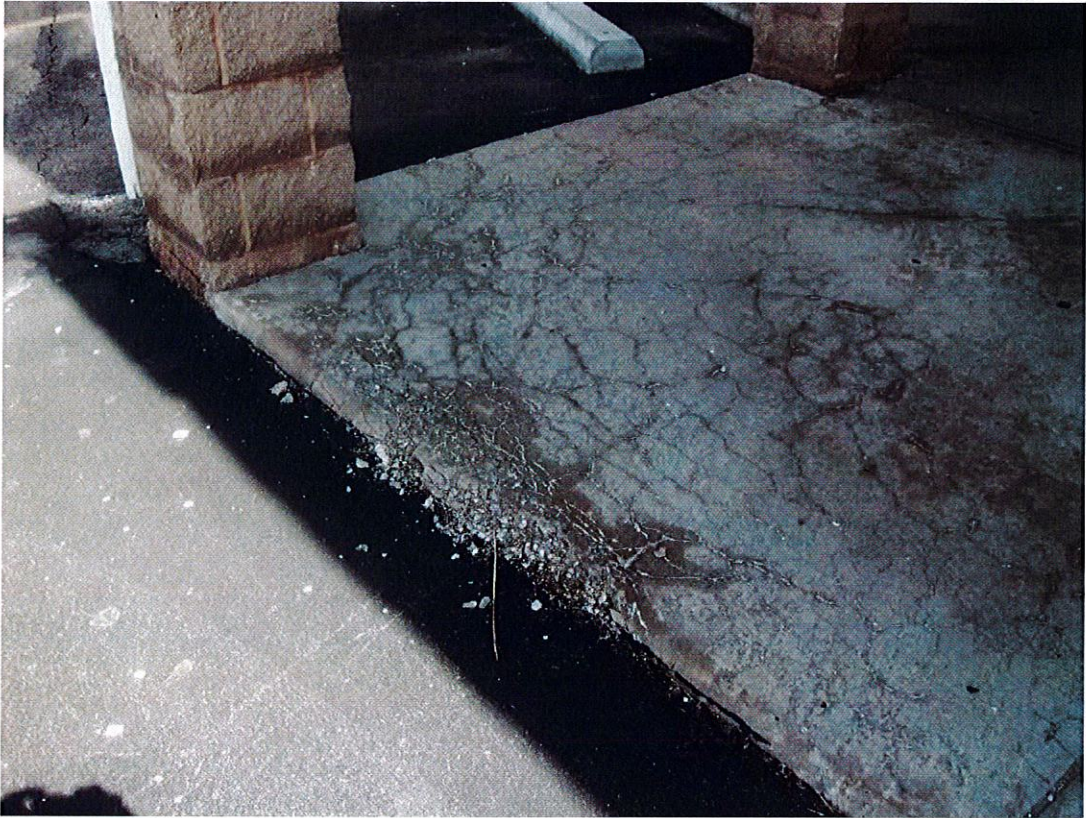
Photo 18 – Deteriorating concrete sidewalk.

Several locations within the District were observed with deteriorating concrete sidewalks. While this is not a critical issue at this point, it does show that if action is not taken continued deterioration could occur.

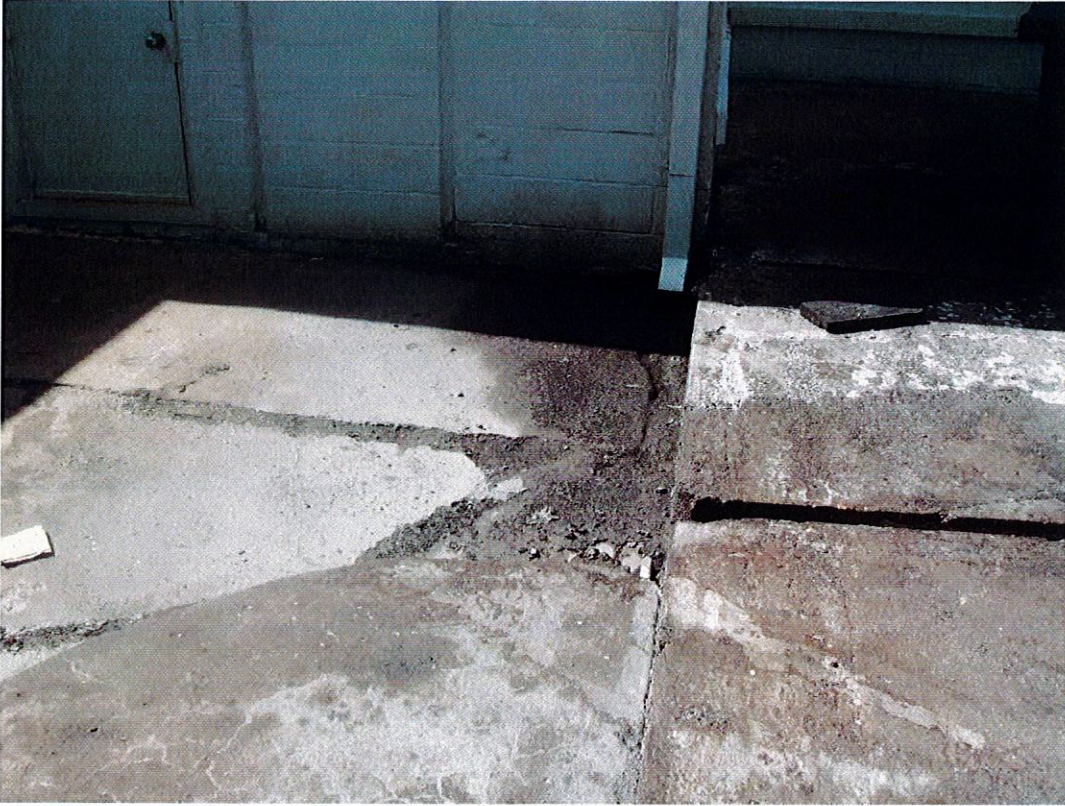
Photo 20 – Inadequate drainage.

Along the northern portion of the shopping center, several locations were noted where roof downspouts were inadequately drained. This can lead to possible water infiltration into the structure of the building.

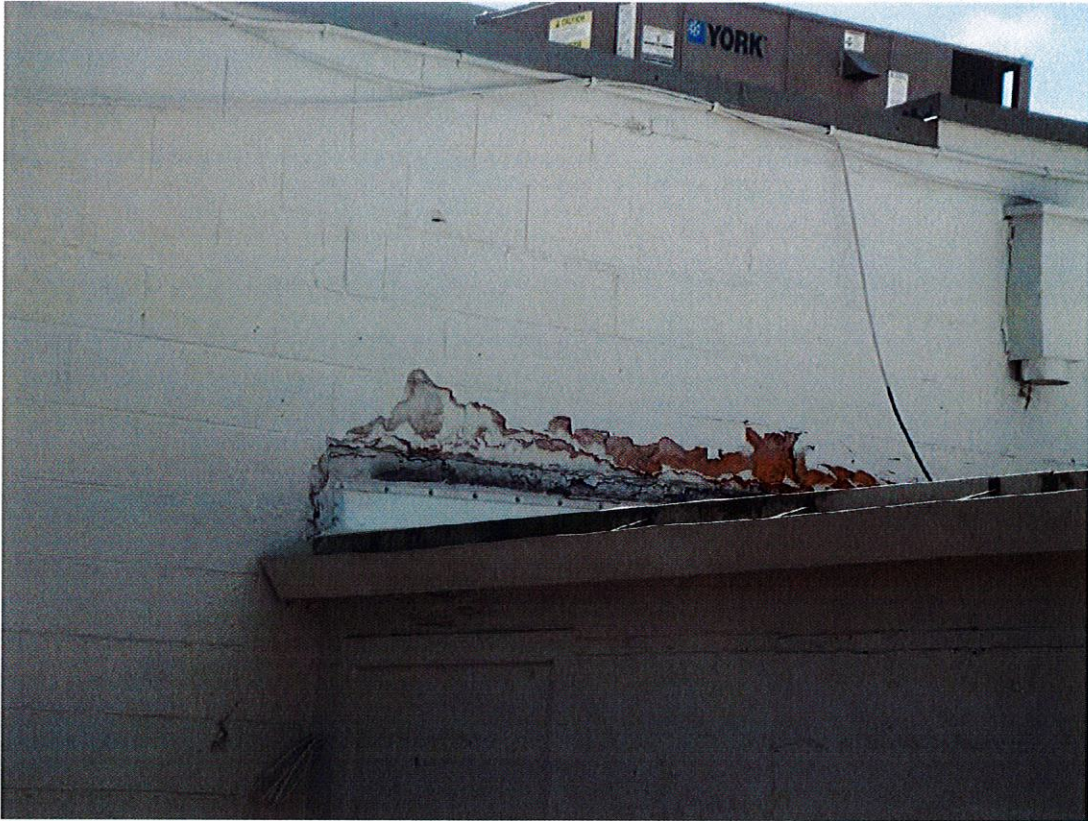
Photo 21 – Deteriorated flashing material.

Also not rainwater gutter system is inadequate and not properly installed.

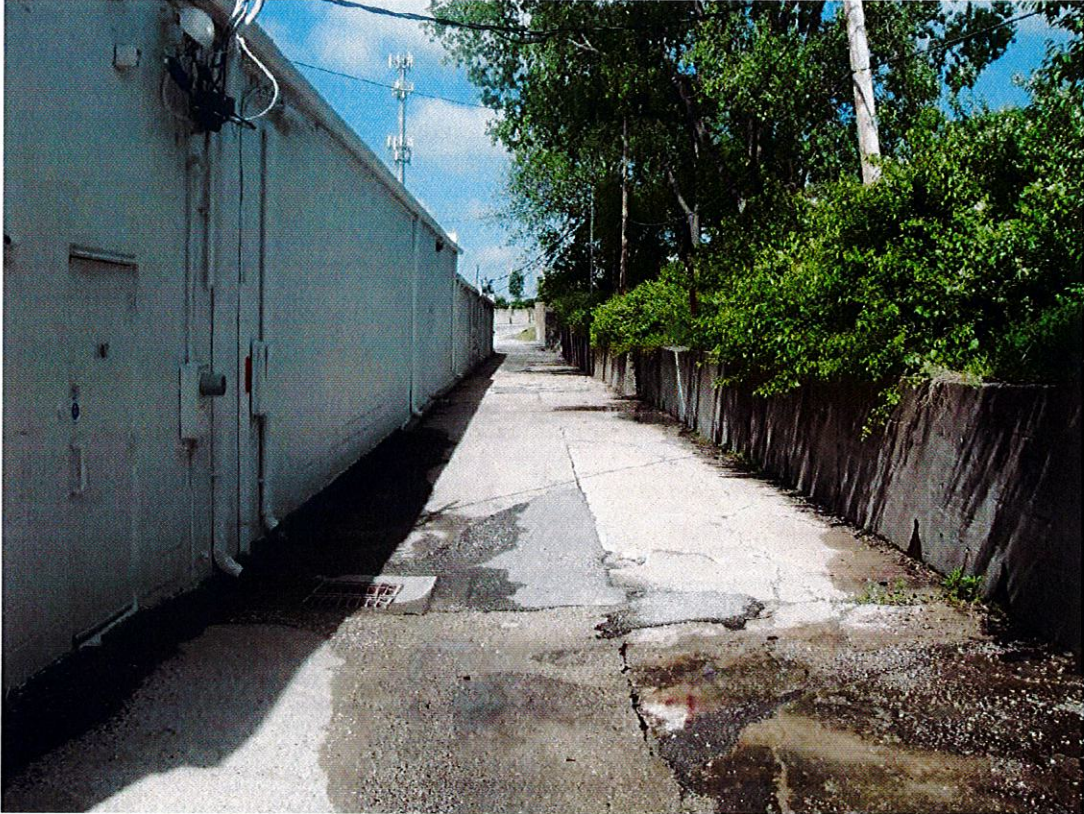
Photo 22 – View of north service alley. Typical of alley condition. Photo looking west.

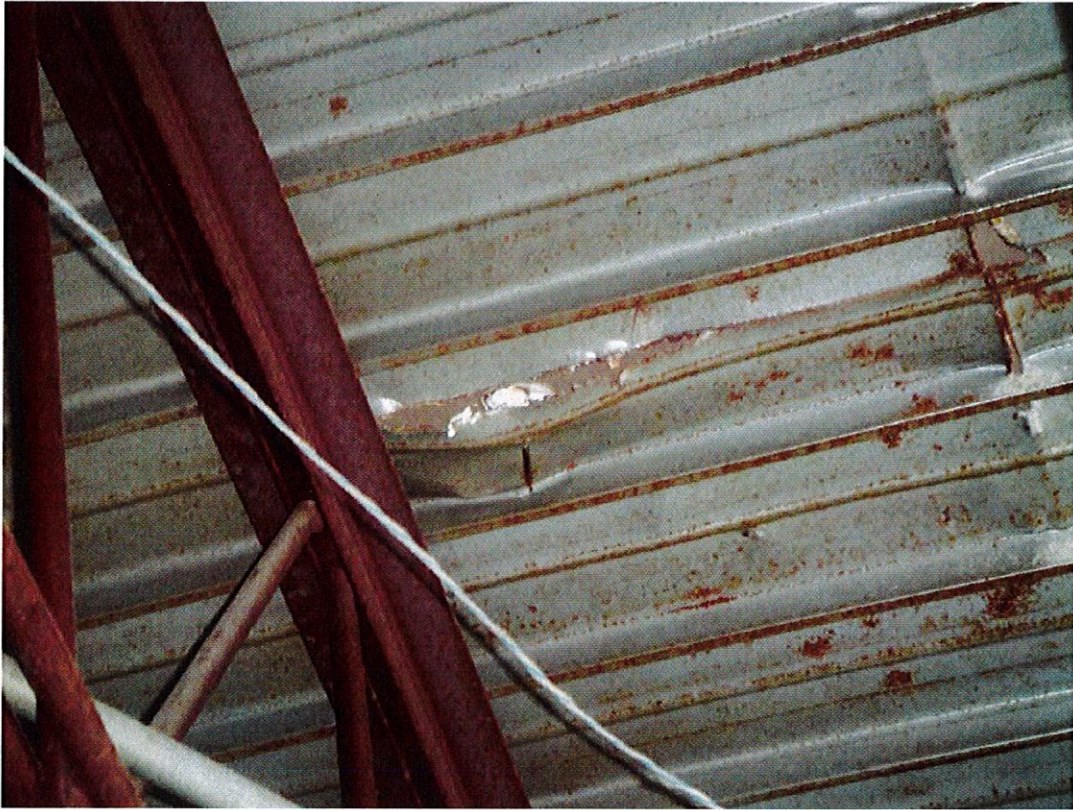
Photo 25 – Roof structure deterioration.

Several locations were observed with deteriorated or damaged roof structures. Deteriorated roof structures can lead to water infiltration and further damage to interior finishes.

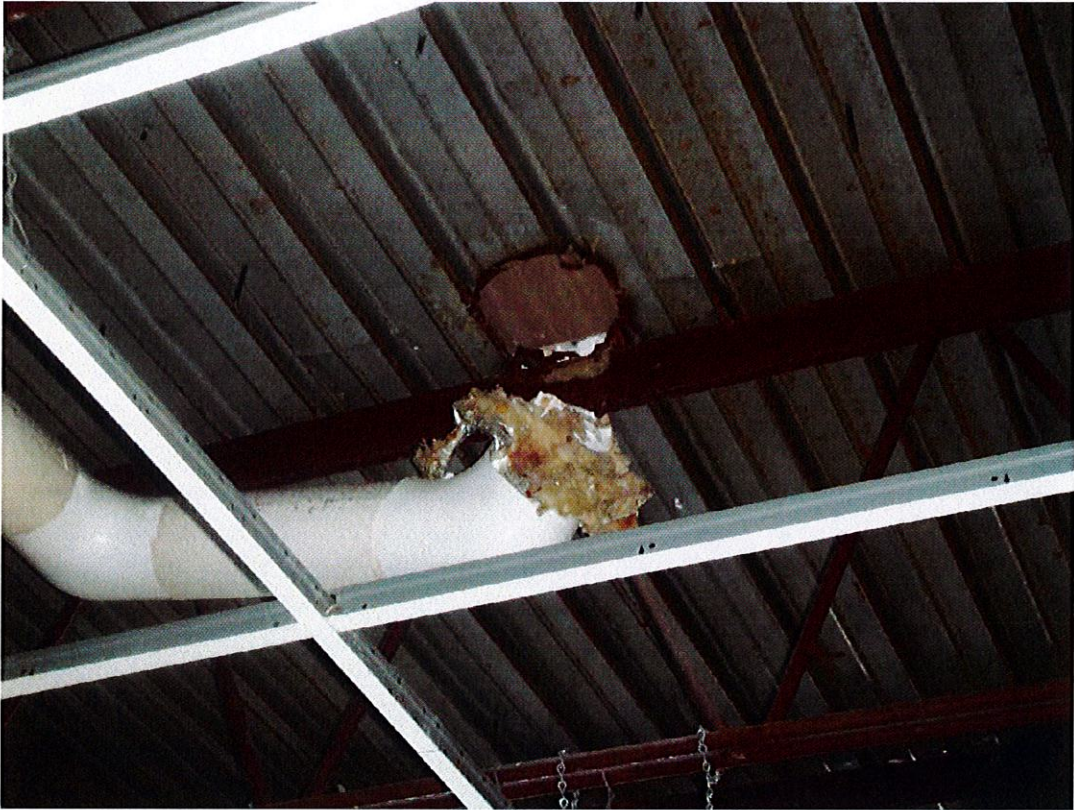
Photo 26 – Roof structure deterioration.

Several locations were observed with deteriorated or damaged roof structures. Deteriorated roof structures can lead to water infiltration and further damage to interior finishes.

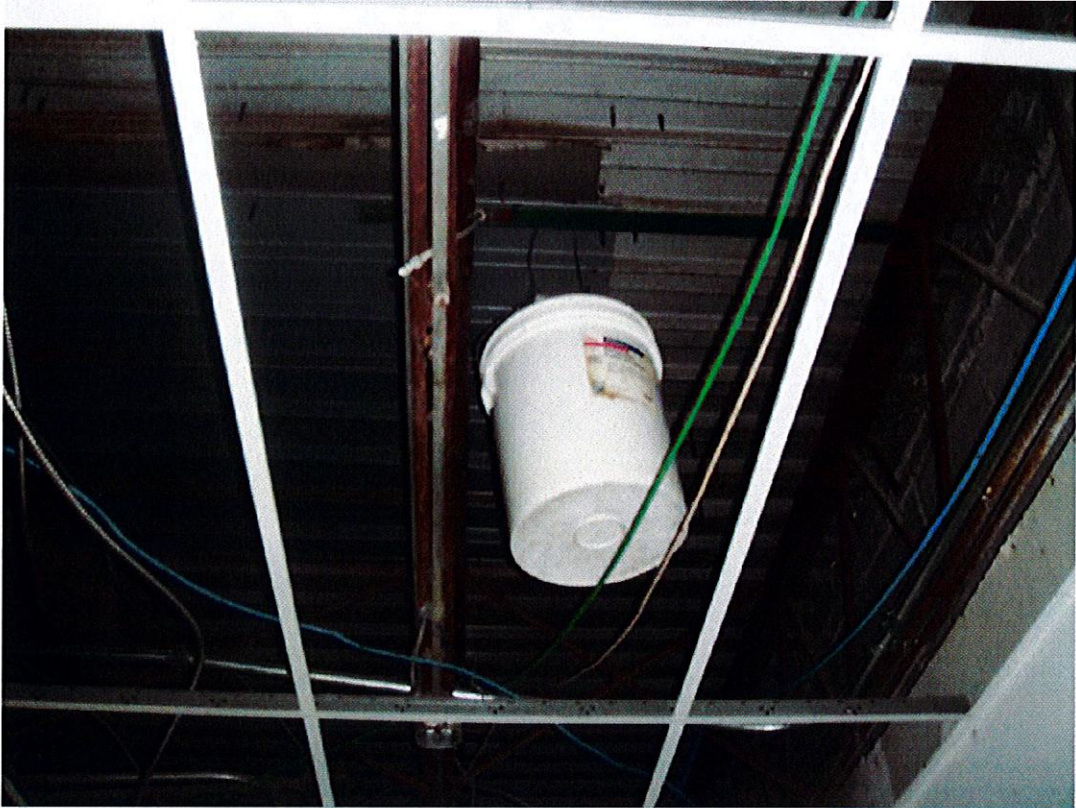
Photo 27 – Roof structure deterioration.

Several locations were observed with deteriorated or damaged roof structures. Deteriorated roof structures can lead to water infiltration and further damage to interior finishes. This images shows a temporary water catchment system.

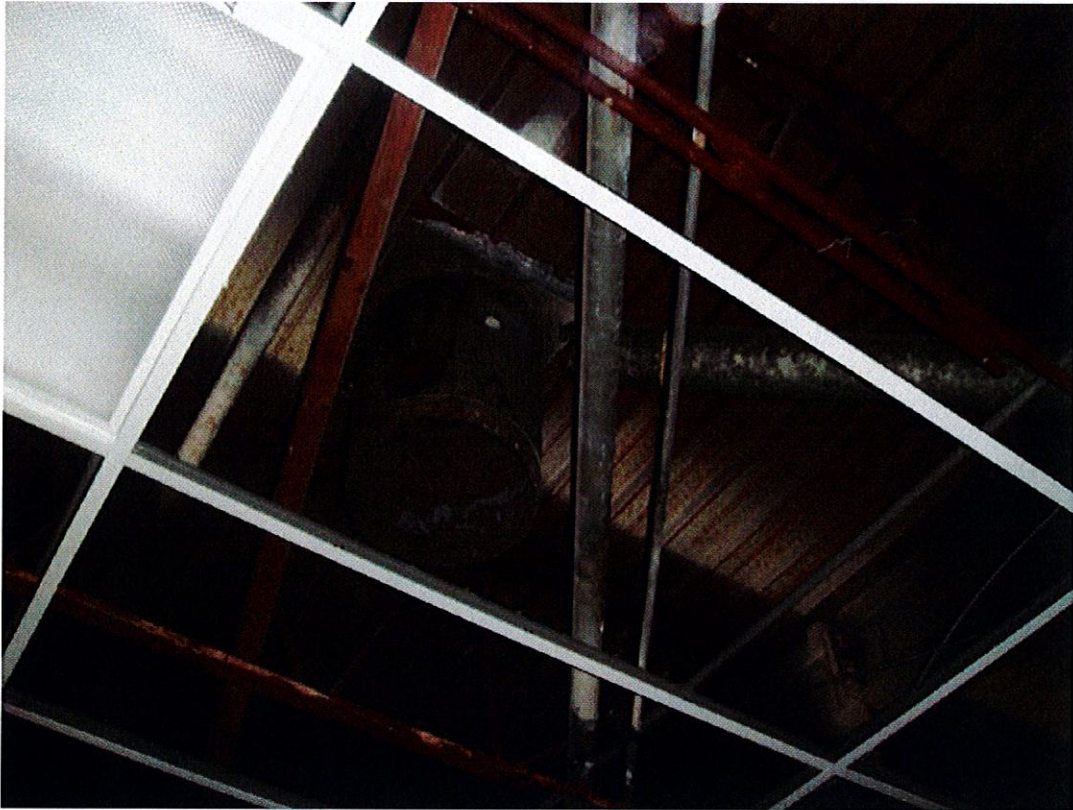
Photo 28 – Roof structure deterioration.

Several locations were observed with deteriorated or damaged roof structures. Deteriorated roof structures can lead to water infiltration and further damage to interior finishes. This image appears to be abandoned roof service vents. Access to the roof was unavailable, so conditions above this location were not observed.

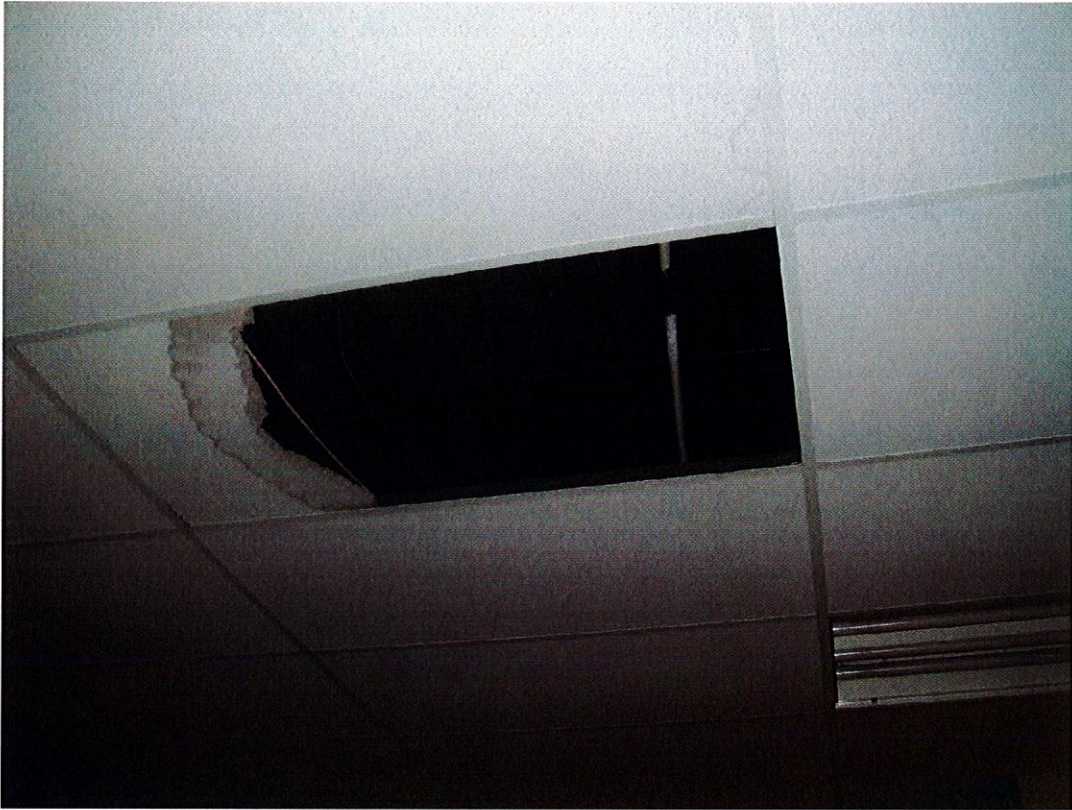
Photo 29 – Interior ceiling tile deterioration.

Deteriorated/damaged ceiling tile shows water damage and deterioration to the point that it has fallen to the floor. This is an indication that the roof structure is compromised at this location.

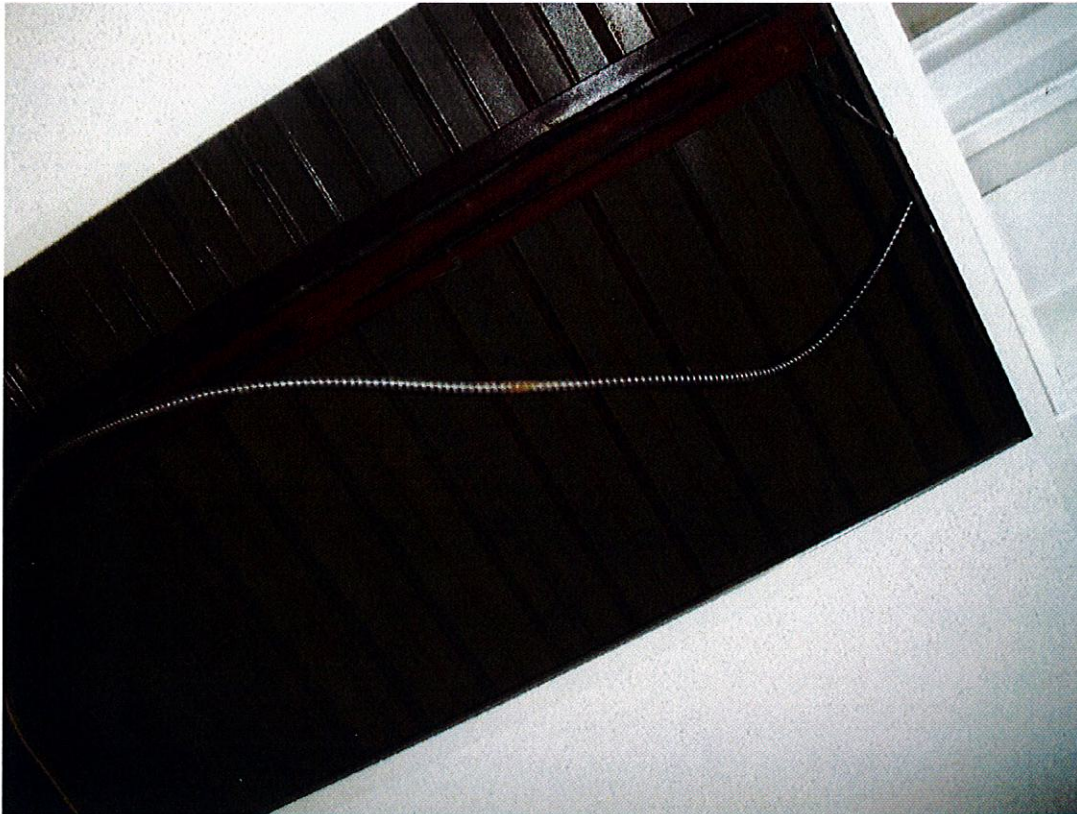
Photo 30 – Roof structure condensation.

Upon inspection, several locations were noted which significant condensation was observed on the underside of the roof structure. This was significant enough that it was dripping and falling onto the ceiling and floor below.

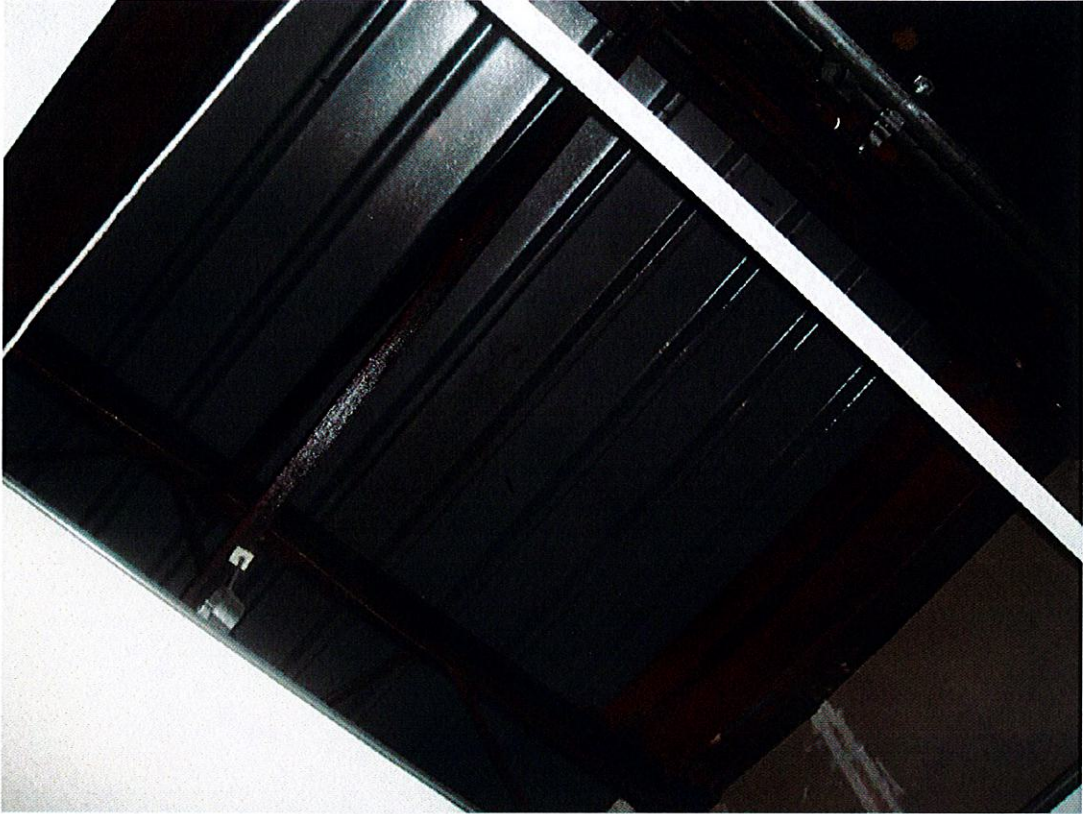
Photo 32 – Roof structure condensation.

Upon inspection, several locations were noted which significant condensation was observed on the underside of the roof structure. This was significant enough that it was dripping and falling onto the ceiling and floor below.

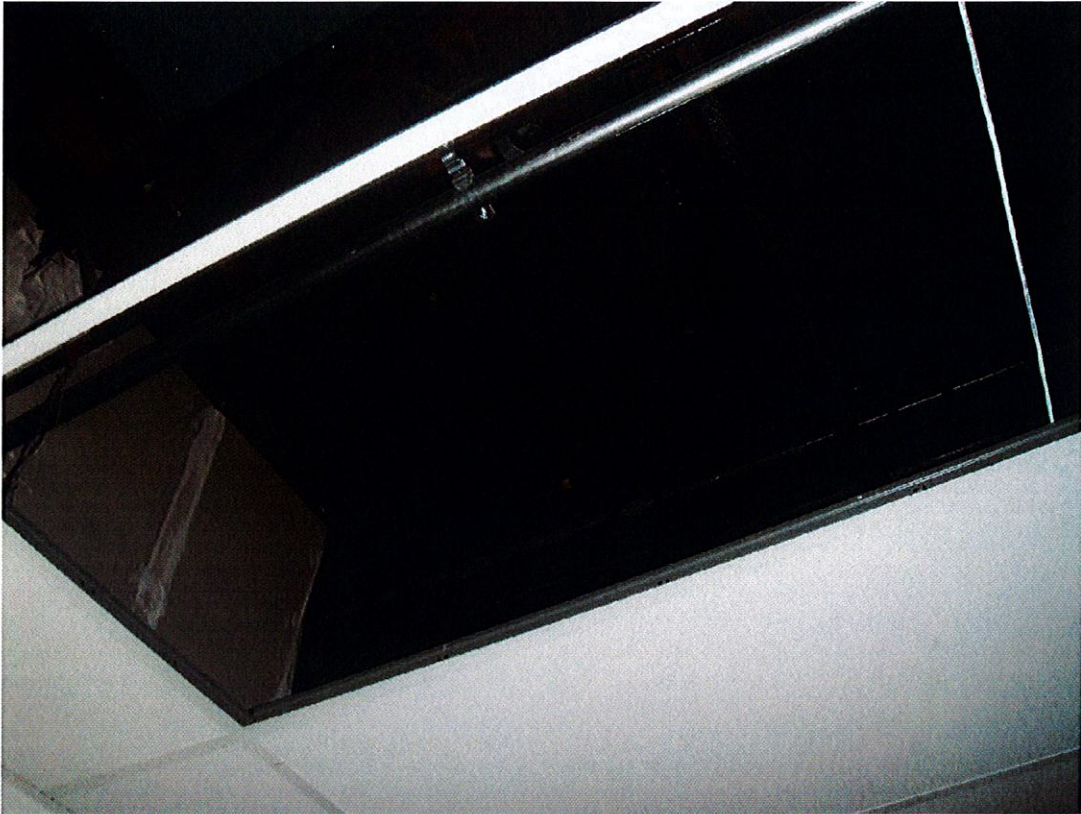
Photo 33 – Roof structure condensation.

Upon inspection, several locations were noted which significant condensation was observed on the underside of the roof structure. This was significant enough that it was dripping and falling onto the ceiling and floor below.

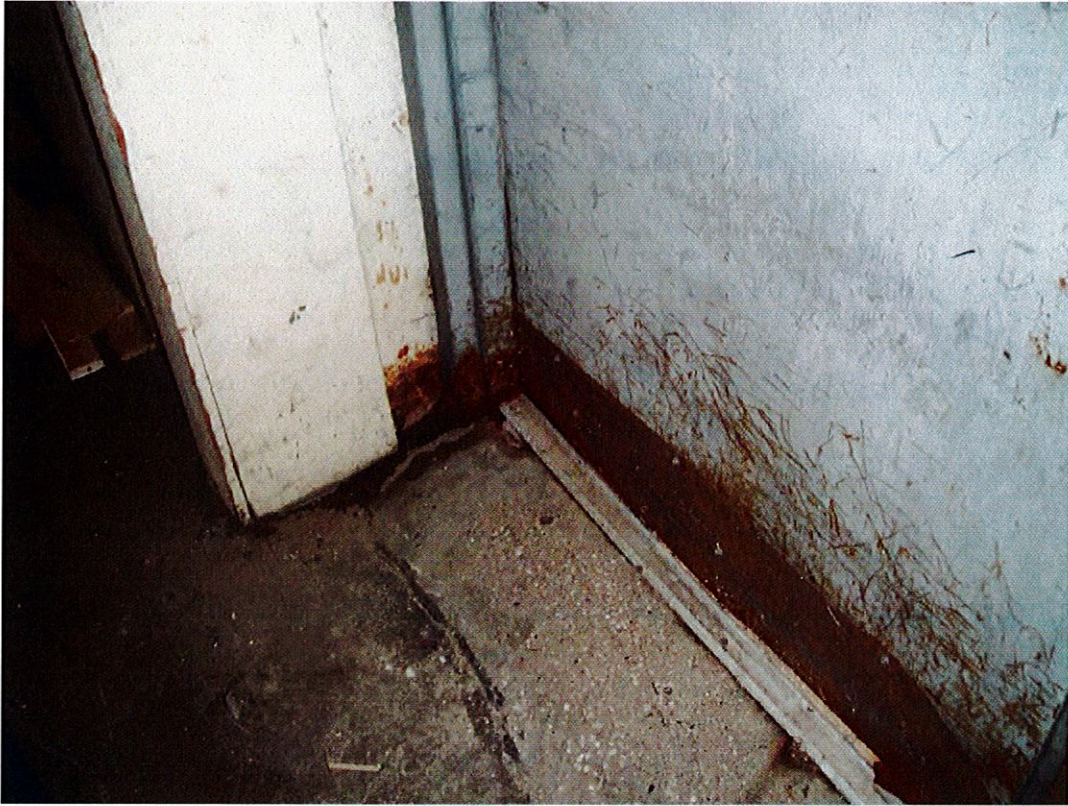
Photo 35 – Deteriorating exterior tenant door.

Tenant exterior door and frame exhibited significant rust and rot at this location. This is a sign of inadequate drainage from the exterior.
