**SOUTHSIDE PLAZA  
COMMUNITY IMPROVEMENT DISTRICT**

PETITION TO AMEND THE PETITION TO  
ESTABLISH THE SOUTHSIDE PLAZA  
COMMUNITY IMPROVEMENT DISTRICT

LEE'S SUMMIT, JACKSON COUNTY, MISSOURI

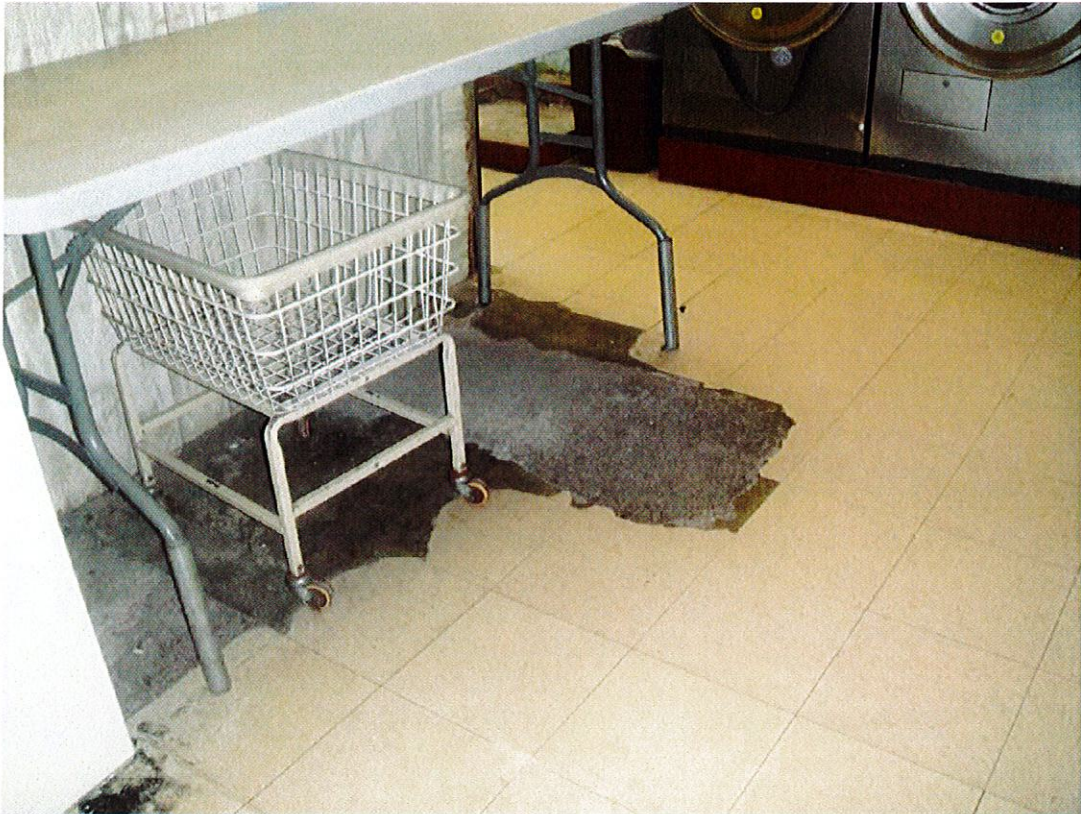
Photo 36 – Deteriorated/damaged floor tile.

Due to the age of improvements within the District, a number of finish materials exhibit wear and tear, often in highly trafficked areas. A regular operations and maintenance program would alleviate these conditions on an annual basis.

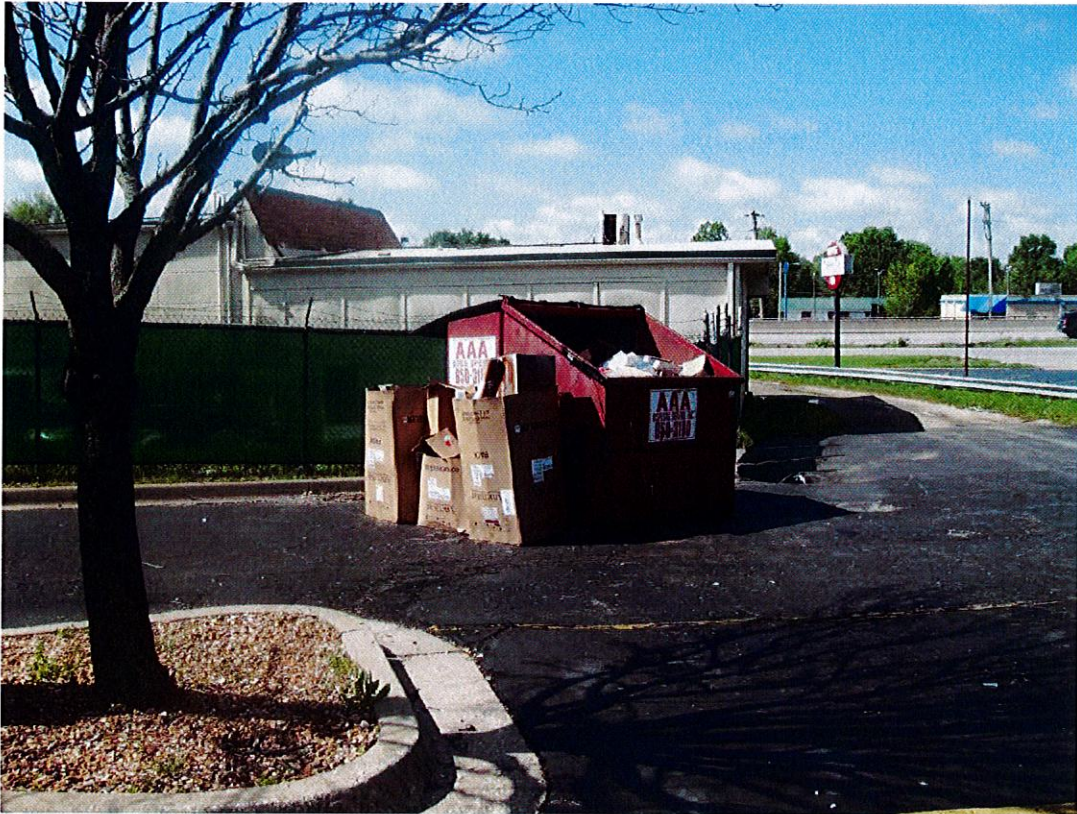
Photo 37 – Overflowing trash dumpster.

Excessive trash and debris was noted at this dumpster location. This condition could promote rodent infestation in and around the property.

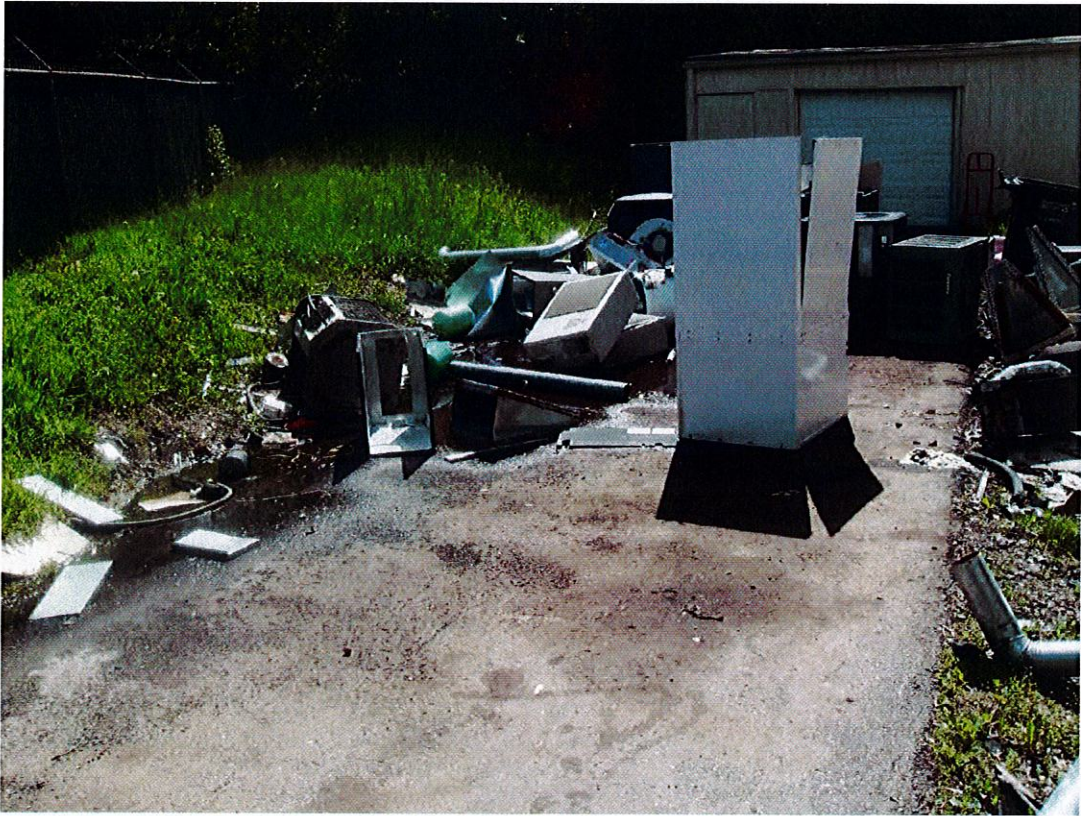
Photo 38 – Excessive exterior storage.

One location within the District exhibited excessive exterior storage. Much of the materials appear to be scrap materials or trash. It should be noted that the area was fenced and screened, but was still readily observable.

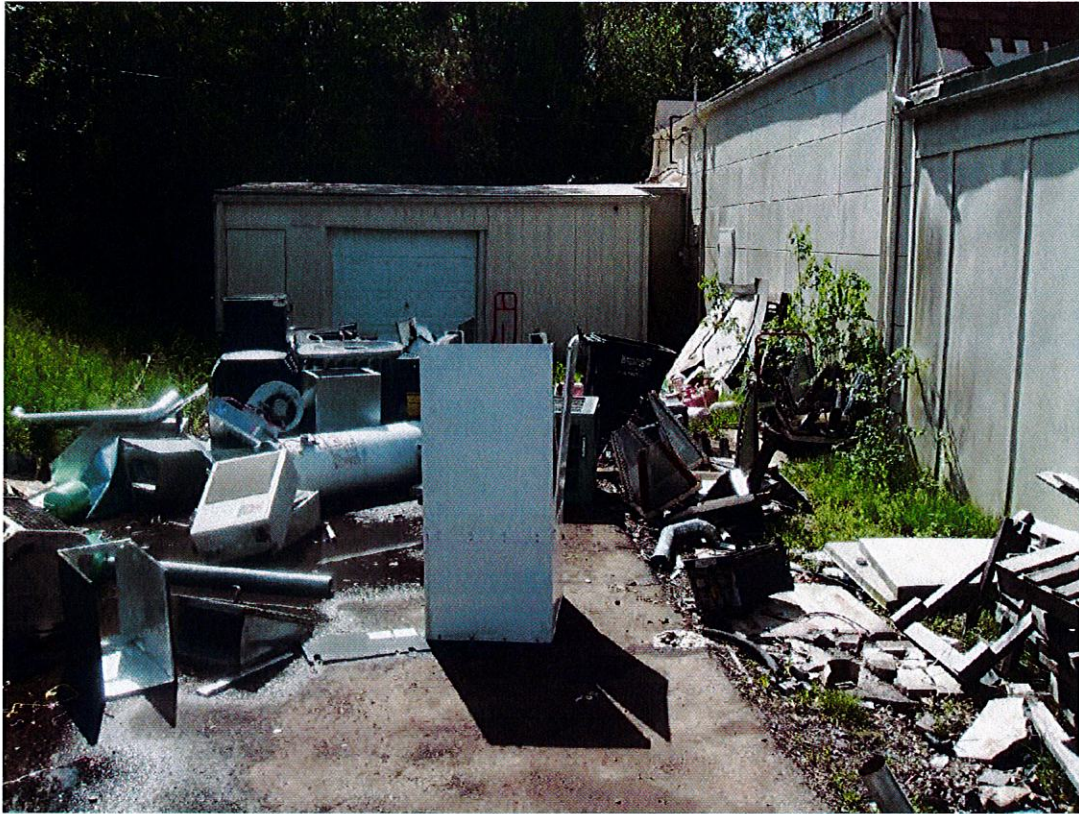
Photo 39 – Excessive exterior storage.

One location within the District exhibited excessive exterior storage. Much of the materials appear to be scrap materials or trash. It should be noted that the area was fenced and screened, but was still readily observable.

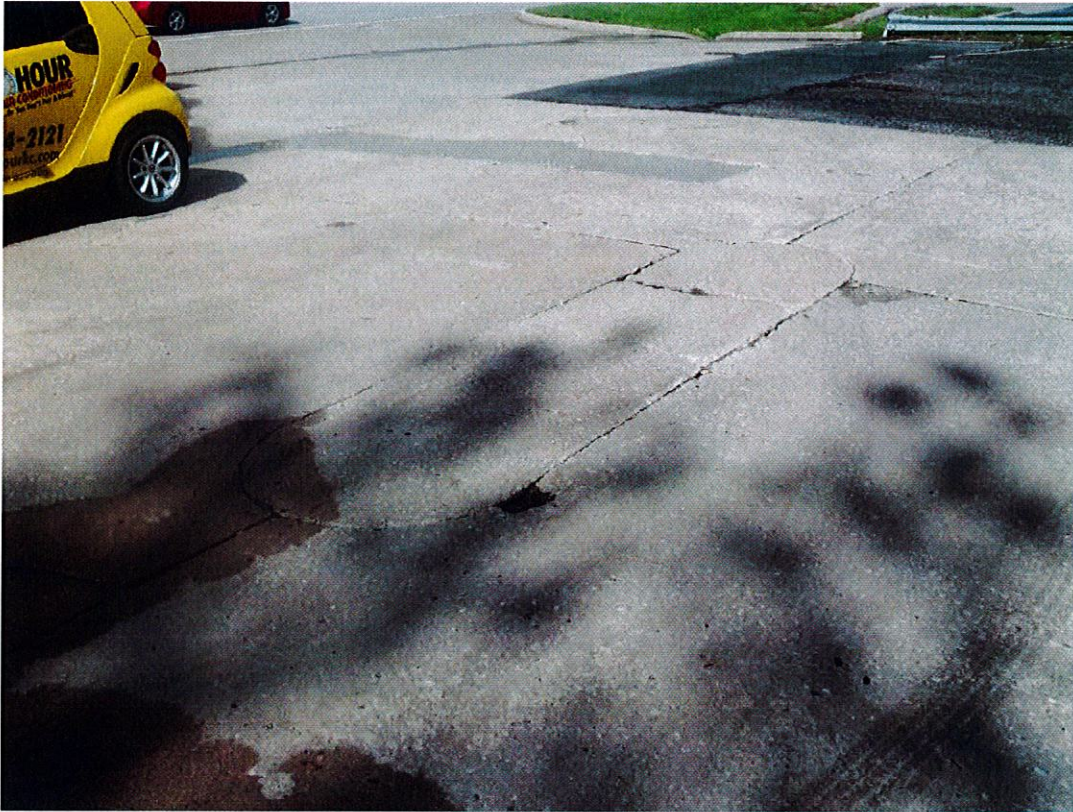
A Phase II Environmental Site Assessments was conducted on August 3, 2005. It was stated that Parcel #2 - 712 Southwest Blue Parkway was a former gas station. Former gas pump locations were noted. Confirmation and records of formal underground storage tank (UST) removal were not obtained as part of this analysis. Soil borings extracted during the analysis did not show levels above thresholds that would warrant additional action. That address is currently occupied by One Hour Heating and Air Conditioning.

Photo 40 – Former gas pump location.

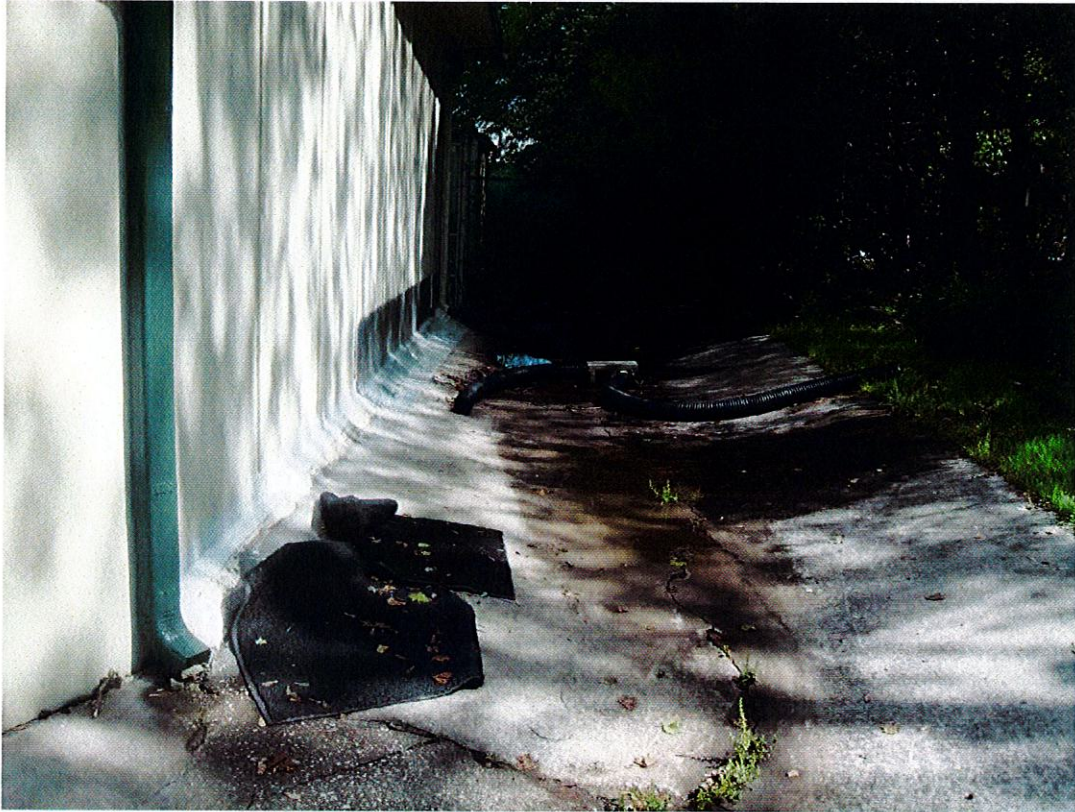
Photo 41 – Inadequate drainage area.

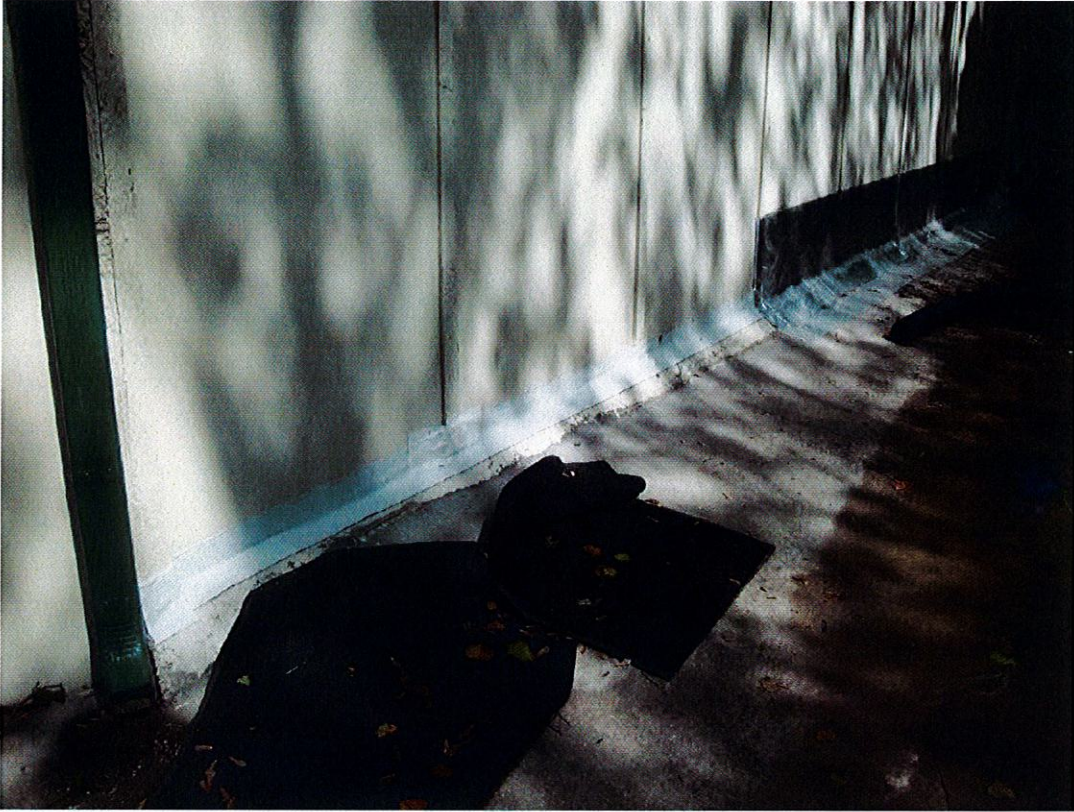
Photo 43 – Inadequate drainage area.

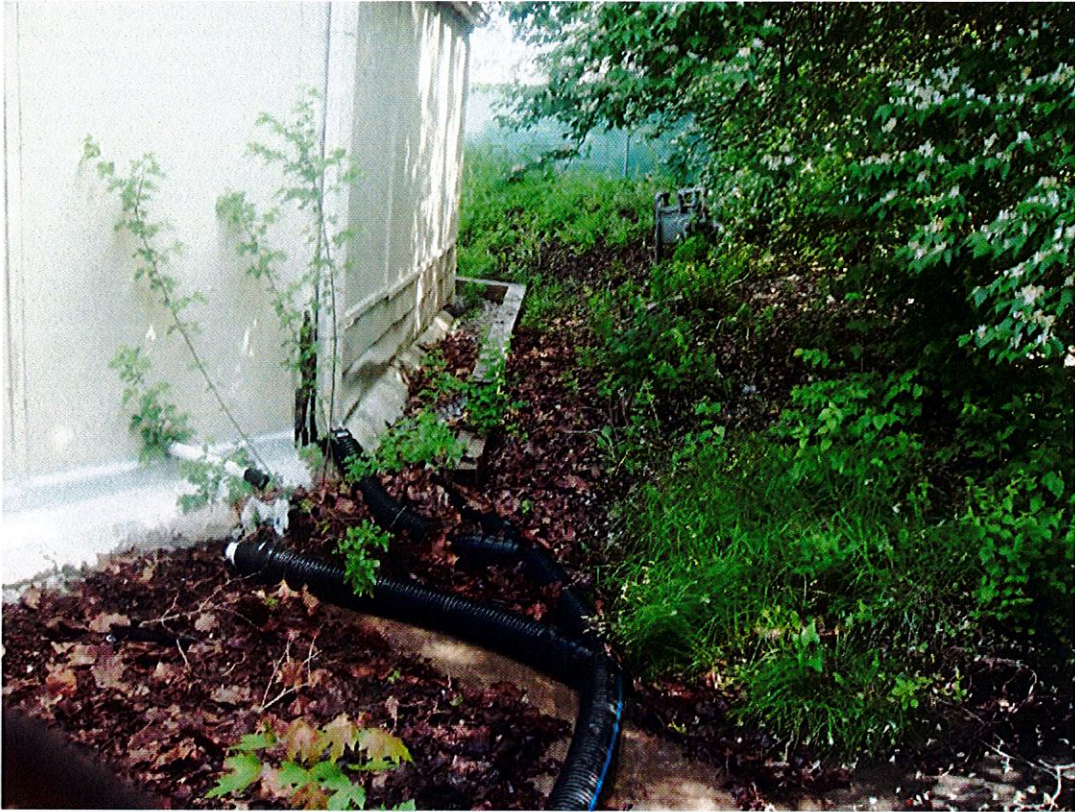
Photo 44 – Inadequate drainage area.

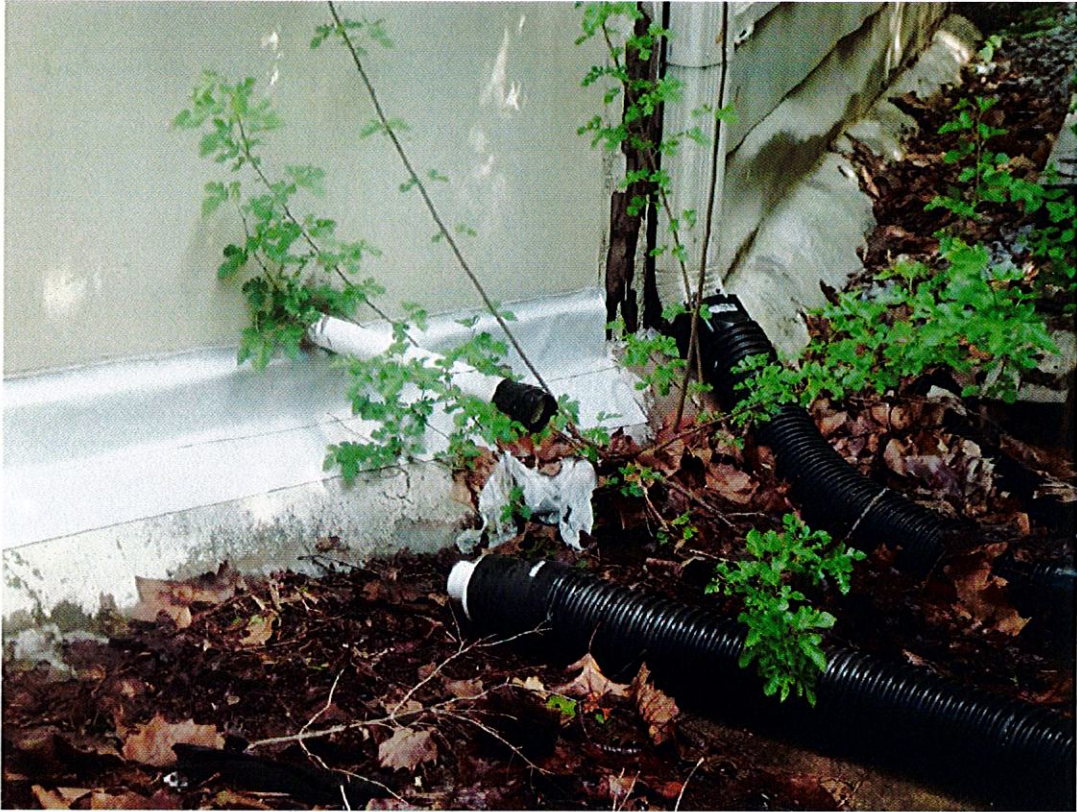
Photo 45 – Inadequate drainage area.

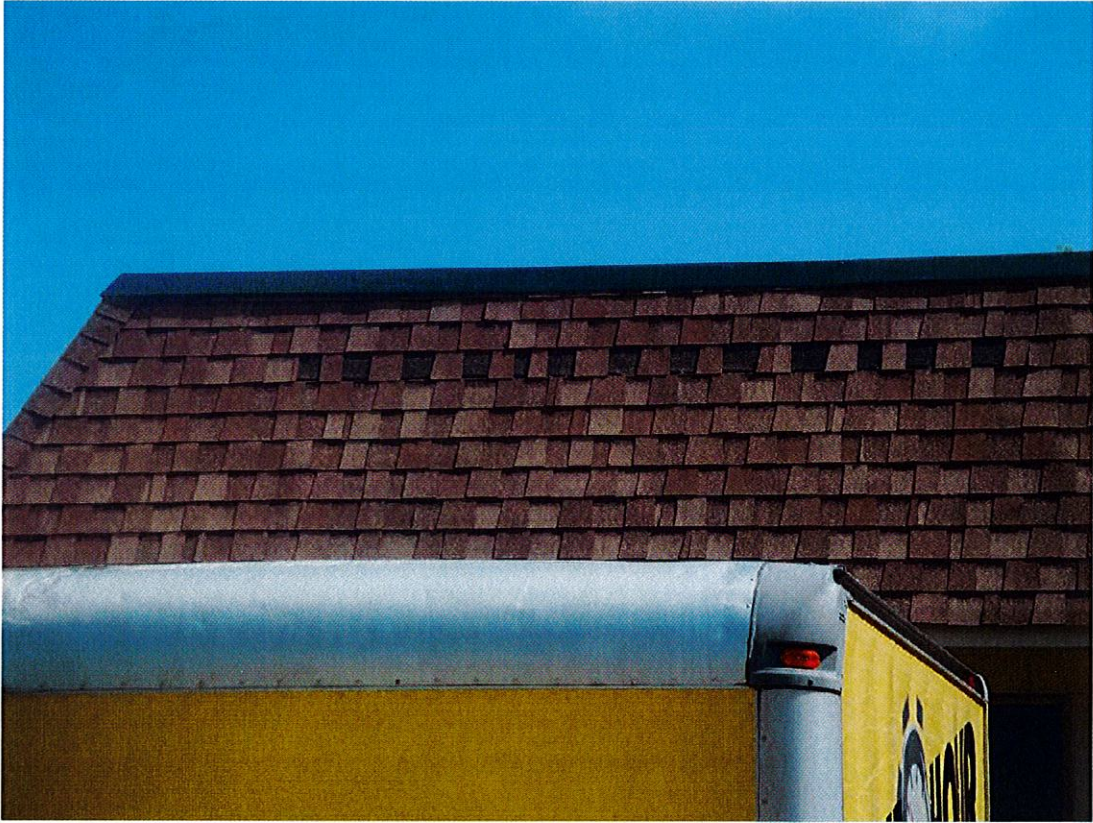
Photo 46 – Deteriorating roofing material.
