**SOUTHSIDE PLAZA
COMMUNITY IMPROVEMENT DISTRICT**

PETITION TO AMEND THE PETITION TO
ESTABLISH THE SOUTHSIDE PLAZA
COMMUNITY IMPROVEMENT DISTRICT

LEE'S SUMMIT, JACKSON COUNTY, MISSOURI

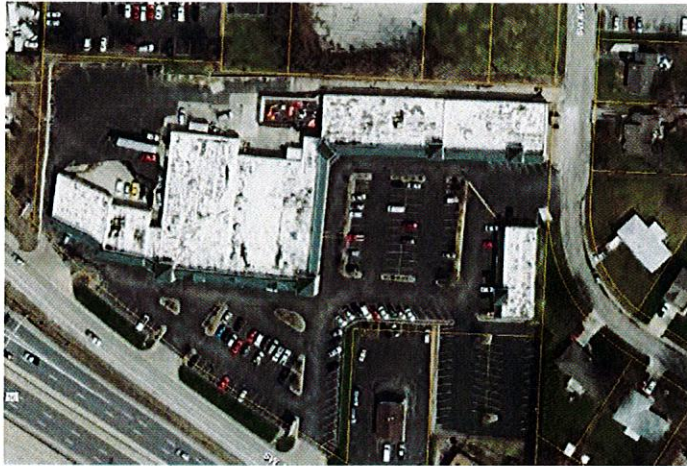
From evaluating aerial photographs, it appears that the roof was replaced between 2010 and 2012. Below shows the before and after of the roof replacement. No roof access was available at time of inspection.

Figure 9 - Before Picture Roof Condition: Year 2010.

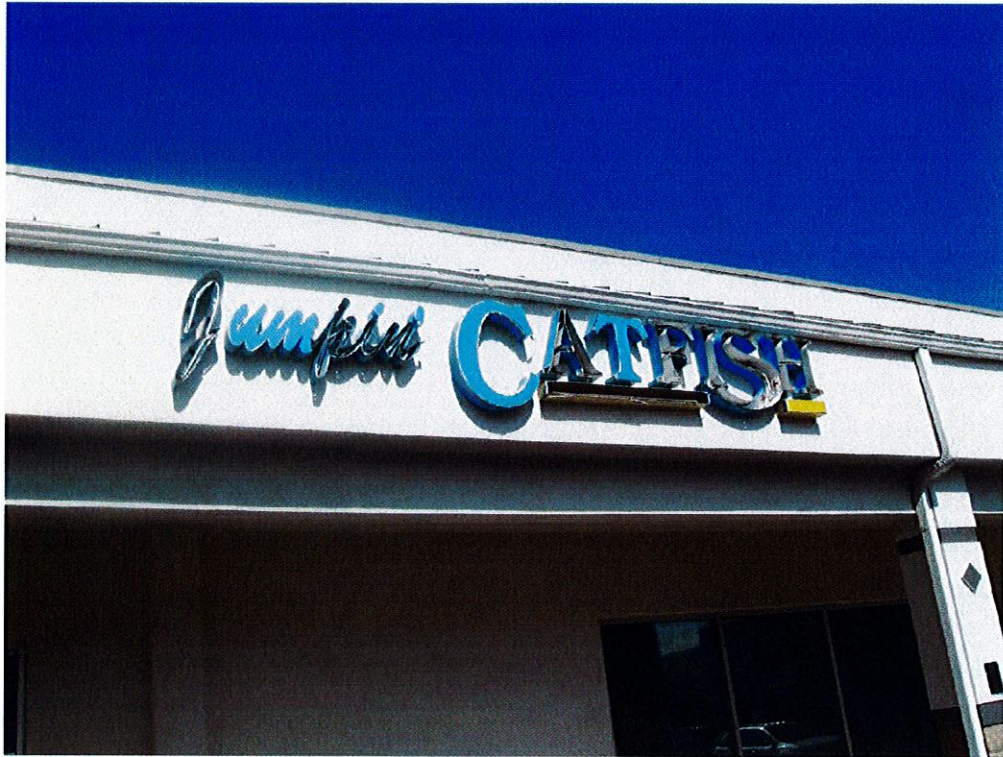
Photo 4 – Deteriorated/damaged tenant signage.

Numerous tenant signs throughout the District were observed to be deteriorated or damaged. This is an indication of deteriorated conditions and a sign of lack of general maintenance.

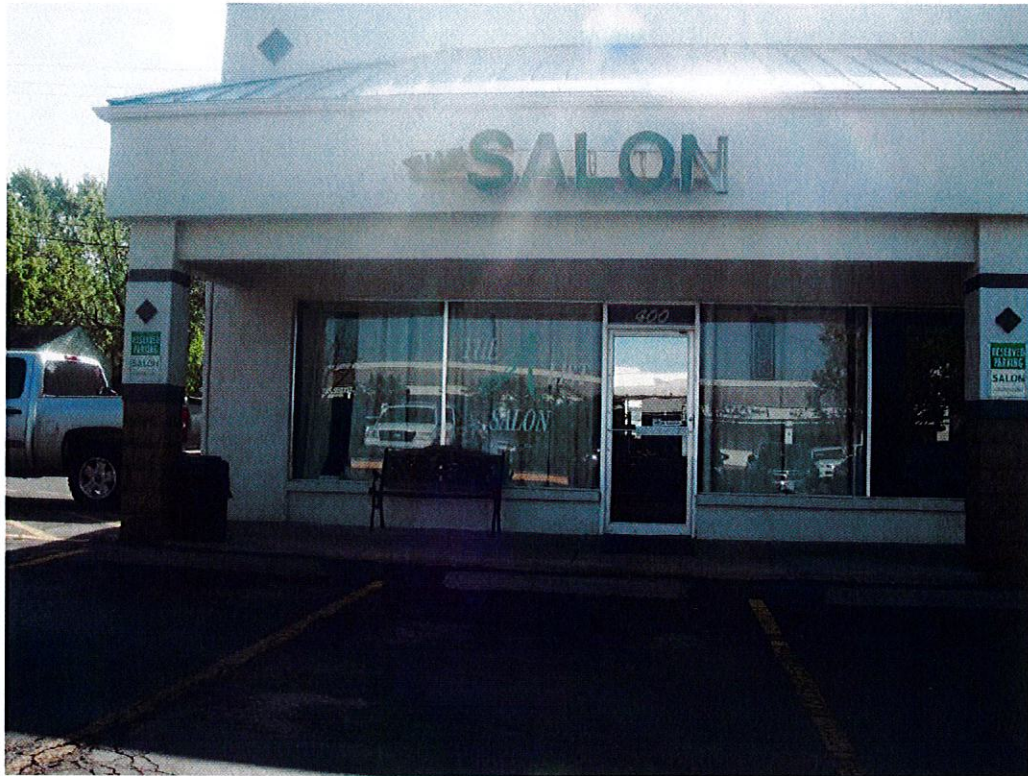
Photo 5 – Deteriorated/damaged tenant signage.

Numerous tenant signs throughout the District were observed to be deteriorated or damaged. This is an indication of deteriorated conditions and a sign of lack of general maintenance.

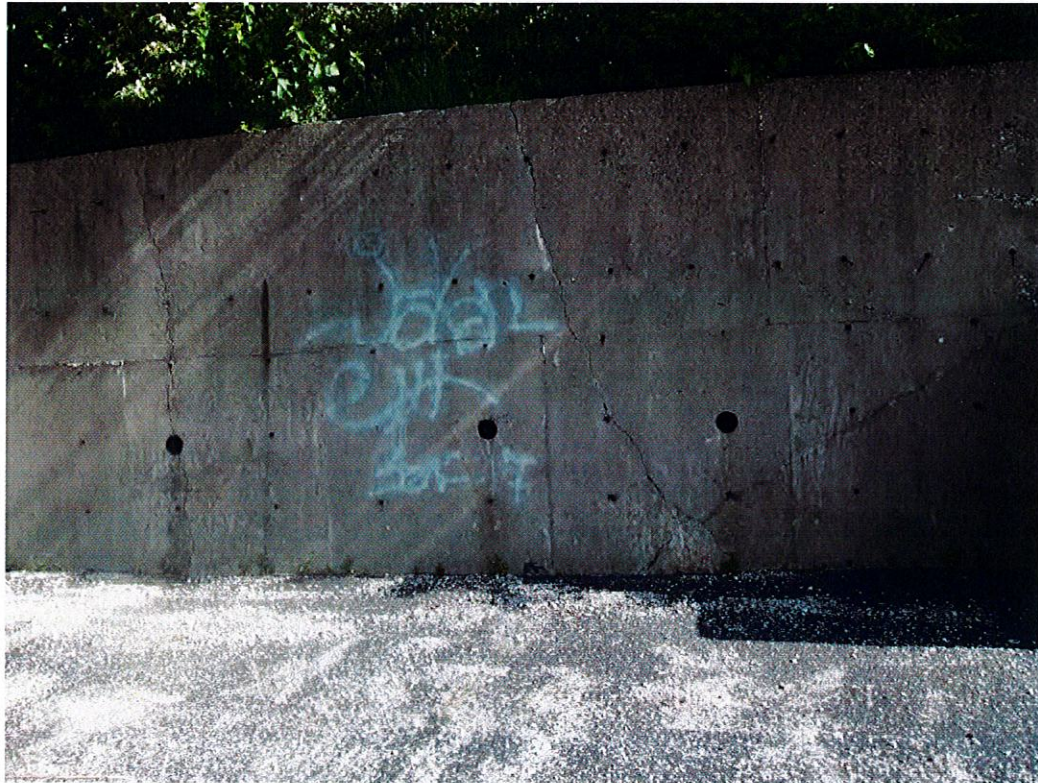
Photo 6 – Graffiti along west and north retaining wall.

Upon inspection, it was noted that graffiti was present in scattered locations throughout the west and northern portion of the District. Graffiti was observed on the west and north retaining walls. This can be an indication of illegal trespassing and vagrancy. Graffiti also can contribute to a social liability of a property or area in that it is unsightly and a sign of illegal activity.

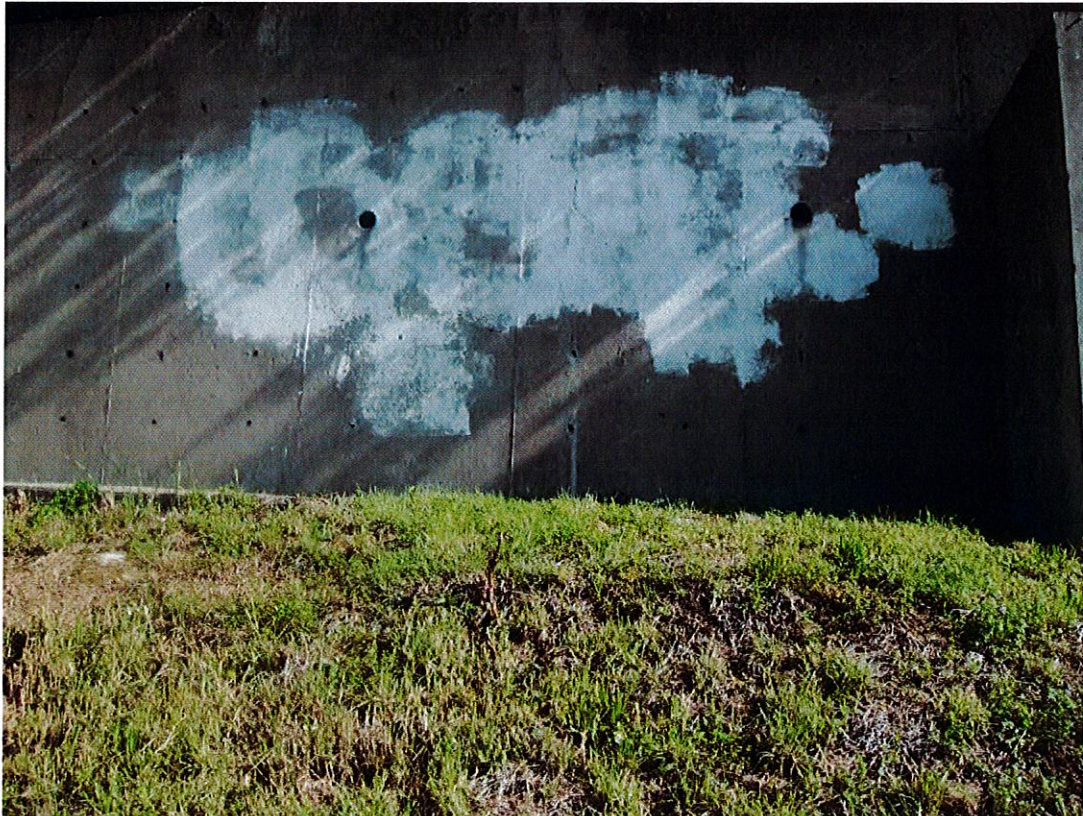
Photo 8 – Graffiti along west and north retaining wall.

Upon inspection, it was noted that graffiti was present in scattered locations throughout the west and northern portion of the District. Graffiti was observed on the west and north retaining walls. This can be an indication of illegal trespassing and vagrancy. Graffiti also can contribute to a social liability of a property or area in that it is unsightly and a sign of illegal activity.

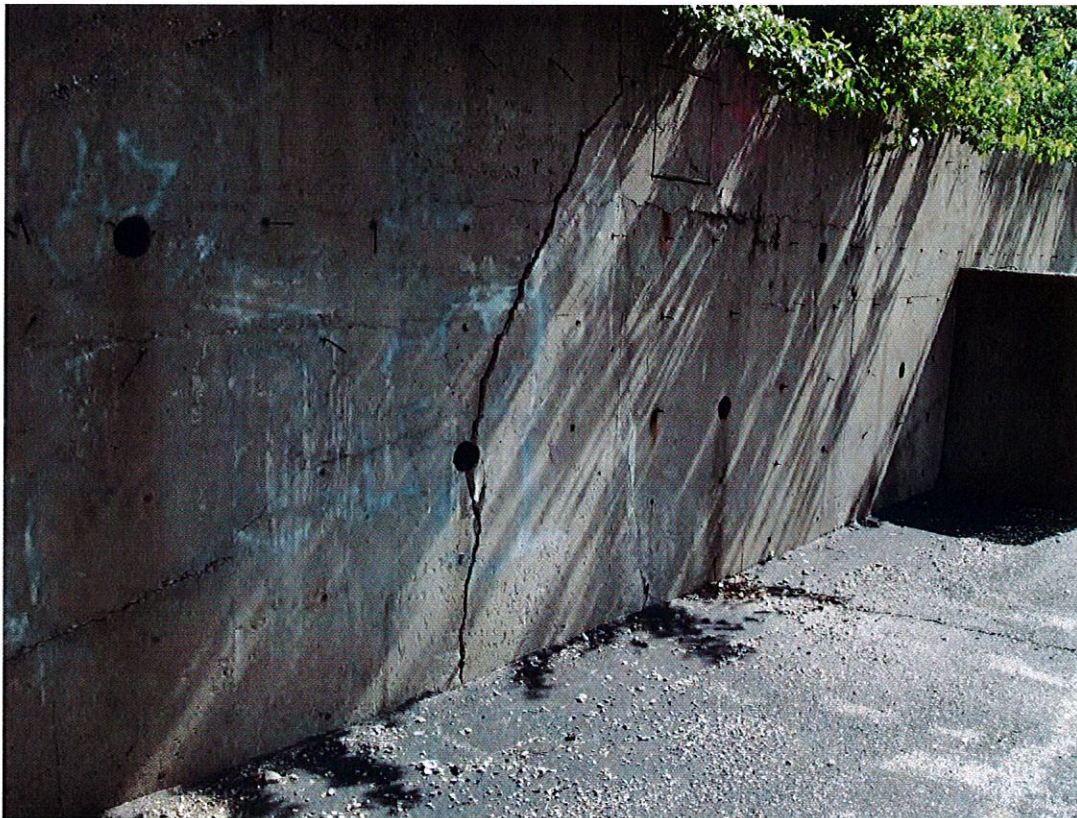
Photo 10 – Deteriorated/compromised retaining wall.

Upon inspection, it was noted that the west and north retaining wall exhibited significant structure deterioration. The photo above shows previous remediation efforts in the form of tie-backs utilized to strengthen and prevent the wall from collapsing, but these efforts appear to have failed. Note significant cracking and concrete spalling, a possible indication that water infiltration has occurred and the drainage system has failed.

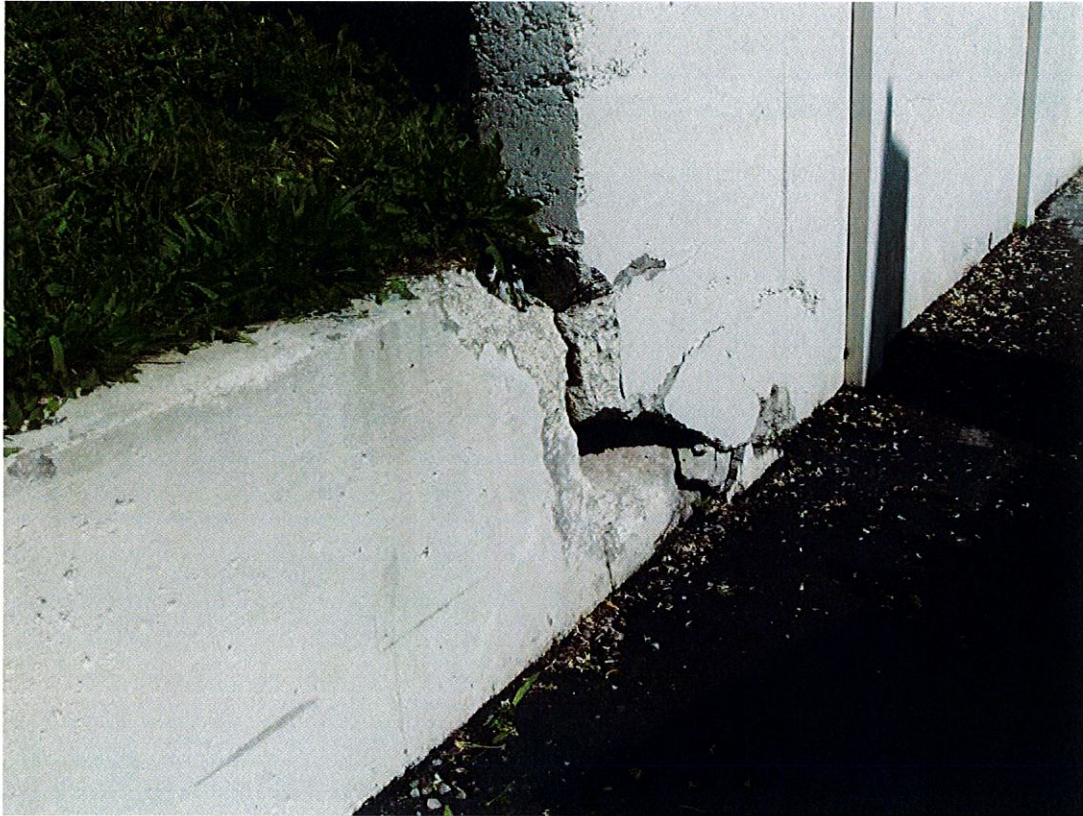
Photo 15 – Deteriorated/compromised retaining wall.

Upon inspection, it was noted that the west and north retaining wall exhibited significant structure deterioration.

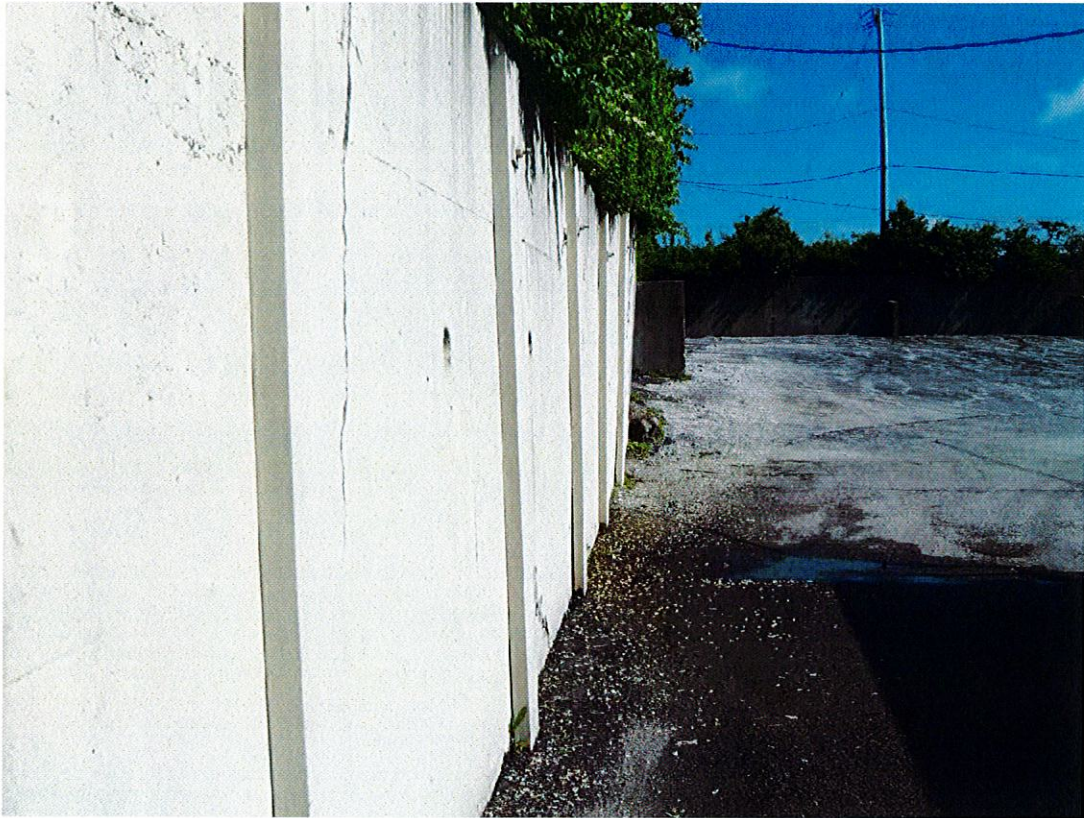
Photo 16 – Deteriorated/compromised retaining wall.

Upon inspection, it was noted that the west and north retaining wall exhibited significant structure deterioration. Deflection in the retaining wall can be noted in this photo.

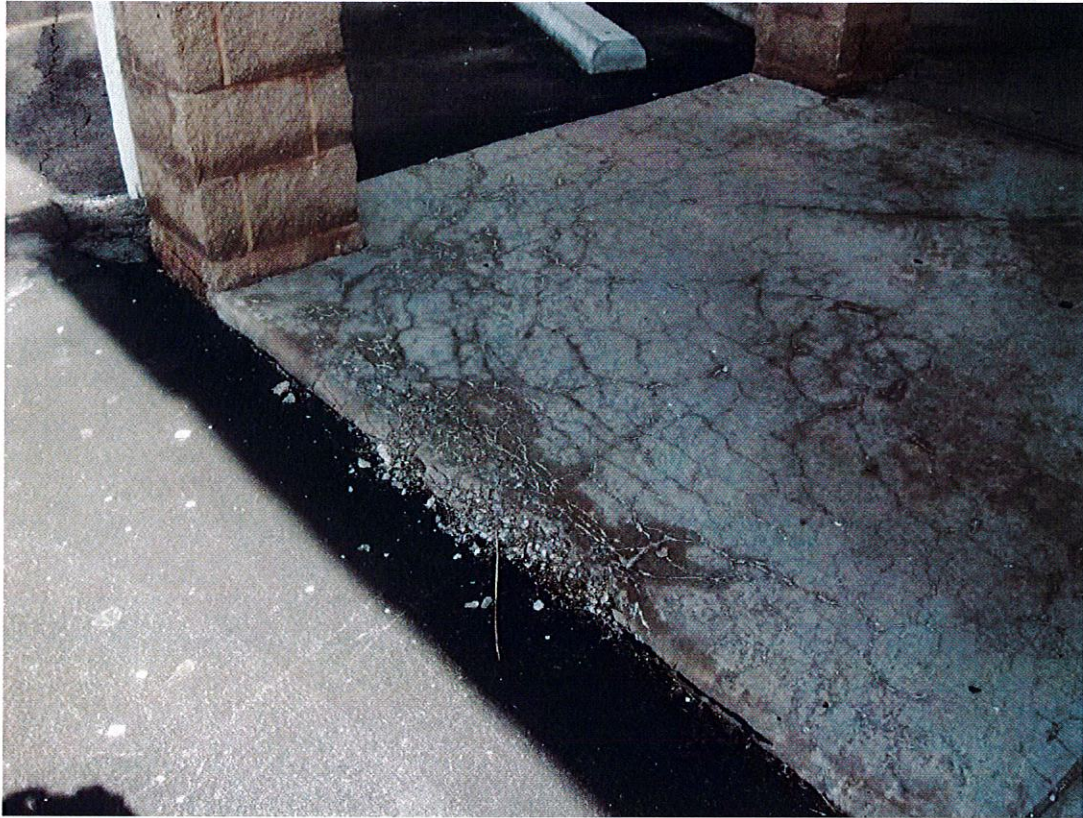
Photo 18 – Deteriorating concrete sidewalk.

Several locations within the District were observed with deteriorating concrete sidewalks. While this is not a critical issue at this point, it does show that if action is not taken continued deterioration could occur.

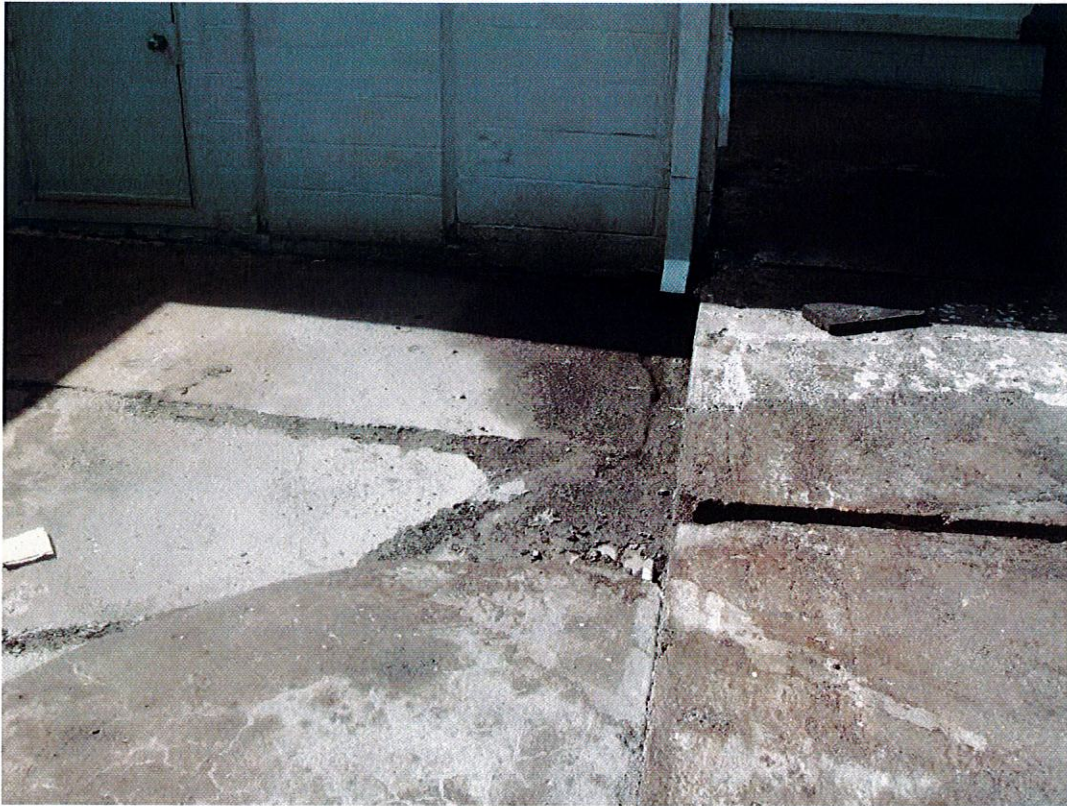
Photo 20 – Inadequate drainage.

Along the northern portion of the shopping center, several locations were noted where roof downspouts were inadequately drained. This can lead to possible water infiltration into the structure of the building.

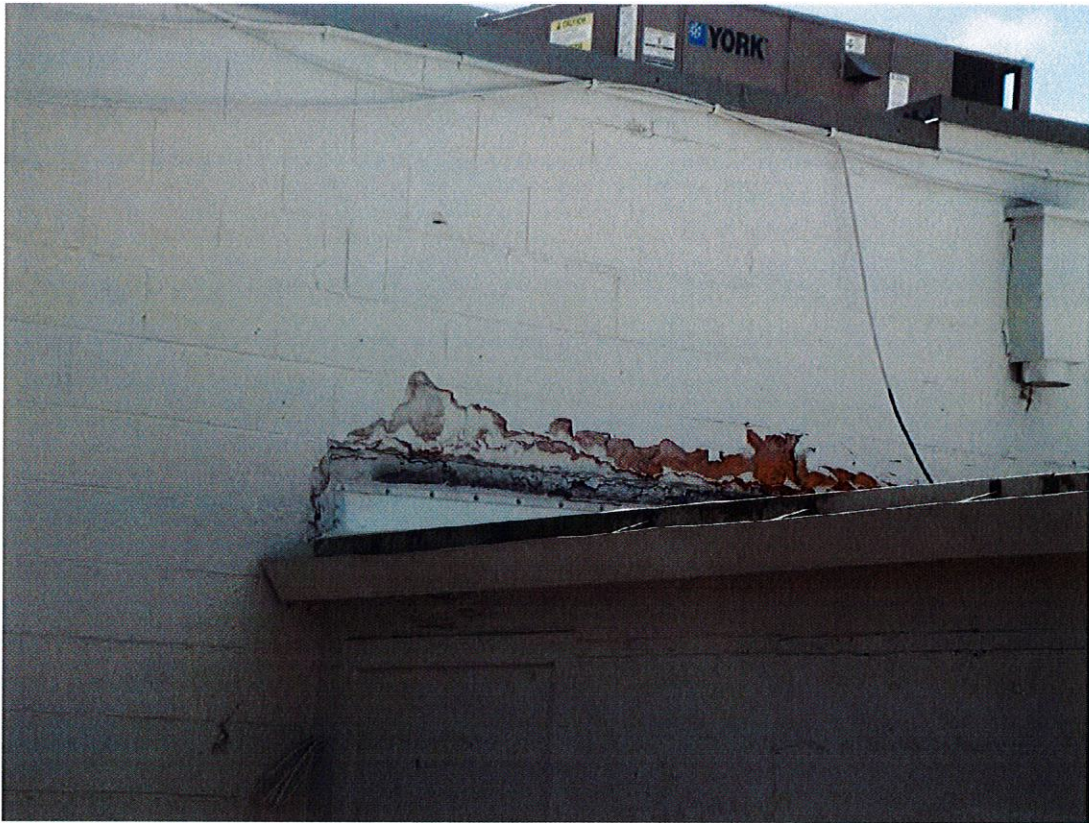
Photo 21 – Deteriorated flashing material.

Also not rainwater gutter system is inadequate and not properly installed.

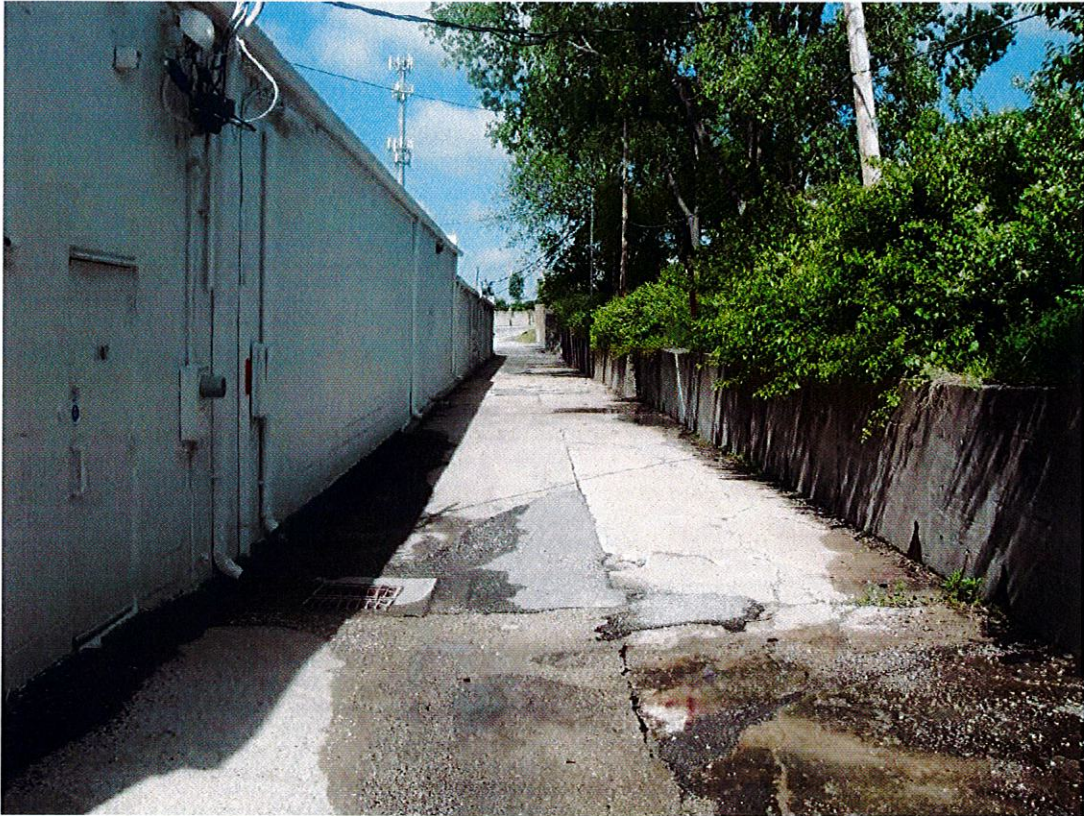
Photo 22 – View of north service alley. Typical of alley condition. Photo looking west.

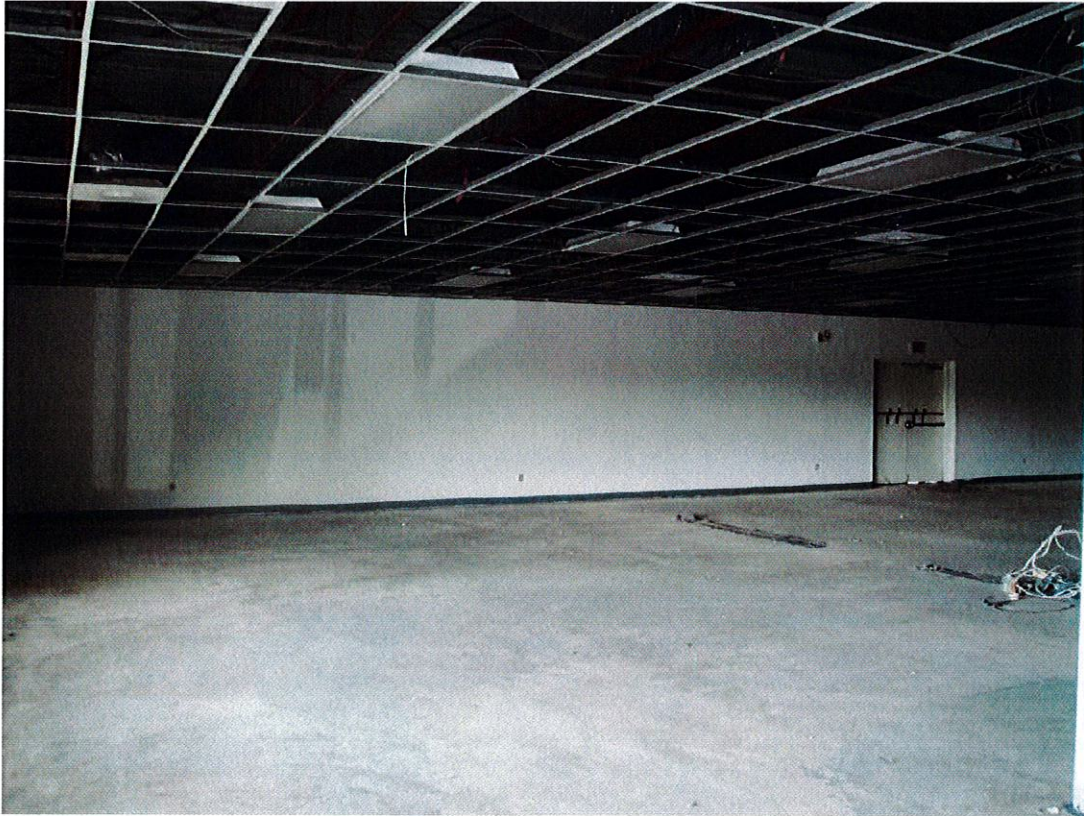
Photo 23 – Vacant tenant space.

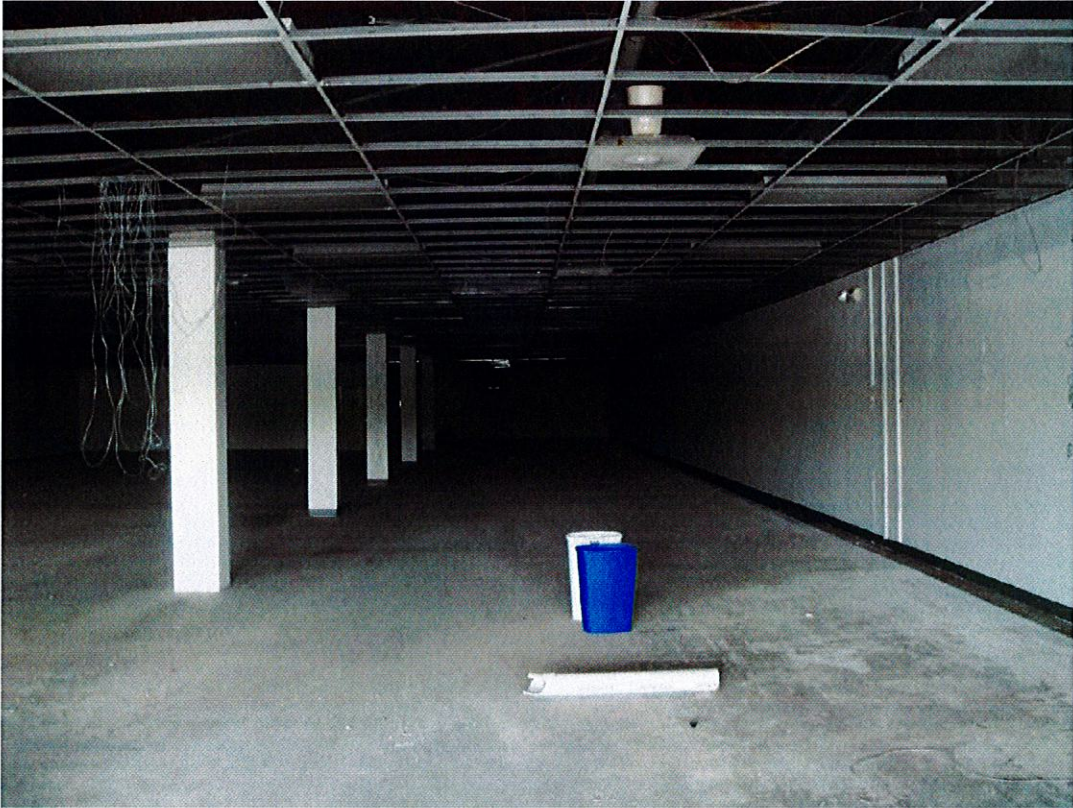
Photo 24 – Vacant tenant space.

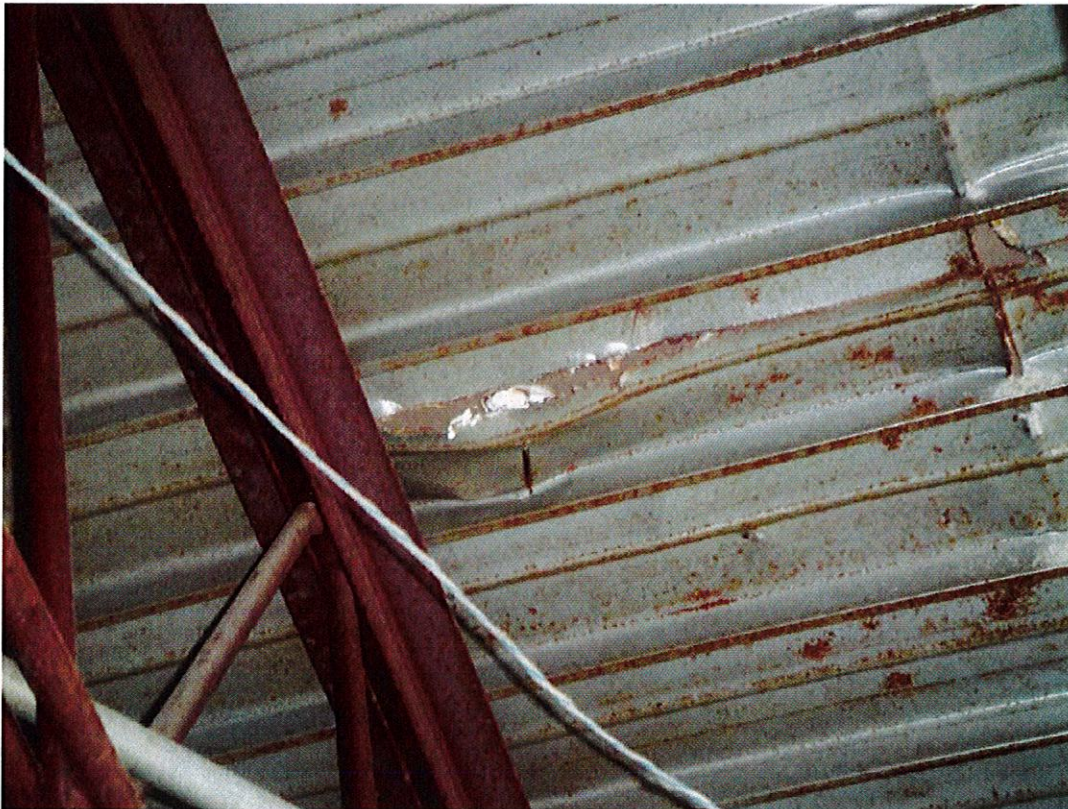
Photo 25 – Roof structure deterioration.

Several locations were observed with deteriorated or damaged roof structures. Deteriorated roof structures can lead to water infiltration and further damage to interior finishes.

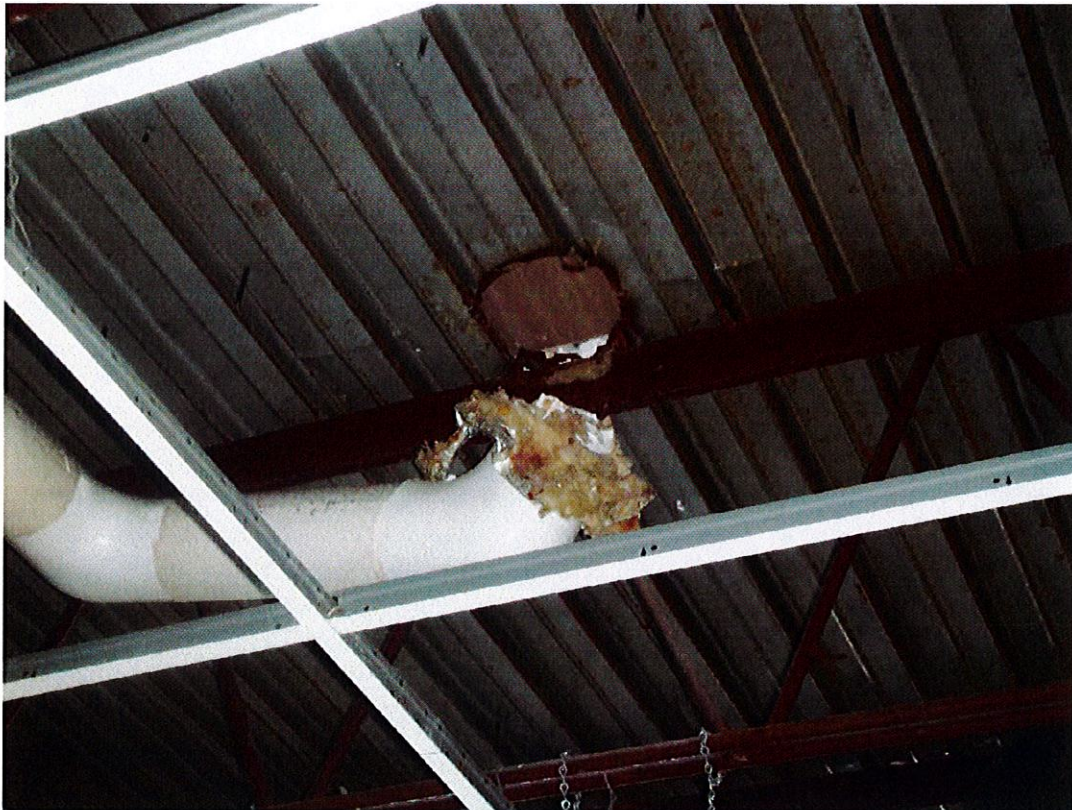
Photo 26 – Roof structure deterioration.

Several locations were observed with deteriorated or damaged roof structures. Deteriorated roof structures can lead to water infiltration and further damage to interior finishes.

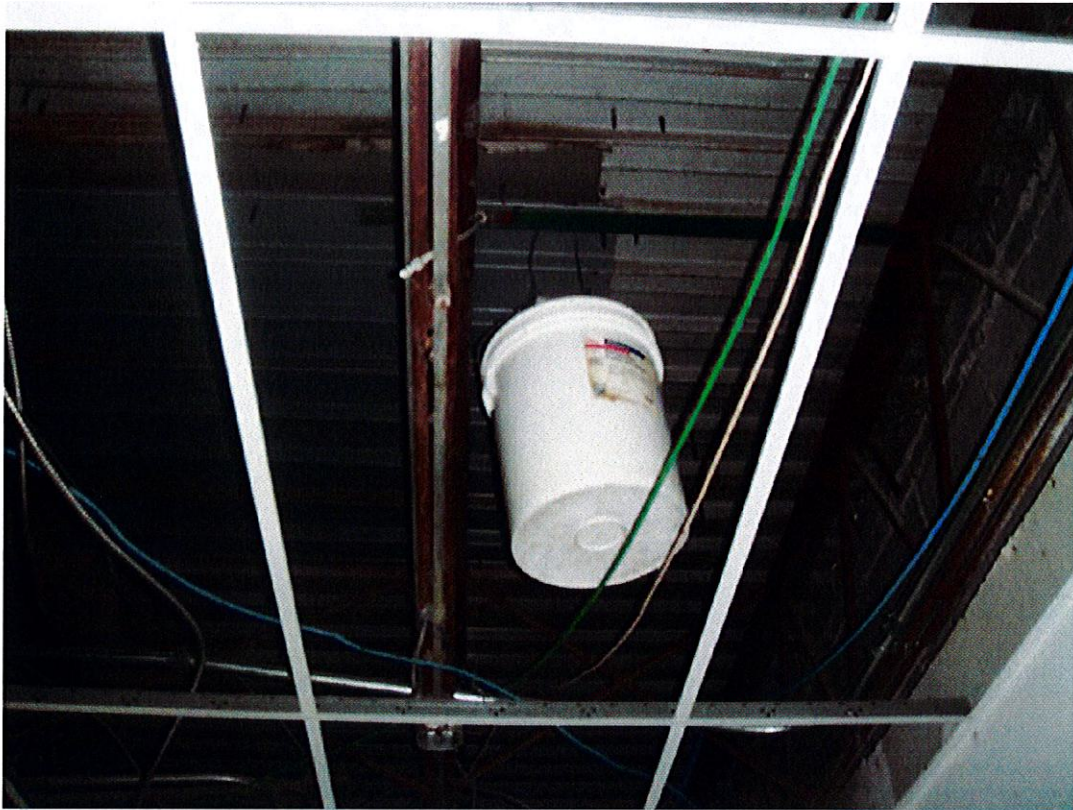
Photo 27 – Roof structure deterioration.

Several locations were observed with deteriorated or damaged roof structures. Deteriorated roof structures can lead to water infiltration and further damage to interior finishes. This images shows a temporary water catchment system.

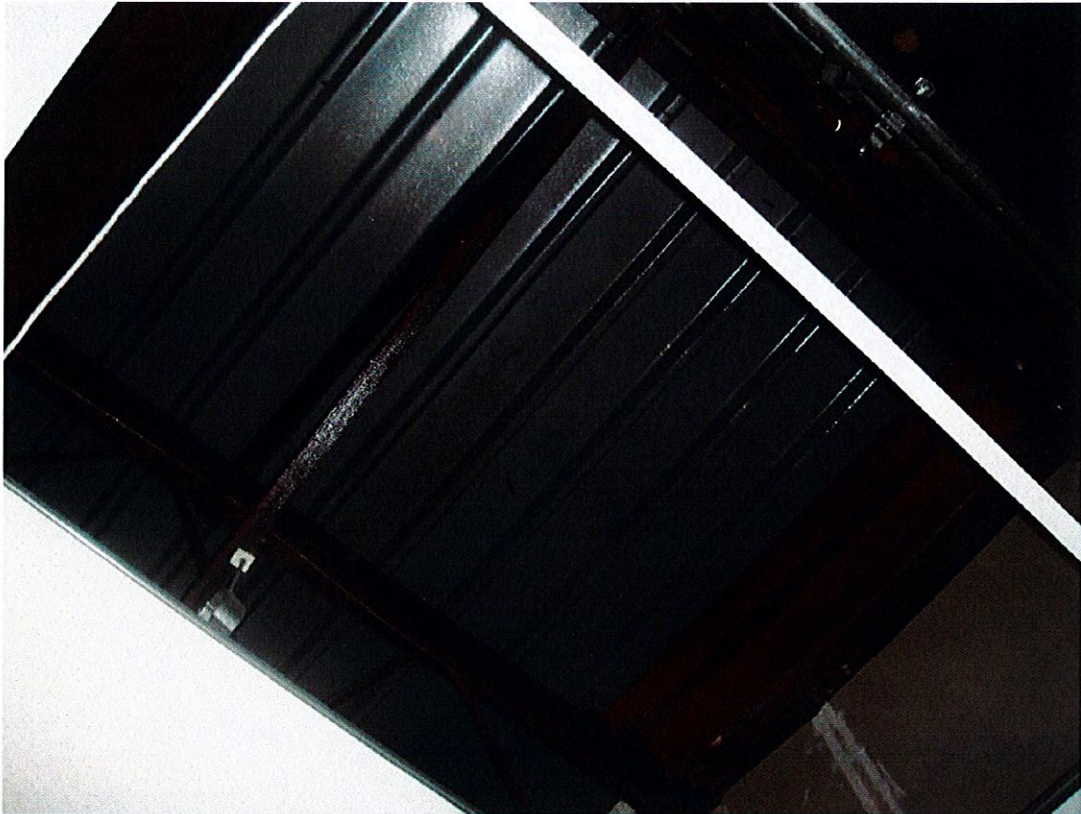
Photo 32 – Roof structure condensation.

Upon inspection, several locations were noted which significant condensation was observed on the underside of the roof structure. This was significant enough that it was dripping and falling onto the ceiling and floor below.

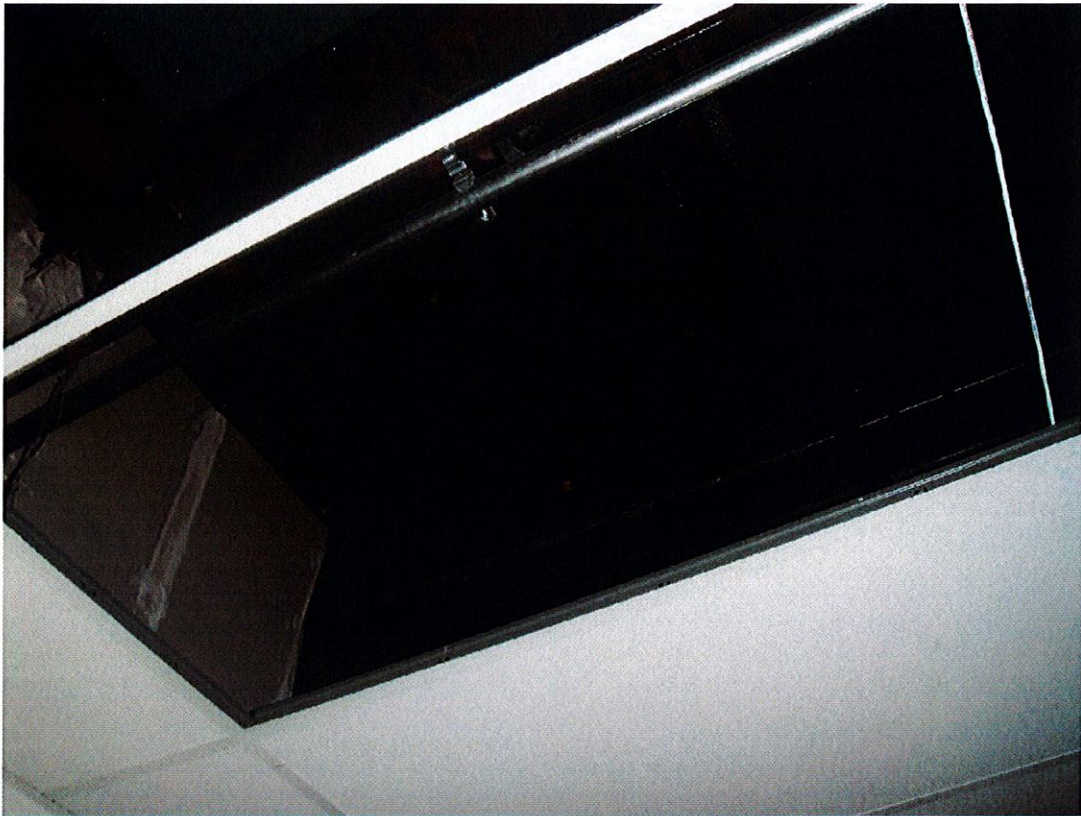
Photo 33 – Roof structure condensation.

Upon inspection, several locations were noted which significant condensation was observed on the underside of the roof structure. This was significant enough that it was dripping and falling onto the ceiling and floor below.

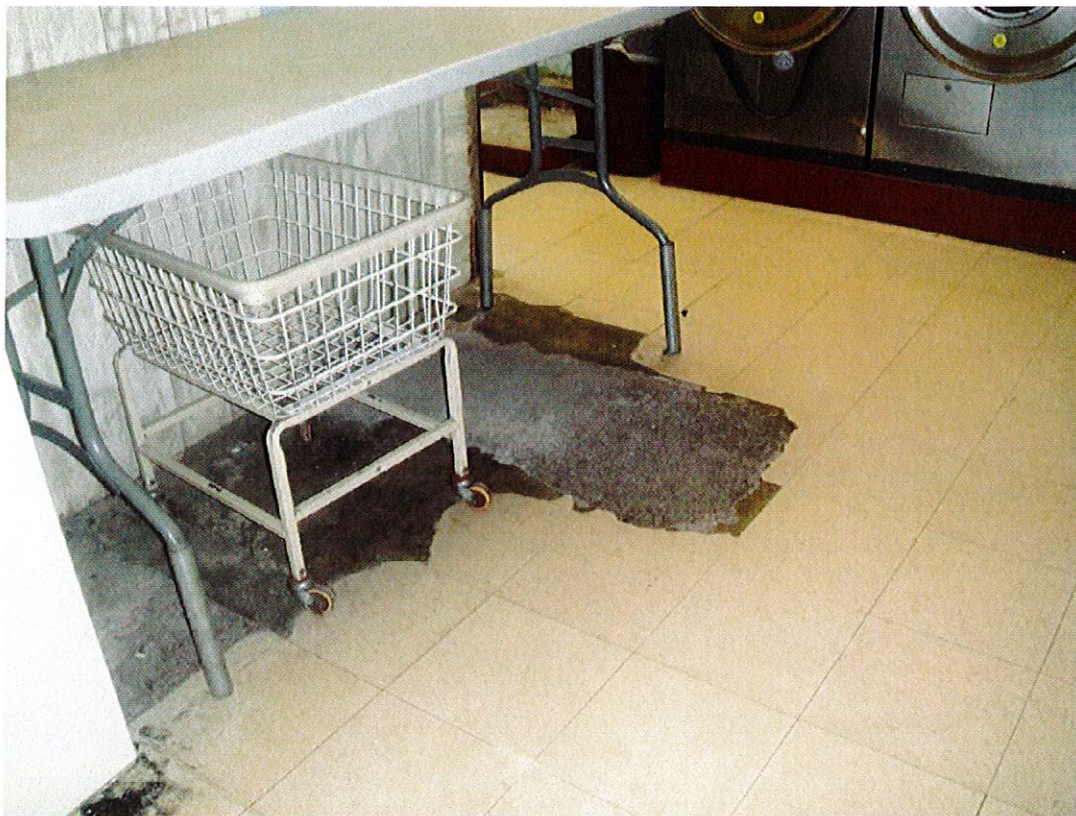
Photo 36 – Deteriorated/damaged floor tile.

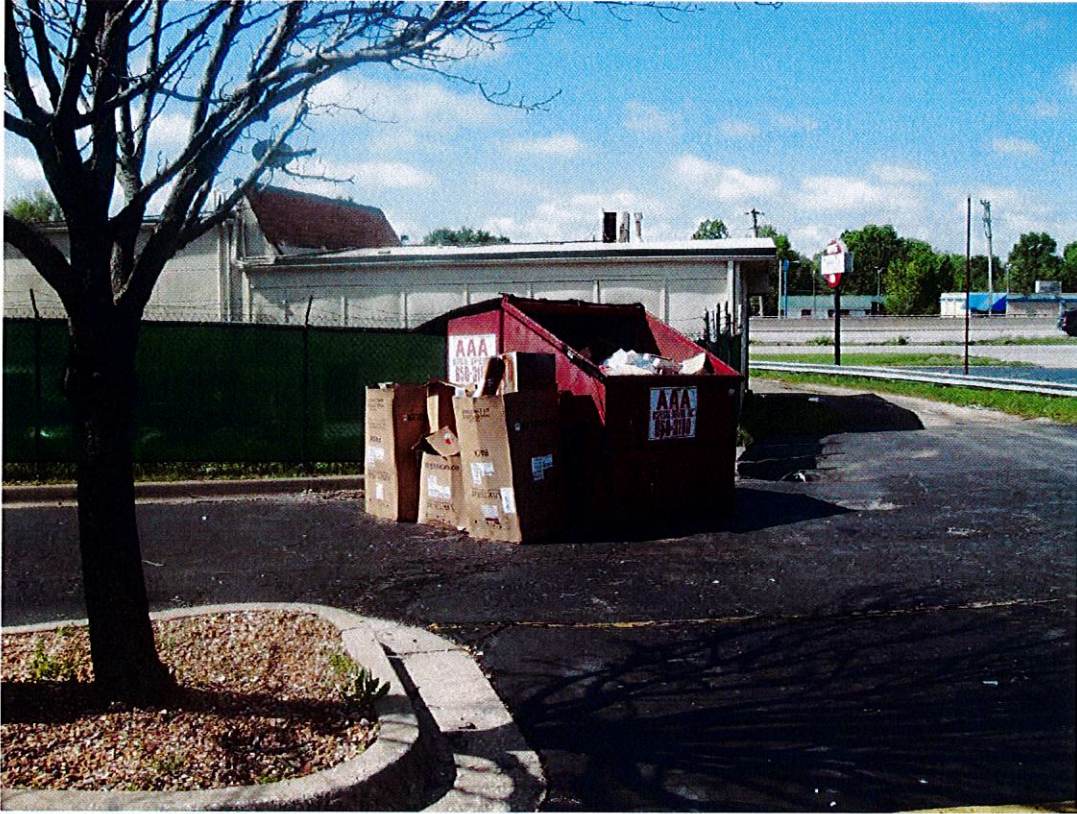
Photo 37 – Overflowing trash dumpster.

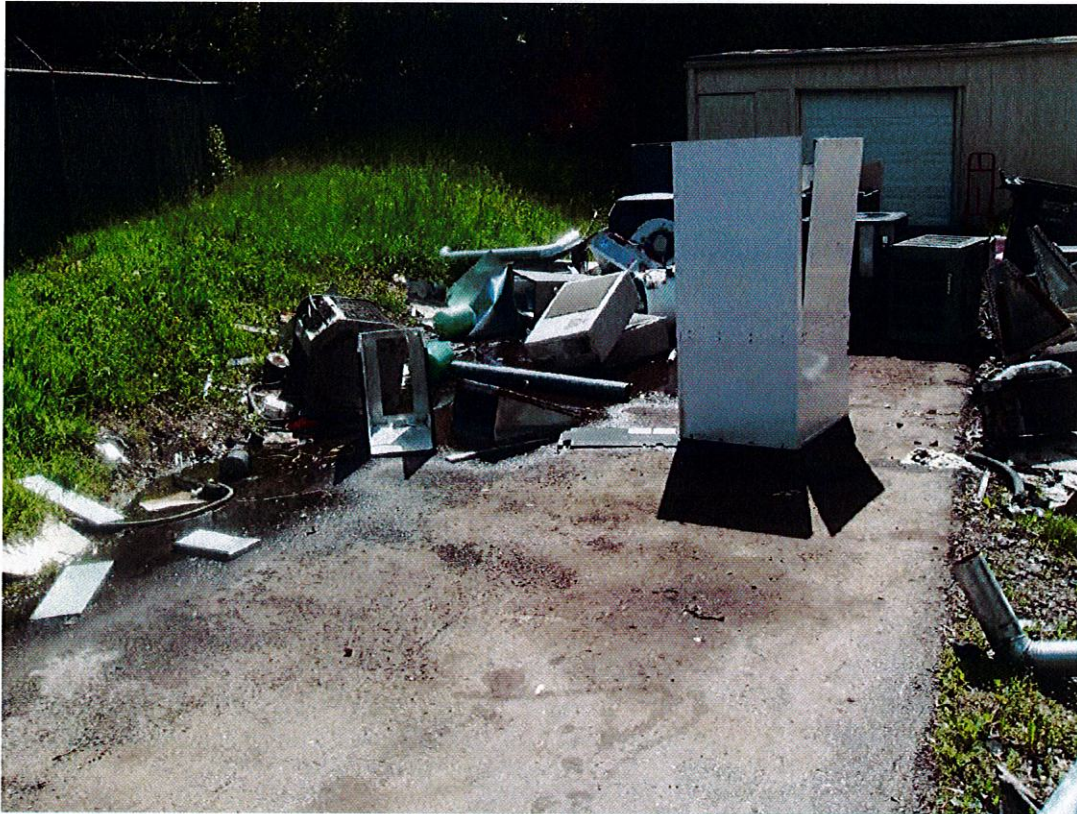
Photo 38 – Excessive exterior storage.

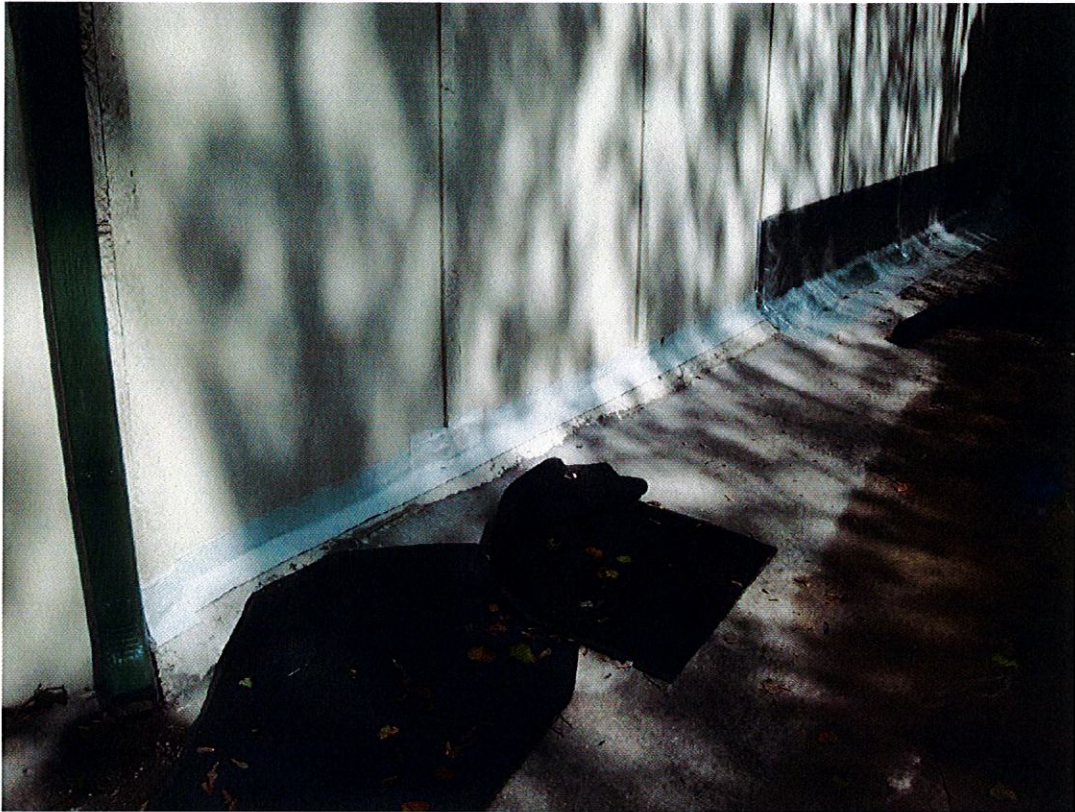
Photo 43 – Inadequate drainage area.

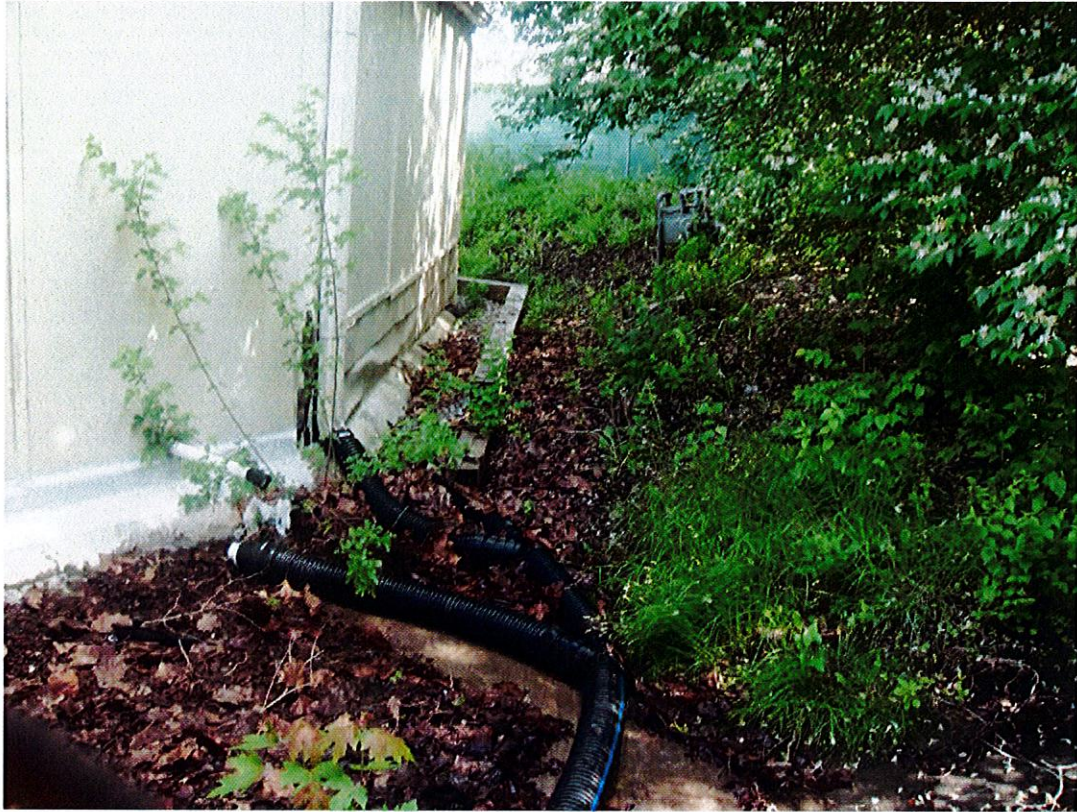
Photo 44 – Inadequate drainage area.

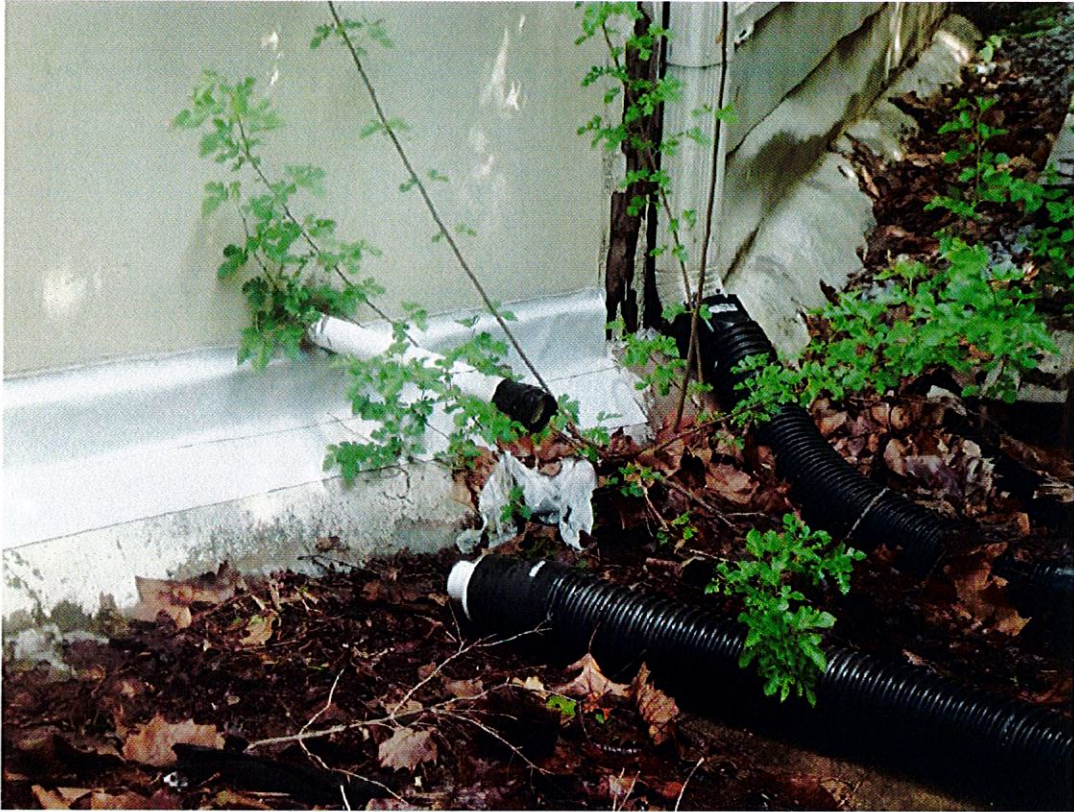
Photo 45 – Inadequate drainage area.
