LEE'S SUMMIT FIRE STATION 1

FEASIBILITY STUDY

Lee's Summit, MO

May 2024

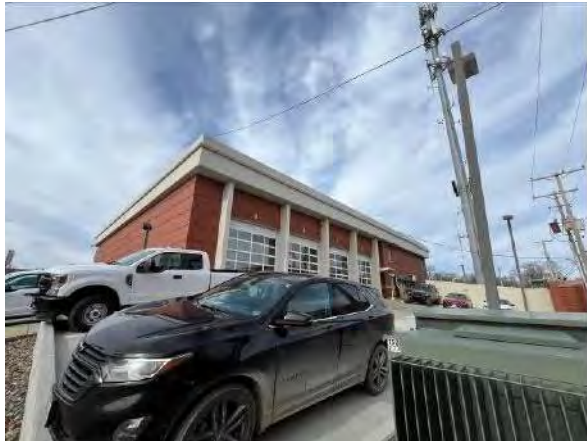
Photo #3 Facing W: Overview of site from E corner

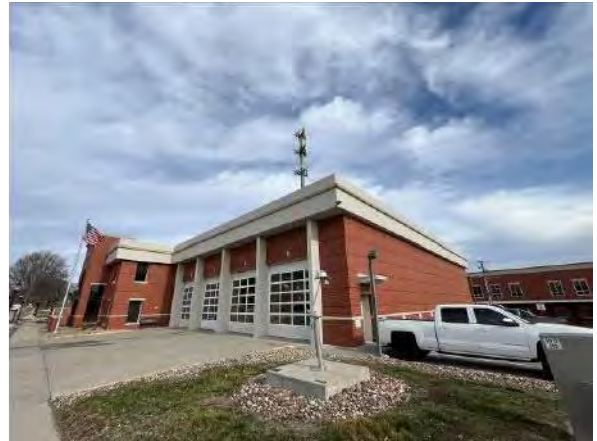
Photo #4 Facing N: Overview of site from S corner

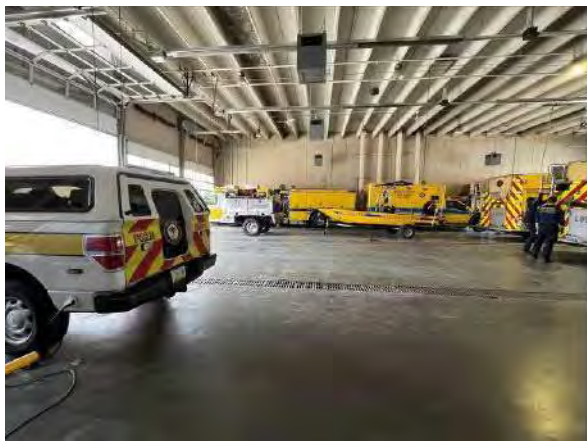
Photo #5 Facing SSE: Overview of Bay

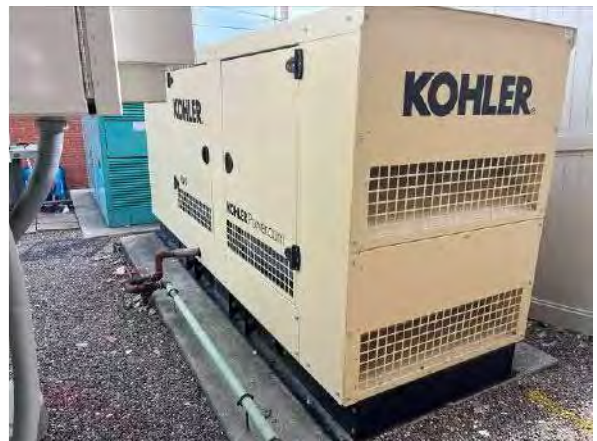
Photo #12 View of natural gas emergency generator

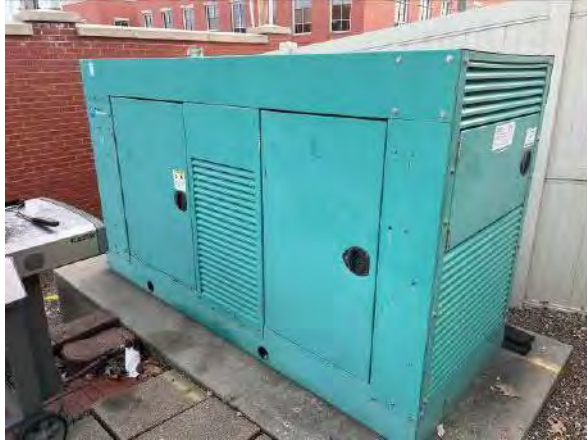
Photo #13 View of natural gas emergency generator

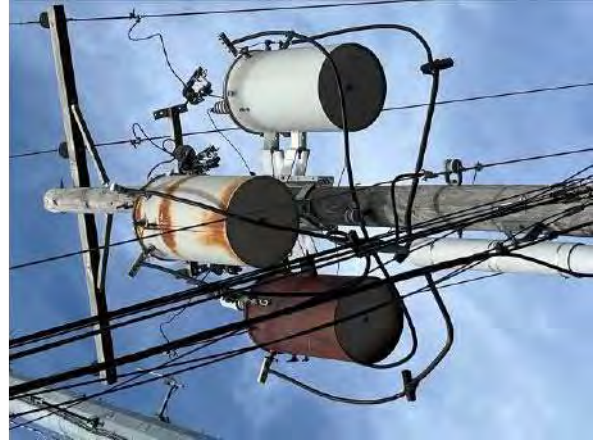
Four pole-mounted transformers and one pad-mounted transformer were observed at the site. One pole-mounted transformer displayed a non-PCB sticker; however, the remaining transformers were unmarked. Some transformers contain mineral oil which may contain PCBs.

Photo #14 View of on-site pole-mounted transformers

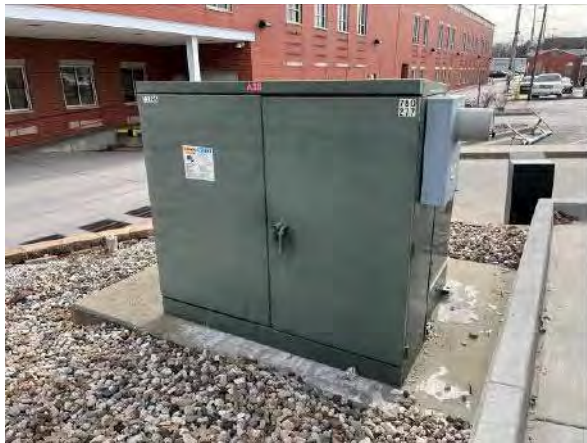
Photo #15 View of on-site pad-mounted transformer

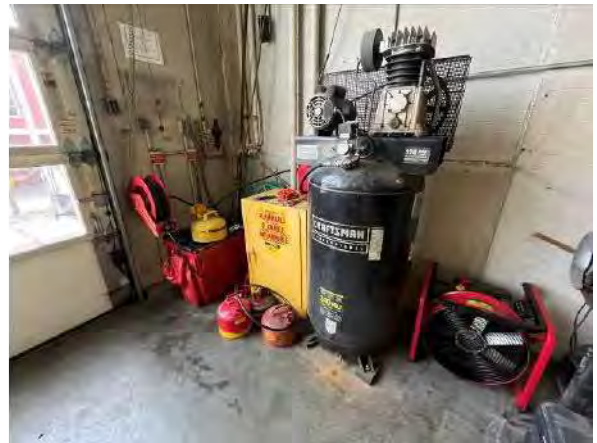
One air compressor was observed at the site. Additionally, a RevolveAir fill station with multiple ~425 to ~680-liter canisters filled with breathing air were observed. No staining or evidence of leaks was observed in their vicinity.

Multiple 5-gallon containers of alcohol-resistant aqueous film-forming foam (AR-AFFF) and four ~3-5 gallon gas/diesel cans were observed at the site. No staining or evidence of leaks, or floor drains, was observed in their vicinity.

Photo #16 View of air compressor and four ~3-5 gallon gas/diesel cans

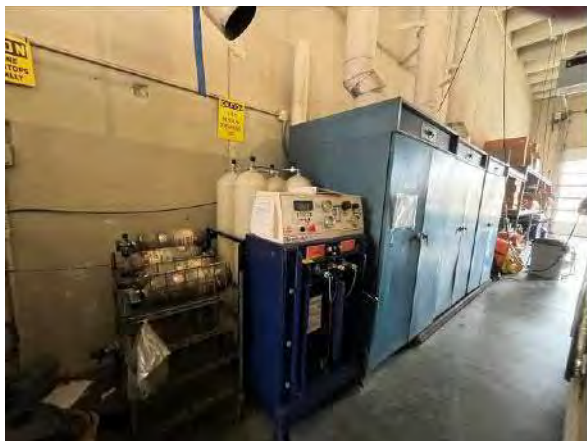
Photo #17 View of oxygen tank storage in Bay
