# LEE'S SUMMIT FIRE STATION 1

## FEASIBILITY STUDY

Lee's Summit, MO

May 2024

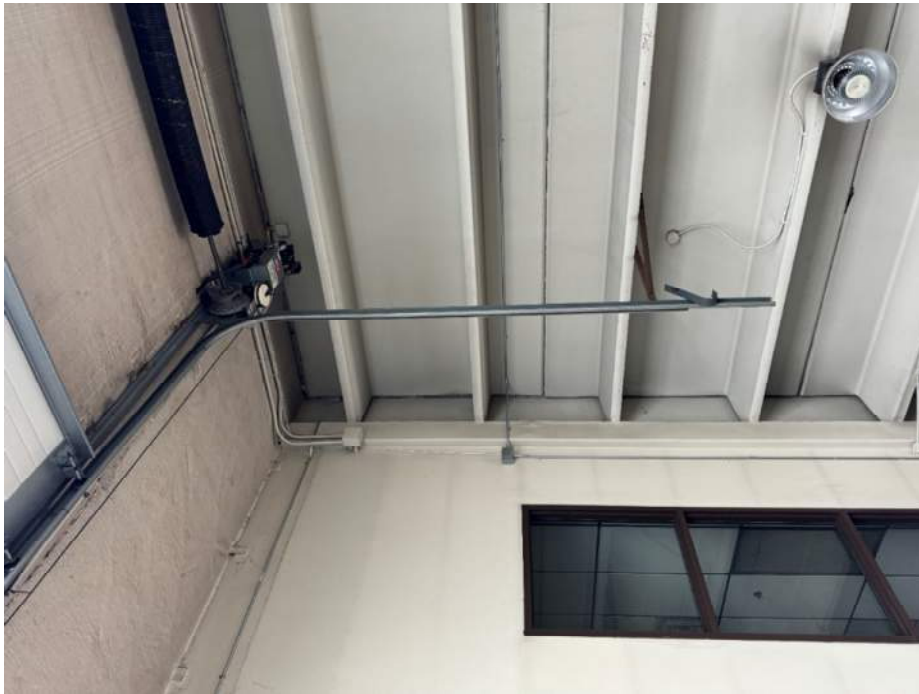
1. Double Tee roof beam at northwest corner of apparatus bay. It appears the double tee member might have been cast short and does not have full bearing on the precast wall corbel. There is a minor crack propagating from the double tee web at 45 degrees in the flange. We cannot determine with certainty why this double tee appears to be short. It is our opinion that this member was likely cast short and determined at the time of erecting to still be within acceptable tolerance for the precaster. While we cannot rule out movement of the structure which has caused this double tee member to shift, we would anticipate other signs of movement which were not perceived at the time of our visit. Therefore, we would conclude this was a precast fabrication error.

Figure 2: Precast double tee bearing on precast corbel.

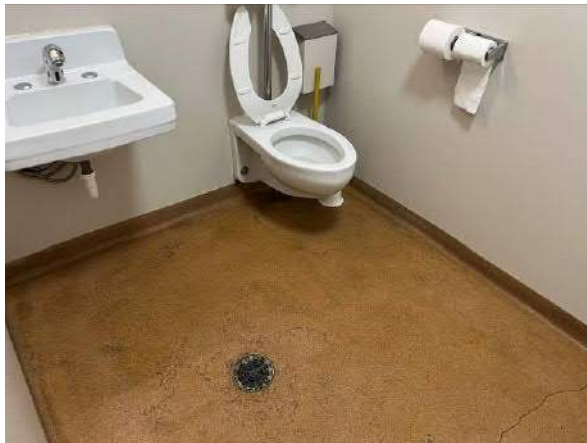
**Photo #9** Typical on-site bathroom with floor drain

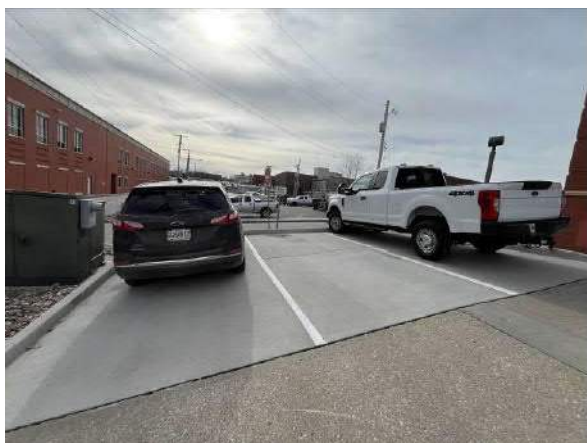
**Photo #11** Facing SE: View of location of closed former USTs

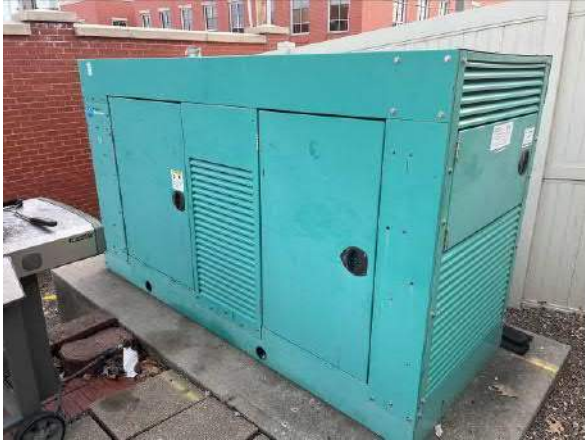
Two natural gas-powered emergency generators were observed at the site. No staining or evidence of leaks was observed in their vicinity.

**Photo #13** View of natural gas emergency generator

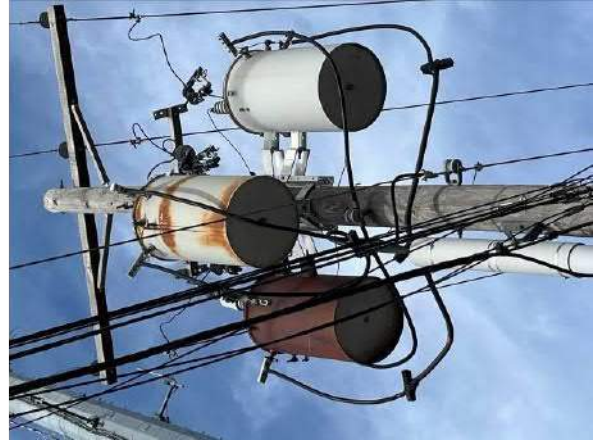
Four pole-mounted transformers and one pad-mounted transformer were observed at the site. One pole-mounted transformer displayed a non-PCB sticker; however, the remaining transformers were unmarked. Some transformers contain mineral oil which may contain PCBs.

Evergy maintains responsibility for the transformers, and if the transformers were "PCB contaminated," Evergy is not required to replace the transformer fluids until a release is identified. However, evidence of current or prior release was not observed in the vicinity of the electrical equipment during the site reconnaissance.

**Photo #14** View of on-site pole-mounted transformers

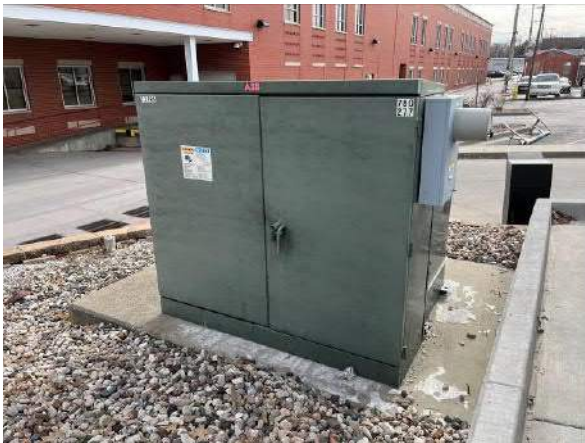
**Photo #15** View of on-site pad-mounted transformer

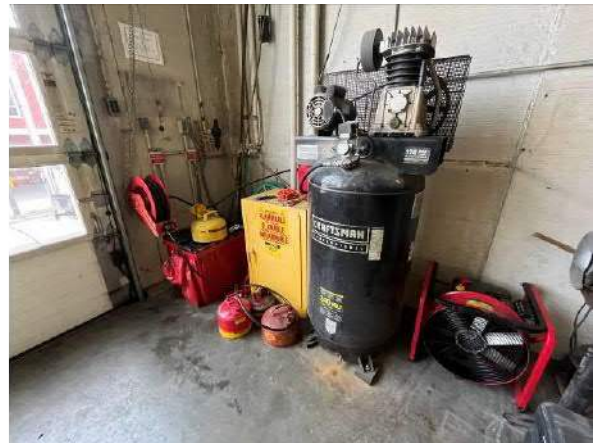
One air compressor was observed at the site. Additionally, a RevolveAir fill station with multiple ~425 to ~680-liter canisters filled with breathing air were observed. No staining or evidence of leaks was observed in their vicinity.

Multiple 5-gallon containers of alcohol-resistant aqueous film-forming foam (AR-AFFF) and four ~3-5 gallon gas/diesel cans were observed at the site. No staining or evidence of leaks, or floor drains, was observed in their vicinity.

**Photo #16** View of air compressor and four ~3-5 gallon gas/diesel cans

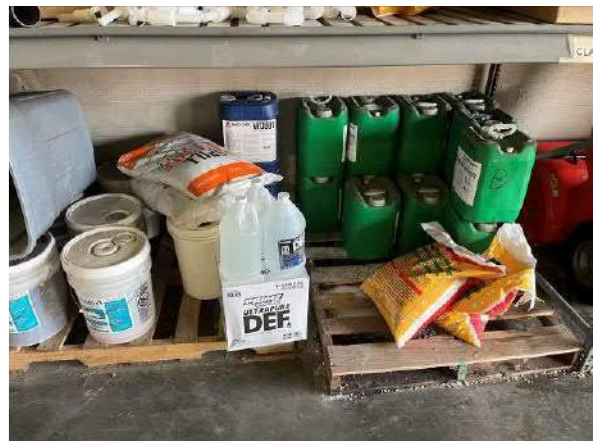
**Photo #18** View of 5-gallon containers of alcohol-resistant aqueous film-forming foam (AR-AFFF)
