**Report
on
Structural Stability of Engineered Lumber in Fire Conditions**

**Project Number: 07CA42520
File Number: NC9140**

**Underwriters Laboratories Inc.
333 Pfingsten Road, Northbrook, IL 60062**

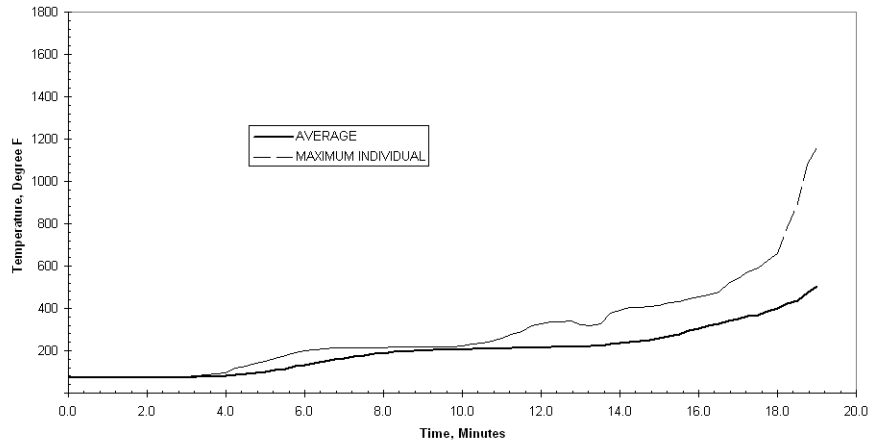
Temperatures of Between the Sub Floor and Finish Floor – The average and maximum temperatures between the sub floor and finish floor just before the moment of collapse (18 min 45 sec) were 383°F and 939°F respectively. The maximum individual temperature was recorded by thermocouple number 8. The average temperature was plotted on Figure 3.

Figure 3 - Plot of the Subfloor Temperatures vs. Time for Assembly No. 1

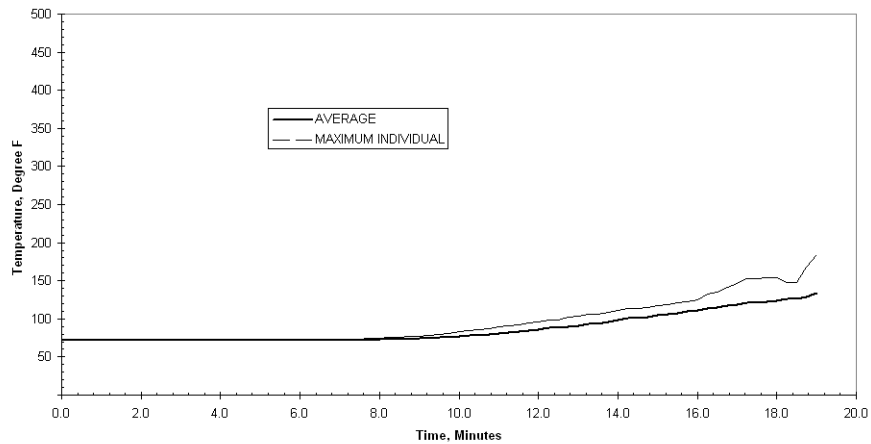
Temperatures of the Unexposed Surface – The average and maximum temperatures of the unexposed surface just before the moment of collapse (18 min 45 sec) were 122°F and 616°F respectively. The maximum individual temperature was recorded by thermocouple number 61. The average temperature and maximum temperatures were plotted on Figure 4.

Figure 4 - Plot of the Unexposed Surface Temperatures vs. Time for Assembly No. 1

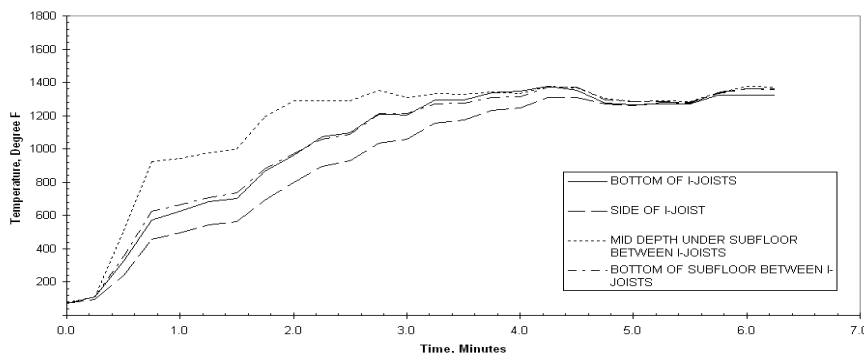
Temperatures on the Side of Mid Depth of the Wood I Joists – The average and maximum temperatures of the sides of the wood joists just before the moment of collapse (6 min 3 sec) were 1362°F and 1486°F respectively. The individual temperature was recorded by thermocouple number 45. A plot of these temperatures can be seen on Figure 9.

Temperatures of the Mid Depth Between Wood Joists – The average and maximum temperatures of the mid depth between the wood joists just before the moment of collapse (6 min 3 sec) were 1377°F and 1430°F respectively. The individual temperature was recorded by thermocouple number 58. A plot of these temperatures can be seen on Figure 9.

Temperatures of the Sub Floor Between Wood Joists – The average and maximum temperatures of the sub floor between the wood joists just before the moment of collapse (6 min 3 sec) were 1361°F and 1417°F respectively. The individual temperature was recorded by thermocouple number 70. A plot of these temperatures can be seen on Figure 9.

Figure 9 - Plot of Temperatures Below Subfloor vs. Time for Assembly No. 2

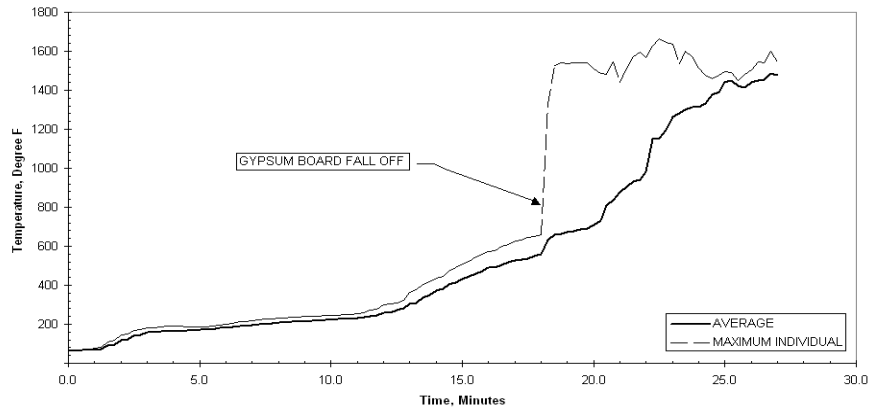
Temperatures of the Unexposed Side of Gypsum Board – The average and maximum temperatures of the unexposed surface just before the gypsum board fall off (17 min 15 sec) were 531°F and 634°F respectively. The individual temperature was recorded by thermocouple number 57. A plot of these temperatures can be seen on Figure 26.

Figure 26 - Plot of Temperature of the Unexposed Surface of Gypsum Board vs. Time for Assembly No. 4

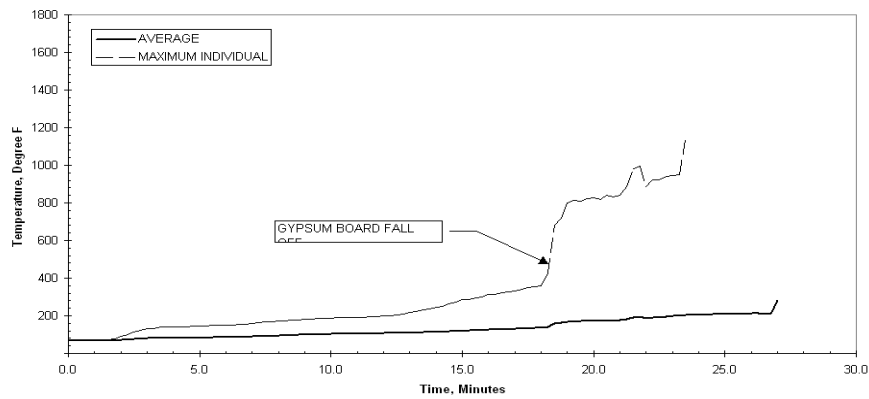
Temperatures Between the Sub Floor and Carpet Padding – The average and maximum temperatures between the sub floor and finish floor just before the moment of collapse (26 min 45 sec) were 191°F and 361°F respectively. The individual temperature was recorded by thermocouple number 7. A plot of these temperatures can be seen on Figure 27.

Figure 27 - Plot of Temperature of the Subfloor Temperatures vs. Time

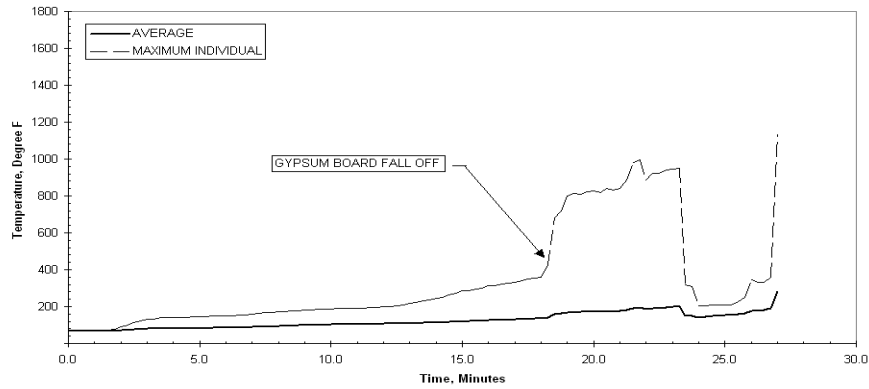
Temperatures Between the Carpet Padding and Carpet – The average and maximum temperatures between the sub floor and finish floor just before the moment of collapse (26 min 45 sec) were 135°F and 188°F respectively. The individual temperature was recorded by thermocouple number 29. A plot of these temperatures can be seen on Figure 28.

Figure 28 - Plot of Temperature of the Carpet Padding vs. Time for Assembly No. 4

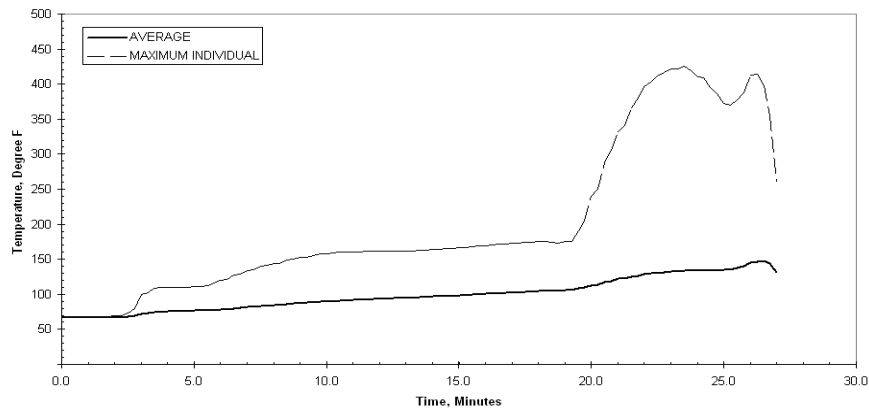
Temperatures of the Unexposed Surface – The average and maximum temperatures of the unexposed surface just before the moment of collapse (26 min 45 sec) were 144°F and 355°F respectively. The individual temperature was recorded by thermocouple number 87. A plot of these temperatures can be seen on Figure 29.

Figure 29 - Plot of Temperature of the Unexposed Surface vs. Time for Assembly No. 4

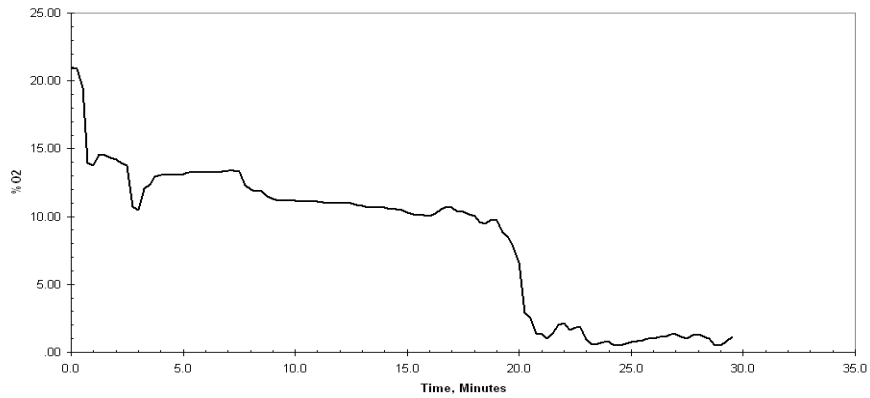
Figure 33 - Oxygen Content vs. Time for Assembly No. 5

The furnace pressure and oxygen concentration during the test are presented in Figure 32 and Figure 33.

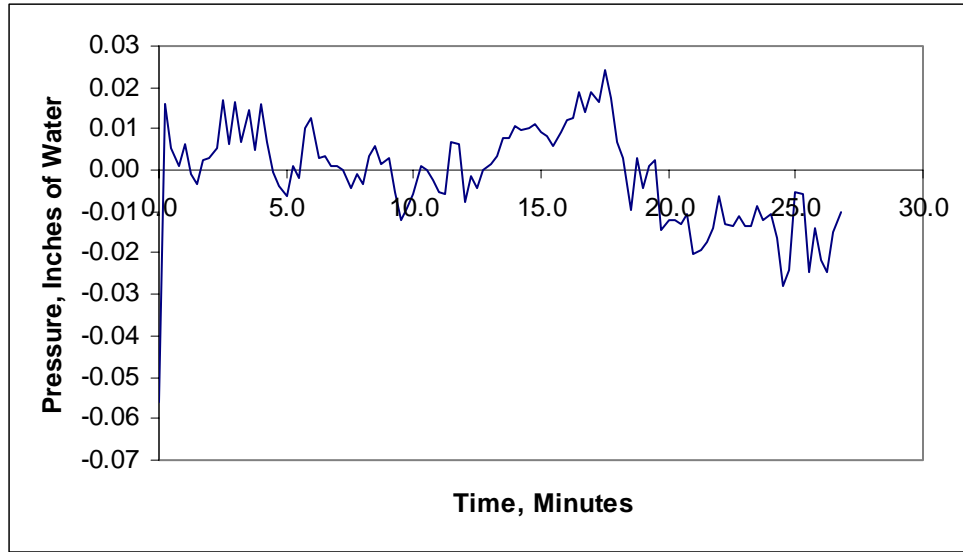
Figure 42 - Furnace Pressure vs. Time for Assembly No. 6

The furnace pressure and oxygen concentration are presented in Figure 42 and Figure 43.

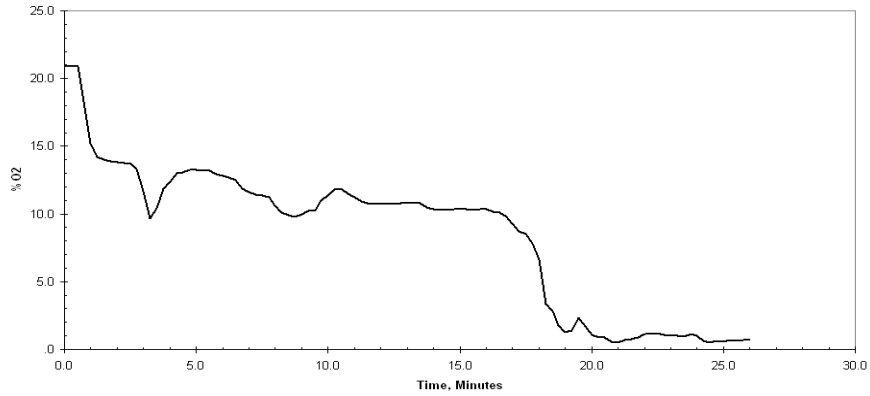
Figure 43 - Oxygen Content vs. Time for Assembly No. 6

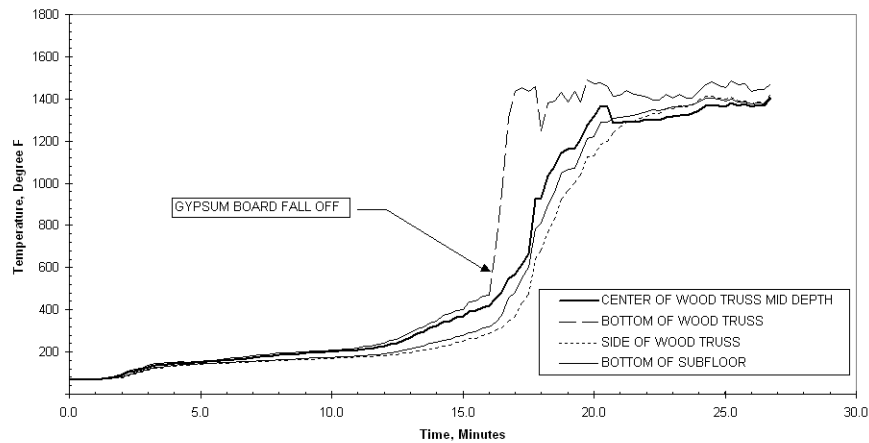
Temperatures of the Mid Depth Between Wood Trusses – The average and maximum temperatures of the mid depth between the wood trusses just before the moment of collapse (29 min 45 sec) were 1403°F and 1474°F respectively. The individual temperature was recorded by thermocouple number 66. A plot of these temperatures can be seen on Figure 6.4.

Temperatures of the Sub Floor Between Wood Trusses – The average and maximum temperatures of the sub floor between the wood joists just before the moment of collapse (29 min 45 sec) were 1411°F and 1476°F respectively. The individual temperature was recorded by thermocouple number 75. A plot of these temperatures can be seen on Figure 6.4.

Figure 44 - Plot of Temperatures of Below Subfloor vs. Time

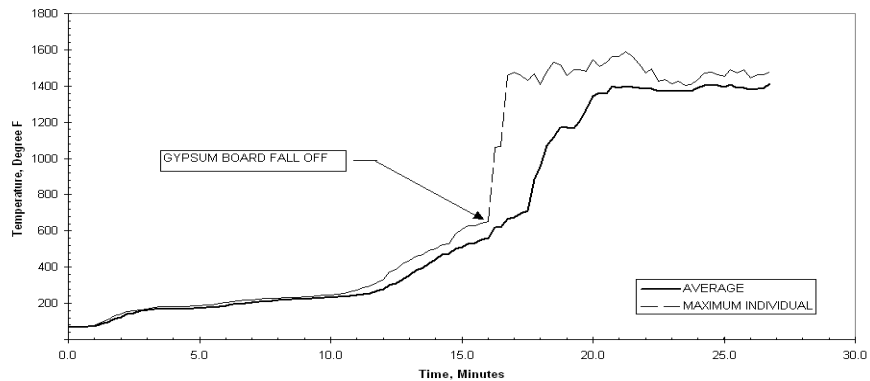
Temperatures of the Unexposed Side of Gypsum Board – The average and maximum temperatures of the unexposed surface just before the gypsum board fall off (16 min) were 559°F and 650°F respectively. The individual temperature was recorded by thermocouple number 52. A plot of these temperatures can be seen on Figure 46.

Figure 46 - Plot of Temperature of the Unexposed Surface of Gypsum Board vs. Time for Test Assembly No. 6

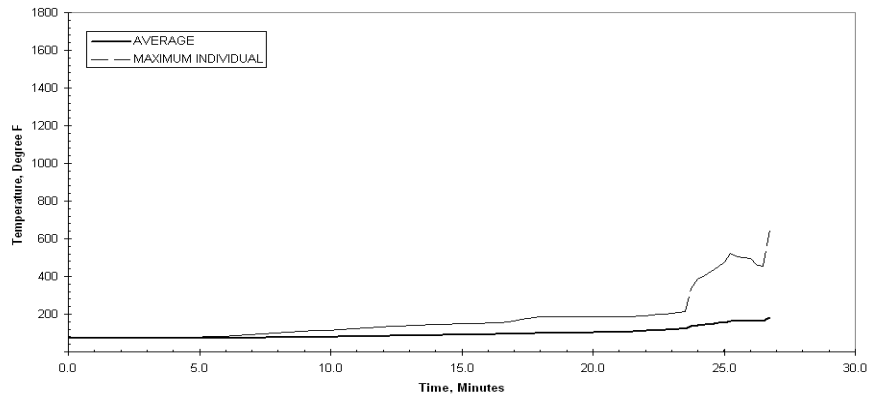
Temperatures of the Unexposed Surface – The average and maximum temperatures of the unexposed surface just before the moment of collapse (29 min 45 sec) were 182°F and 646°F respectively. The individual temperature was recorded by thermocouple number 92. A plot of these temperatures can be seen on Figure 49.

Figure 49 - Plot of Temperatures of the Unexposed Surface vs. Time for Test Assembly No. 6

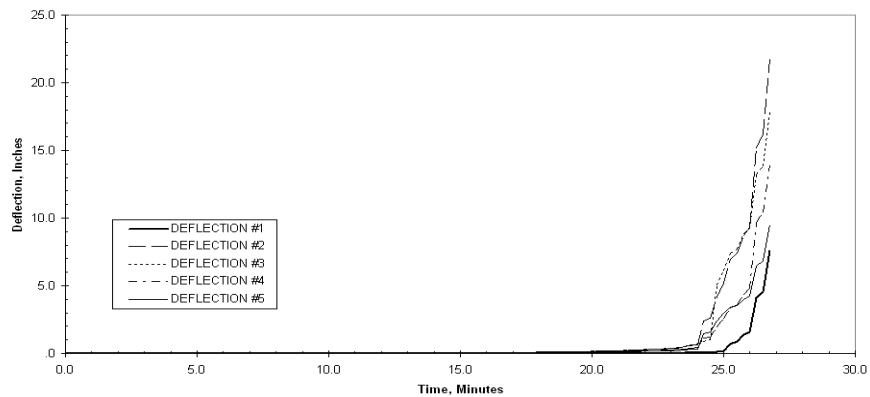
Deflection of the Assembly - The deflection of the floor-ceiling assembly during the fire test is shown on Figure 50. The location of each deflection transducer can be seen in Appendix A under Test Assembly 6.

Figure 50 - Plot of Deflections vs. Time for Test Assembly No. 6

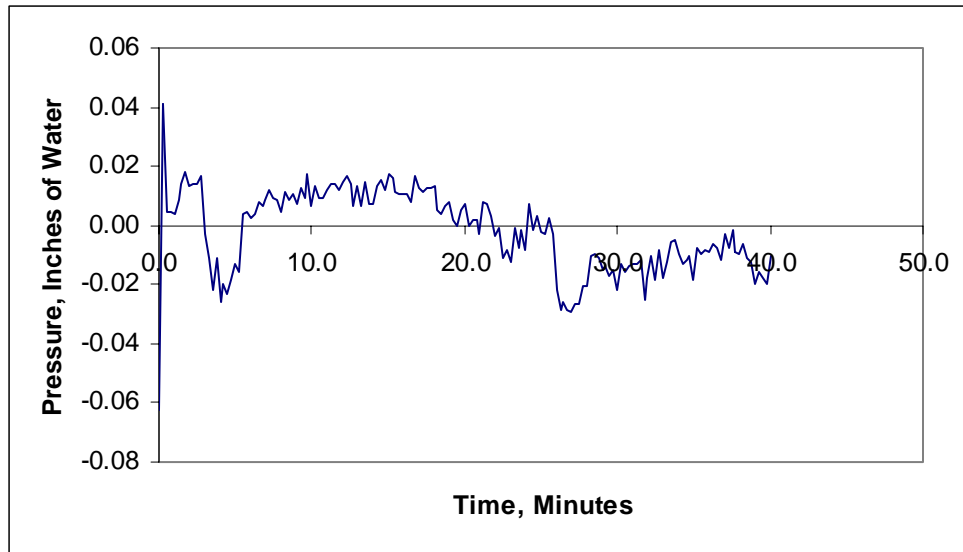
Figure 52 – Furnace Pressure vs. Time for Assembly No. 7

The furnace pressure and oxygen concentration are presented in Figure 52 and Figure 53.

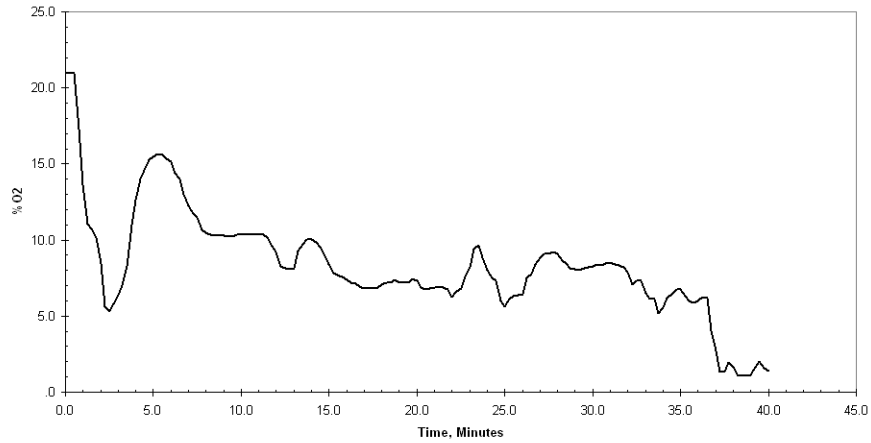
Figure 53 – Oxygen Content vs. Time for Test Assembly No. 7

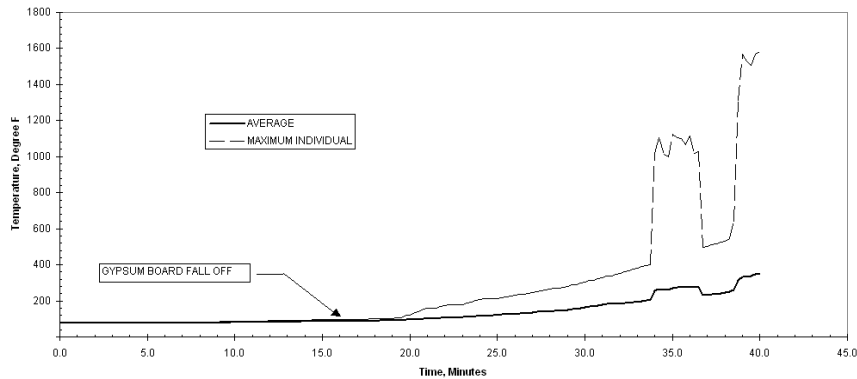
Temperatures on the top of the Roof Deck – The average and maximum temperatures between the roof deck and roof felt just before the moment of collapse (40 min 00 sec) were 352°F and 1585°F respectively. The individual temperature was recorded by thermocouple number 4. A plot of these temperatures can be seen on Figure 56.

Figure 56 – Plot of the Roof Deck Temperatures vs. Time for Test Assembly No. 7

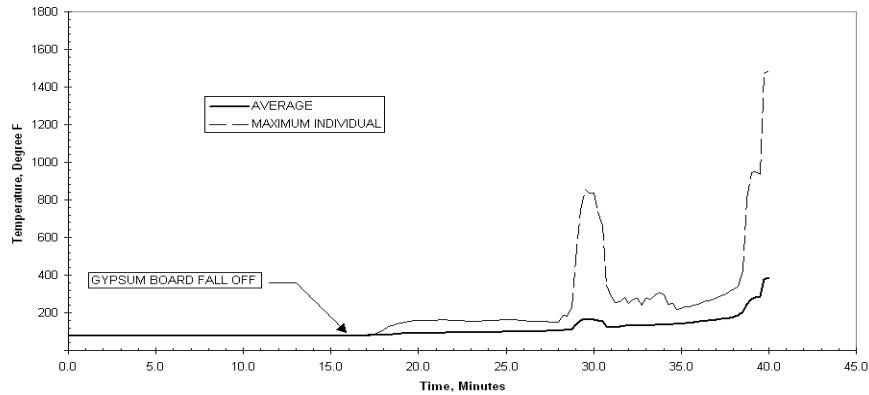
Temperatures of the Unexposed Surface – The average and maximum temperatures of the unexposed surface just before the moment of collapse (40 min 00 sec) were 385°F and 1487°F respectively. The individual temperature was recorded by thermocouple number 81. A plot of these temperatures can be seen on Figure 58.

Figure 58 – Plot of Temperatures of the Unexposed Surface vs. Time for Test Assembly No. 7

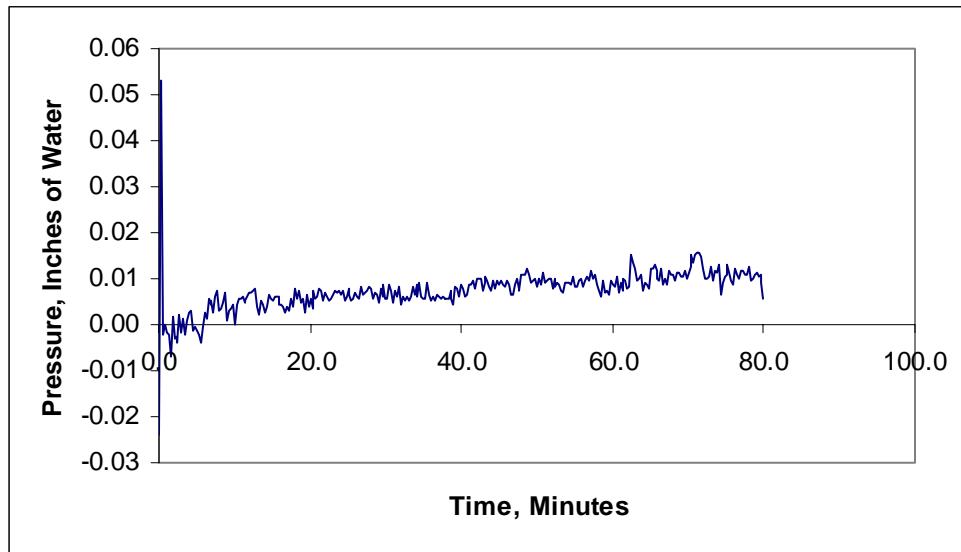
Figure 62 – Furnace Pressure vs. Time for Test Assembly No. 8

The furnace pressure and oxygen concentration are presented Figure 62 and Figure 63.

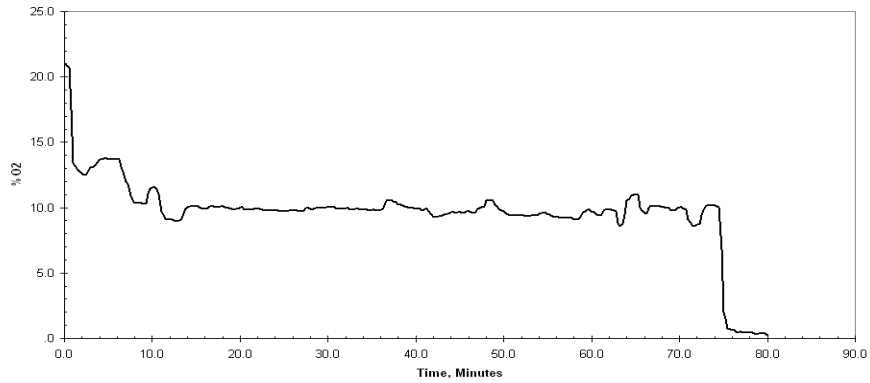
Figure 63 – Oxygen Content vs. Time for Test Assembly No. 8

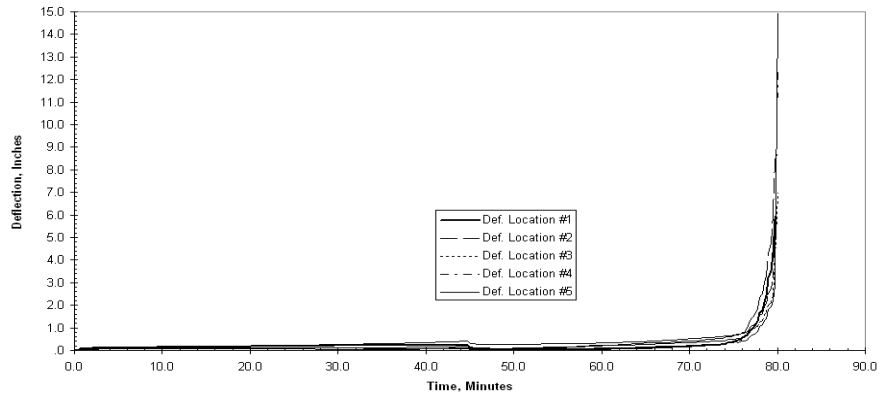
Deflection of the Assembly - The deflection of the floor-ceiling assembly during the fire test is shown on Figure 68. The location of each deflection transducer can be seen in Appendix A under Test Assembly 8.

Figure 68 – Plot of Deflections vs. Time for Test Assembly No. 8

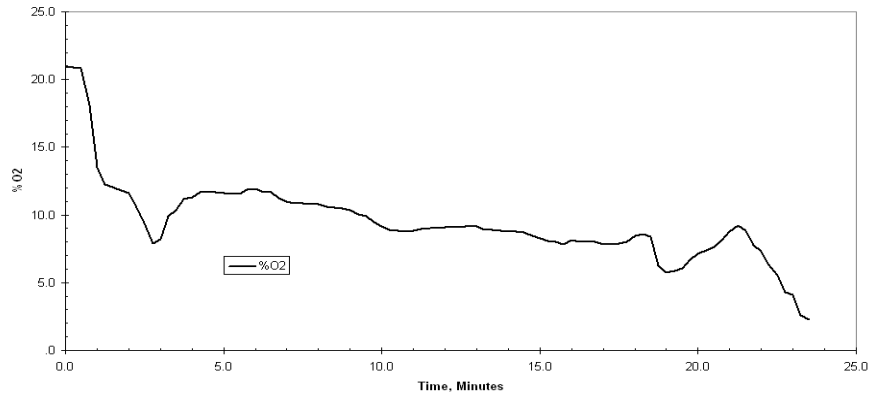
Figure 71 – Oxygen Content vs. Time for Test Assembly No. 9

The furnace pressure and oxygen concentration are presented in Figure 70 and Figure 71.

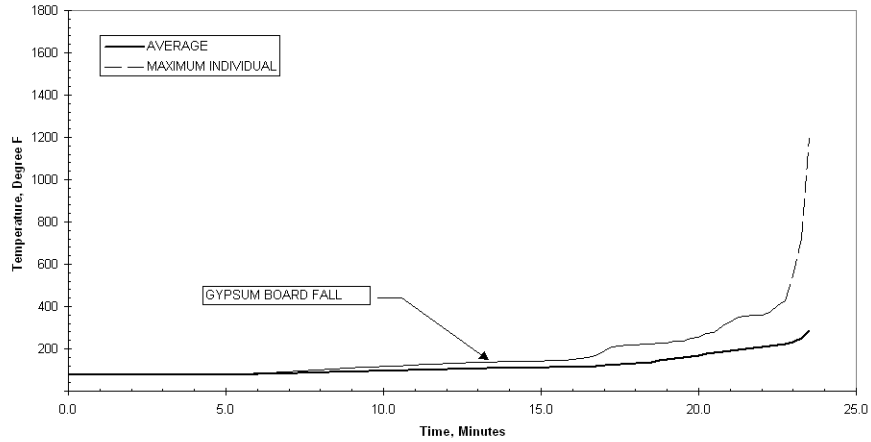
Temperatures on the Top of the Roof Deck – The average and maximum temperatures between the roof deck and roof felt just before the moment of collapse (23 min 15 sec) were 249°F and 723°F respectively. The individual temperature was recorded by thermocouple number 9. A plot of these temperatures can be seen on Figure 9.6.

Figure 9.6 – Plot of Temperature of the Roof Deck Temperatures vs. Time

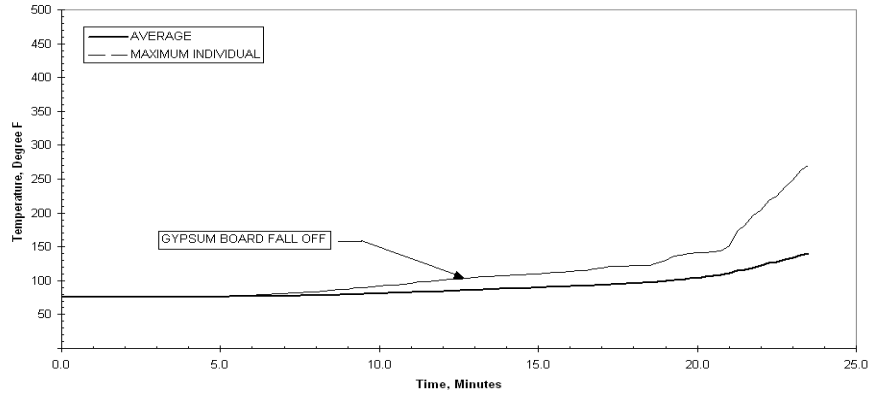
Temperatures of the Unexposed Surface – The average and maximum temperatures of the unexposed surface just before the moment of collapse (23 min 15 sec) were 138°F and 263°F respectively. The individual temperature was recorded by thermocouple number 92. A plot of these temperatures can be seen on Figure 75.

Figure 75 – Plot of Temperatures of the Unexposed Surface vs. Time

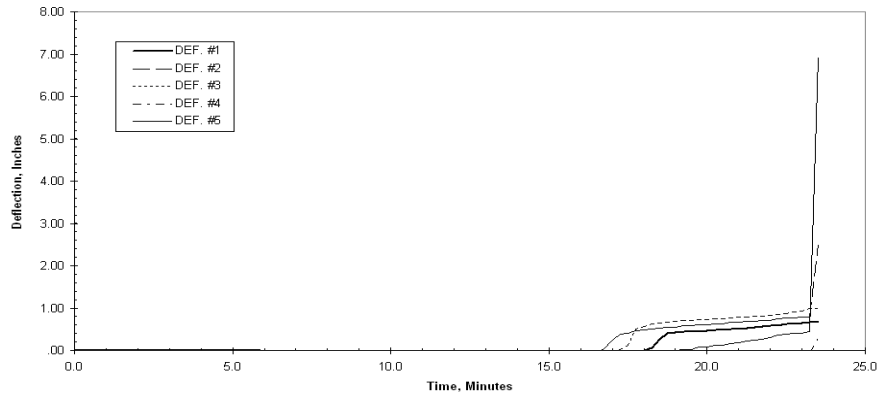
Deflection of the Assembly - The deflection of the floor-ceiling assembly during the fire test is shown on Figure 9.9. The location of each deflection transducer can be seen in Appendix A under Figure 76.

Figure 76 – Plot of Deflections vs. Time

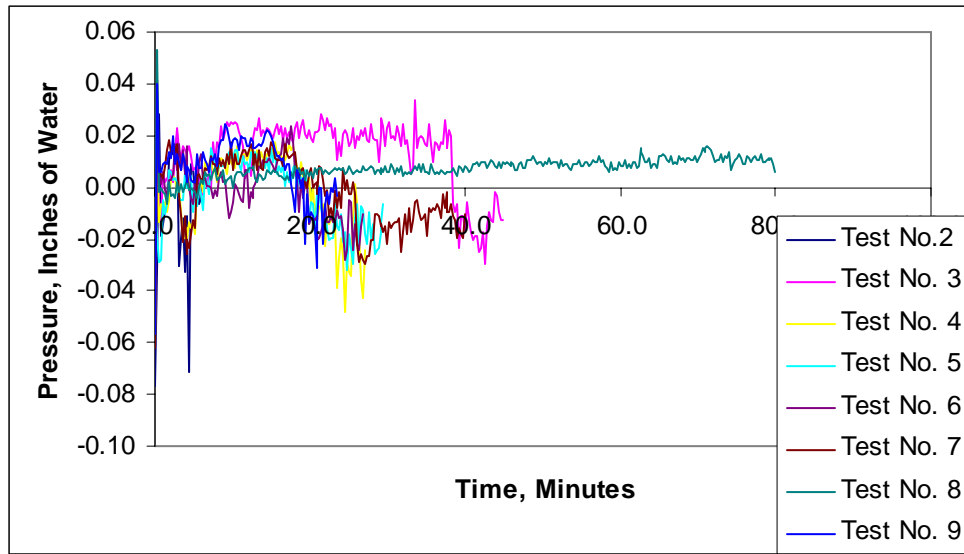
Figure 78 - Furnace Pressure

The furnace pressure was measured at a level approximately 4 inches below the ceiling surface. After the initial few minutes, the furnace pressure ranged from 0.01 to 0.02 inches of water until the ceiling fell. Then the furnace pressure became negative and ranged for 0.01 to 0.03 inches of water.

The average temperature within the furnace, the pressure within the furnace and the percent oxygen content in the furnace exhaust duct were plotted in Figure 77, Figure 78 and Figure 79, respectively.

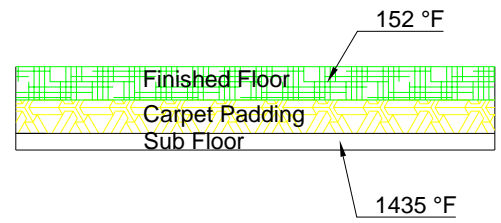
60 seconds before collapse

30 seconds before collapse

Collapse at 26 min.: 45 sec.

Figure 83 - Test Assembly No. 4

The use of thermal imaging cameras by firefighters continues to grow and has many current and potential life safety applications. The temperature on the surfaces of the floor and roof were measured at several locations during each fire test. The temperatures of these surfaces at 60 seconds and at 30 seconds before collapse are shown in Figure 80 to Figure 88.

Table 15 provides a summary of the temperature data in the previous Figure 80 through Figure 88.

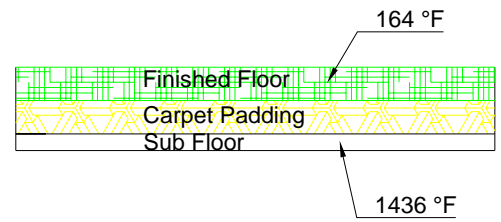
60 seconds before collapse

30 seconds before collapse

Collapse at 29 min.: 15 sec.

Figure 84 - Test Assembly No. 5

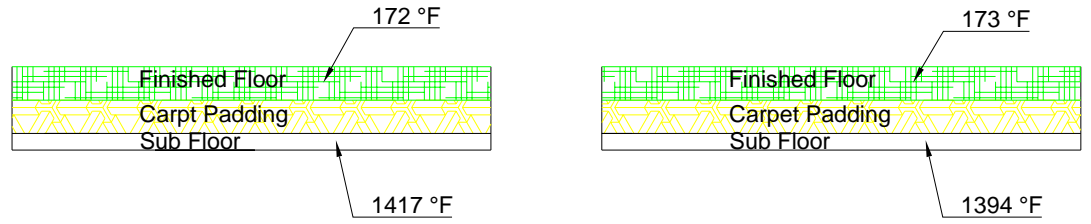
60 seconds before collapse

30 seconds before collapse

Collapse at 79 min.: 45 sec.

Figure 87 - Test Assembly No. 8

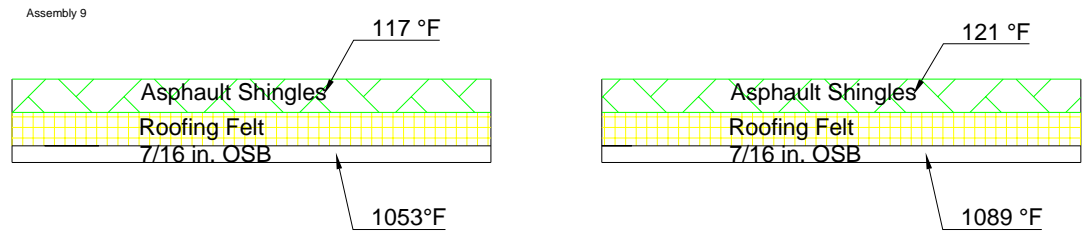
60 seconds before collapse

30 seconds before collapse

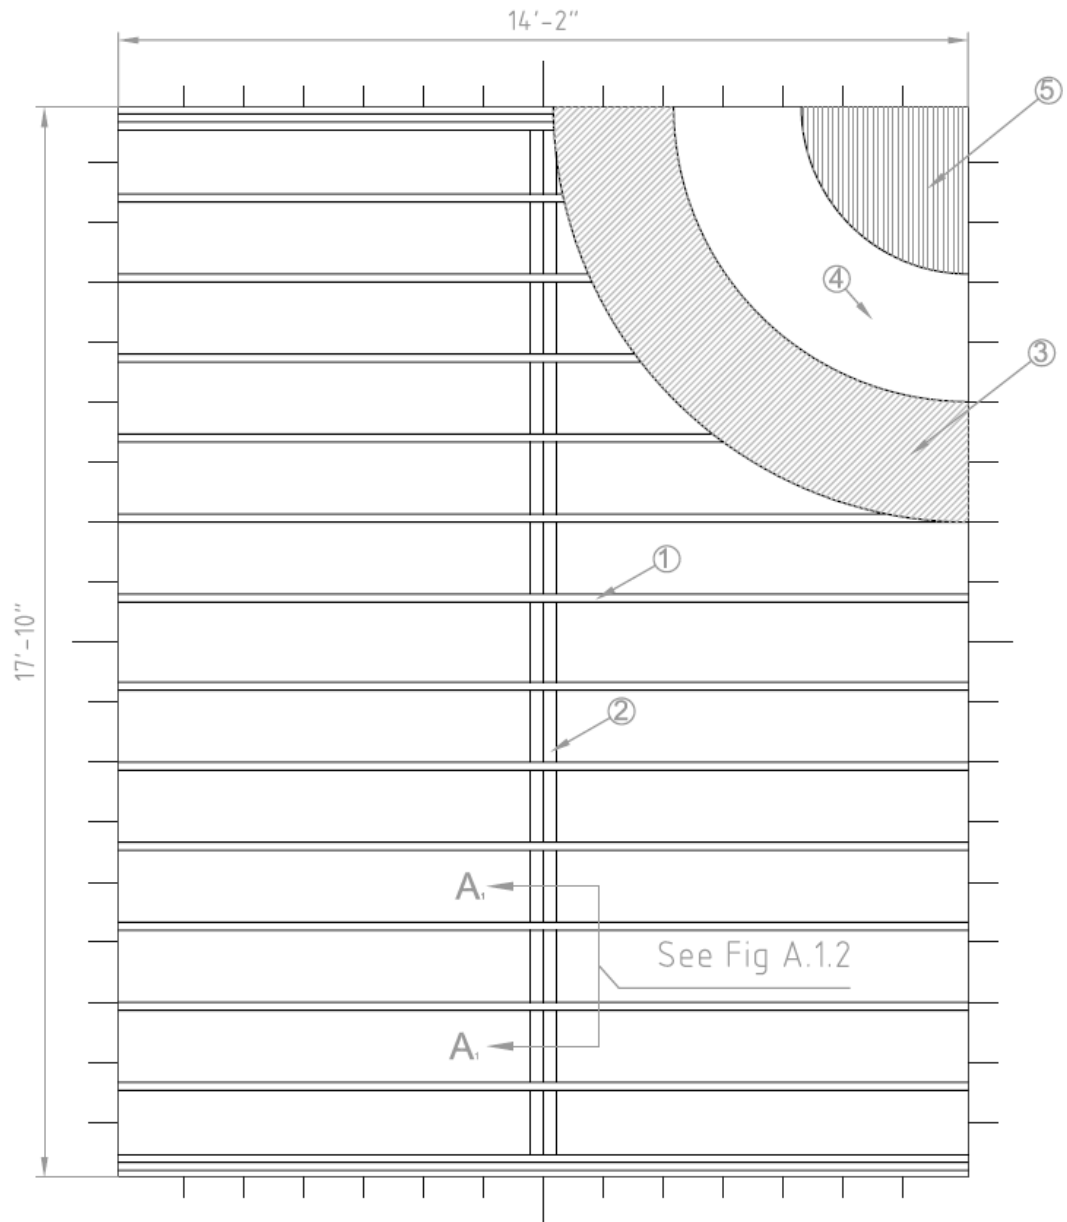
Figure A.1.1 – Construction Layout.

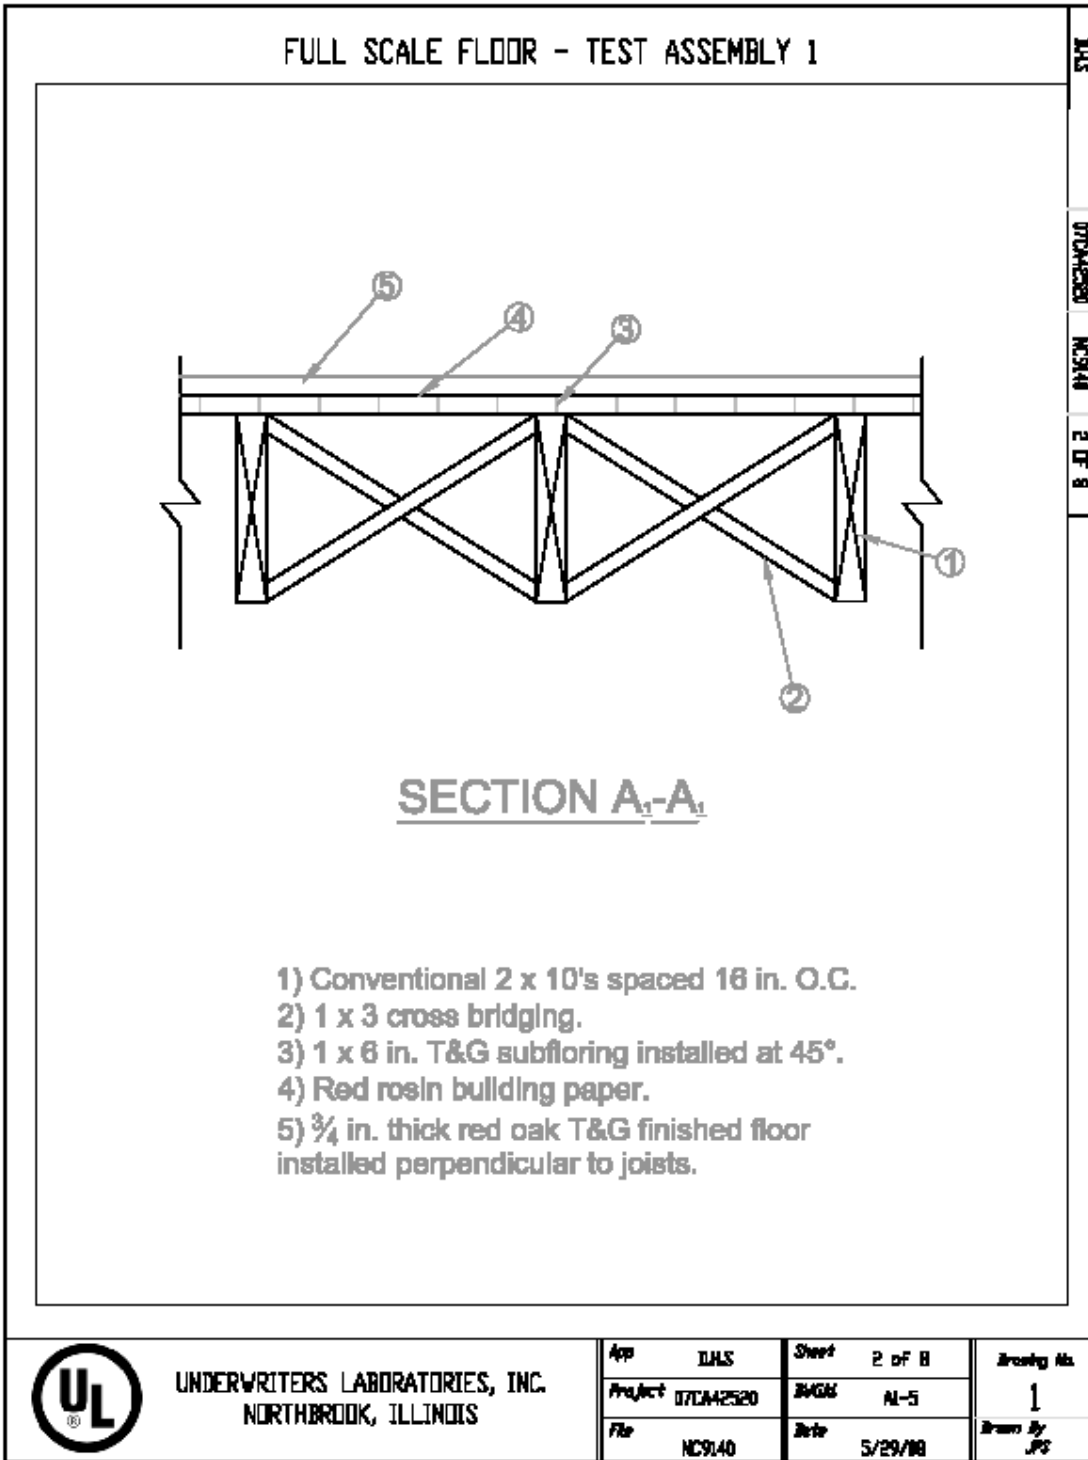
Figure A.1.2 – Construction Layout Section A₁-A₁.

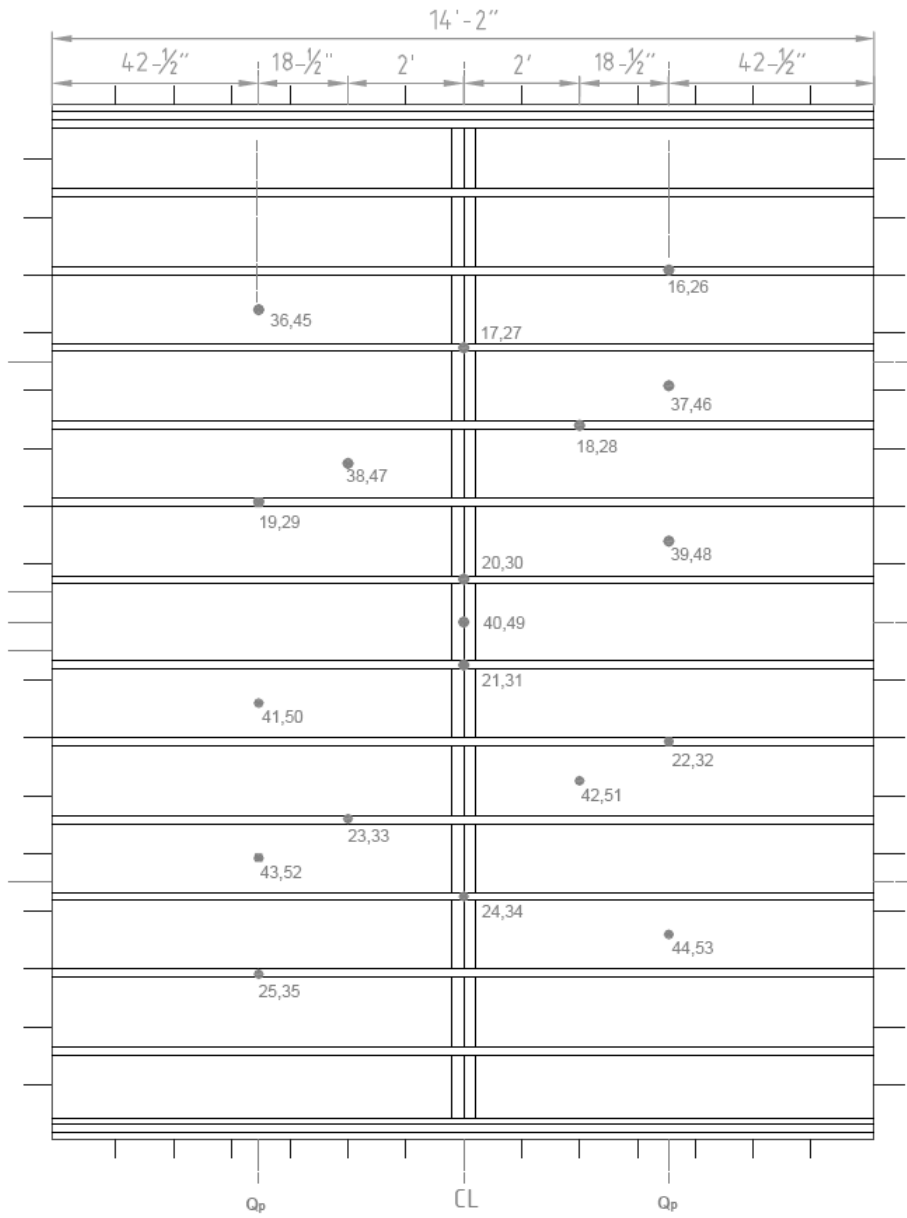
Figure A.1.4 – Thermocouple Locations on Wood Members.

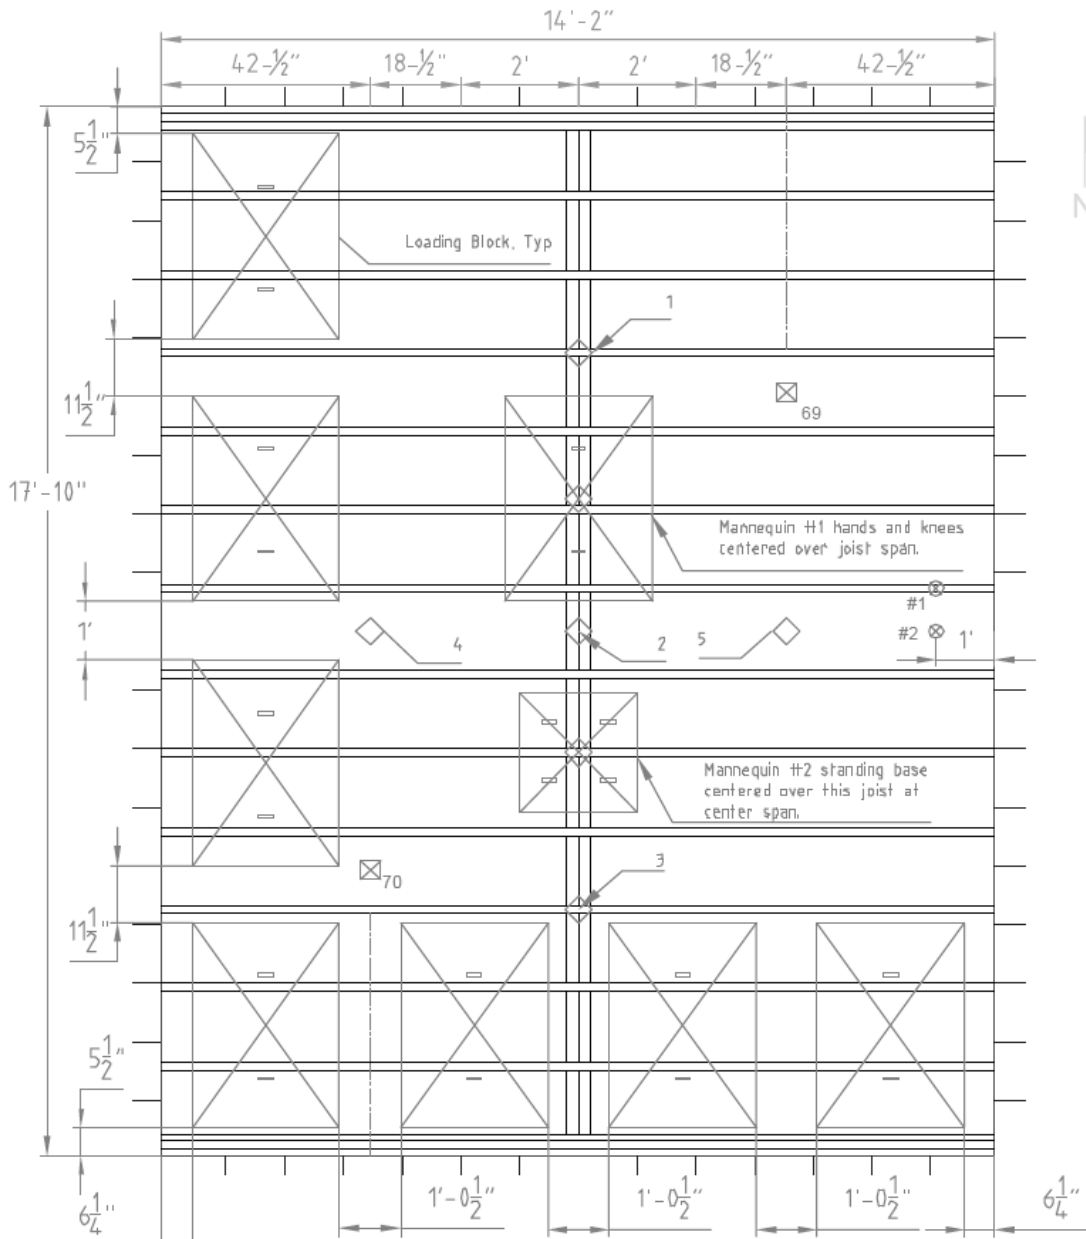
Figure A.1.7 – Loading and Instrumentation Layout (See Figure A.1.8).

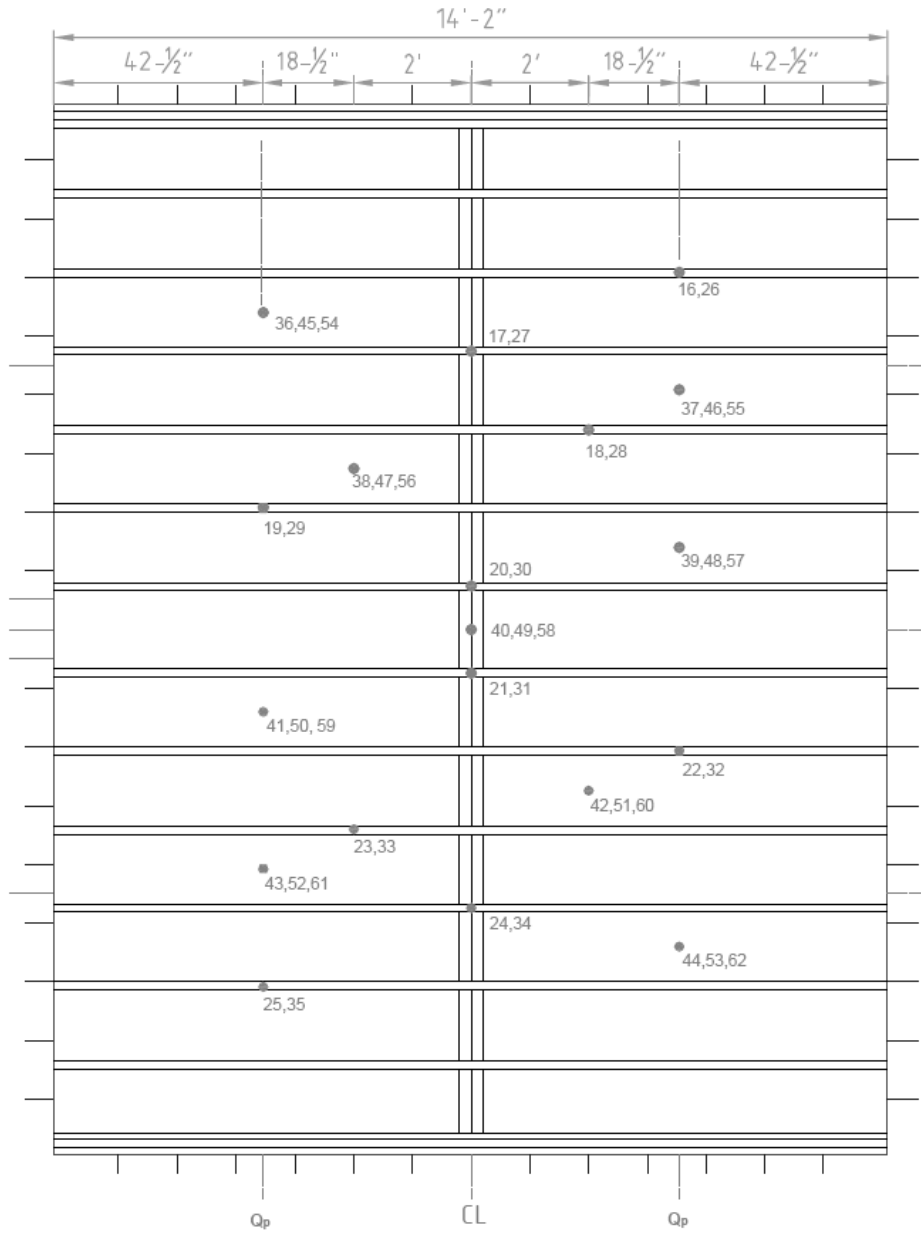
Figure A.3.4 – Thermocouple Locations on Wood Member.

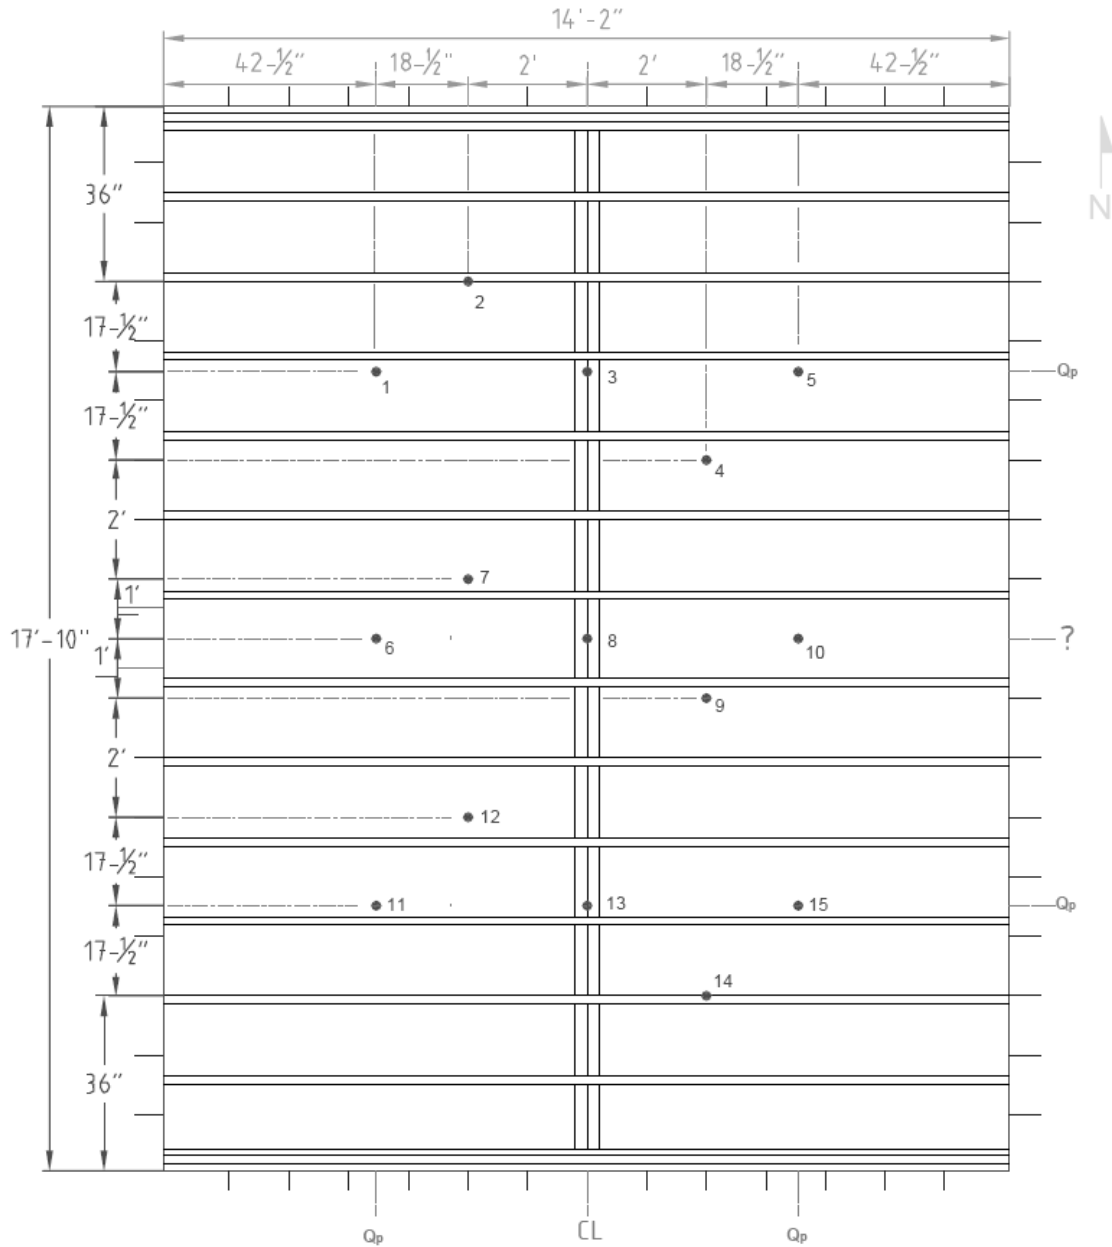
Figure A.3.5 – Thermocouple Locations on Subfloor.

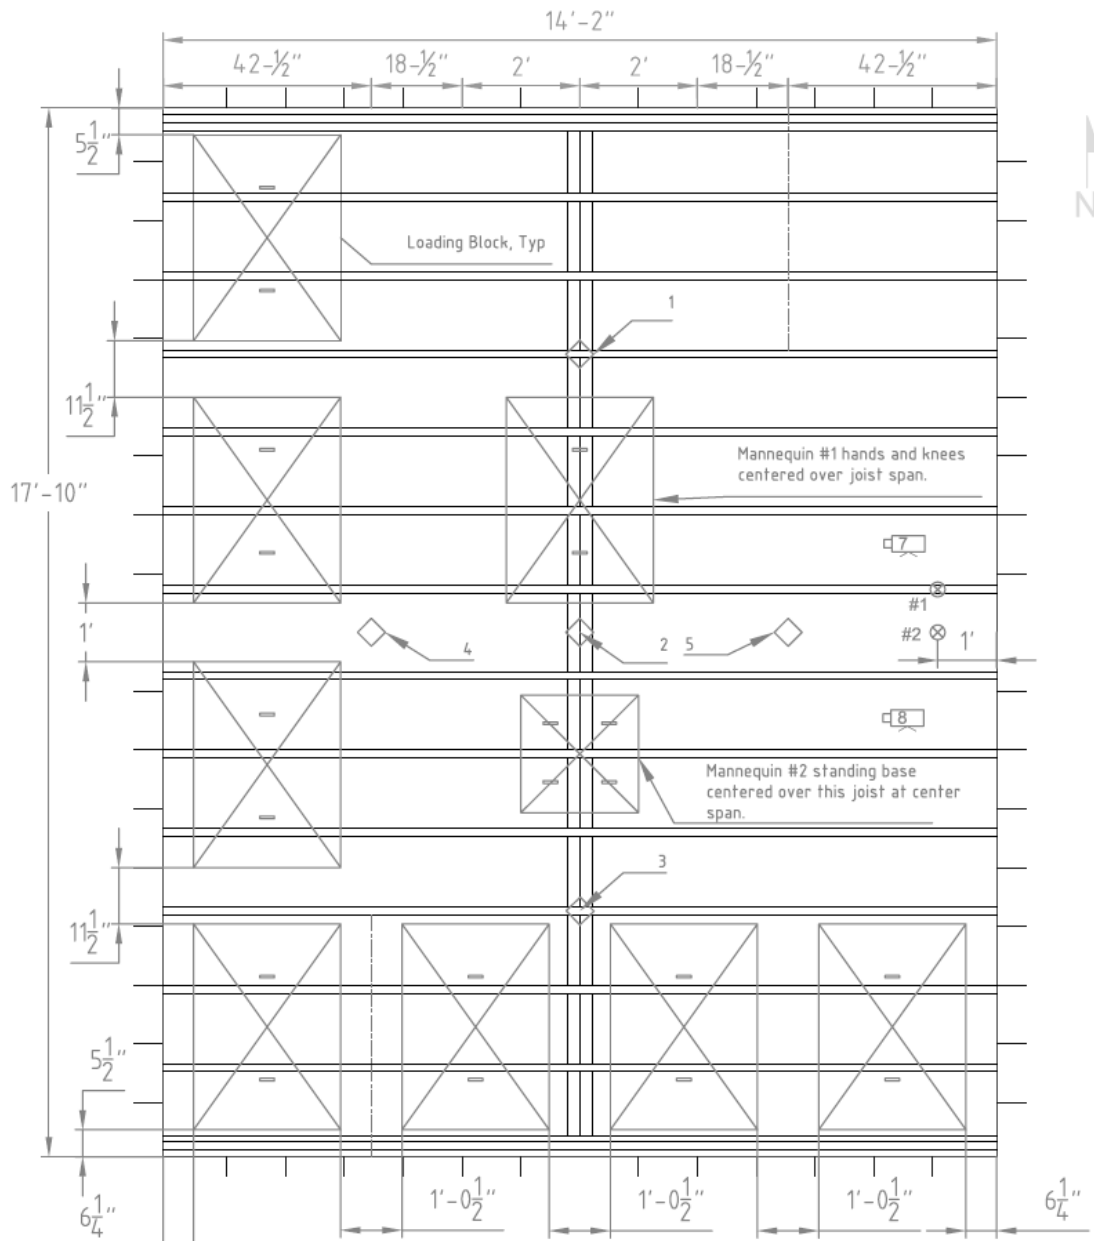
Figure A.3.7 – Loading and Instrumentation Layout (See Figure A.3.8).
