**Report
on
Structural Stability of Engineered Lumber in Fire Conditions**

**Project Number: 07CA42520
File Number: NC9140**

**Underwriters Laboratories Inc.
333 Pfingsten Road, Northbrook, IL 60062**

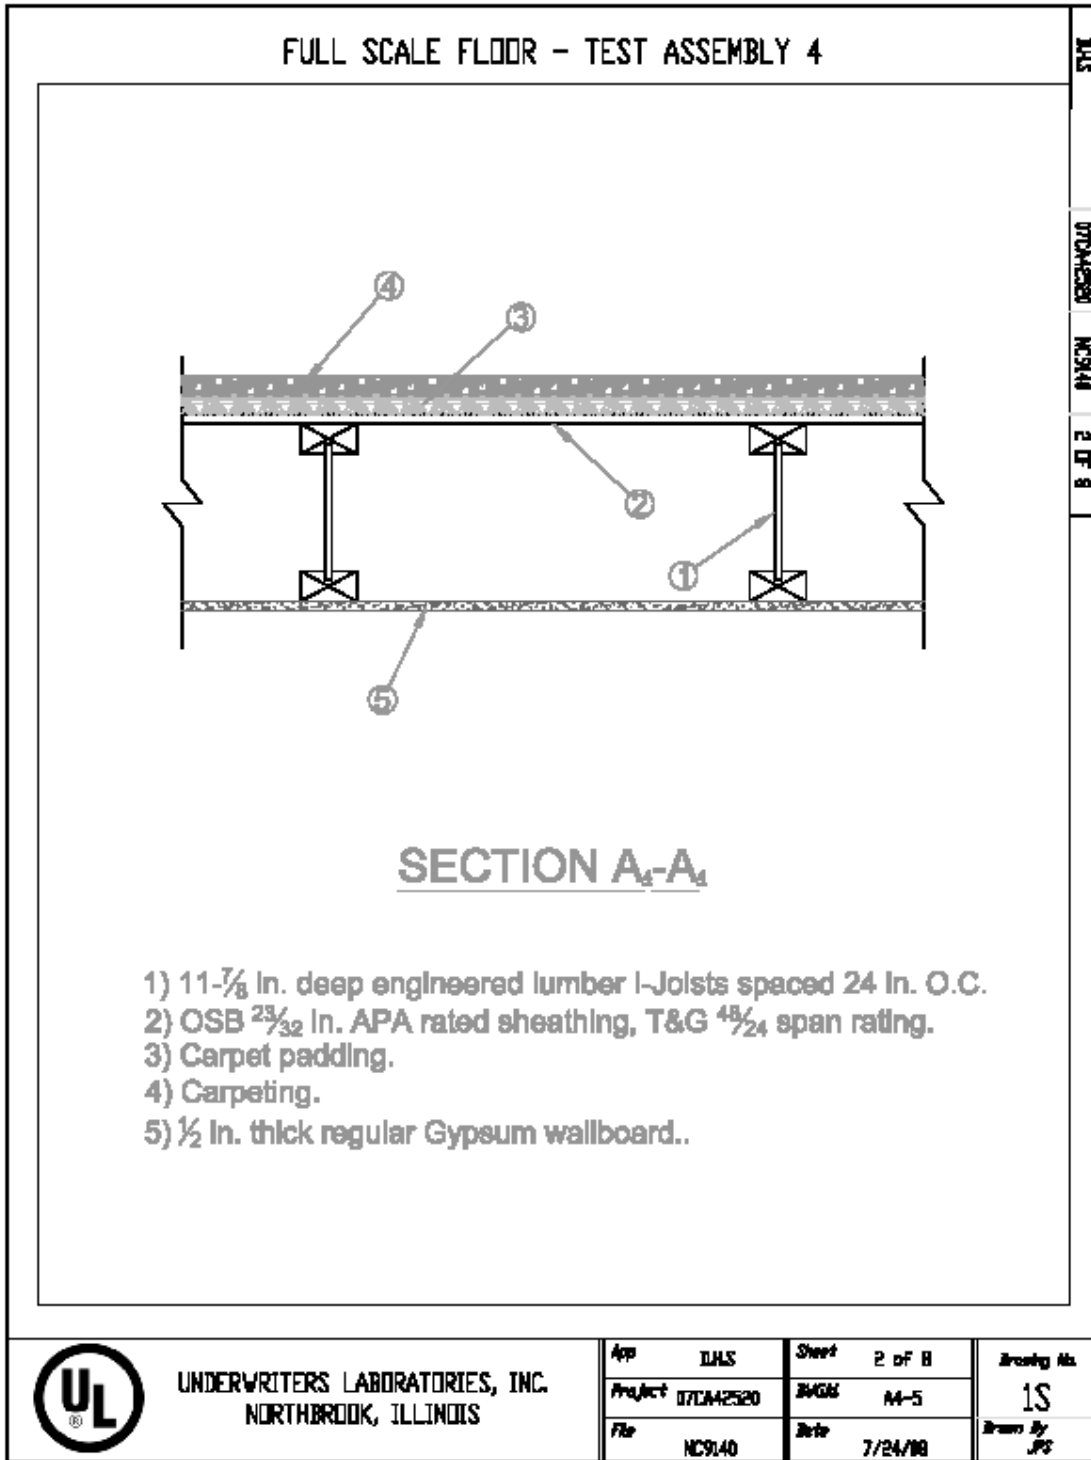
Figure A.4.2 – Construction Layout Section A₄-A₄.

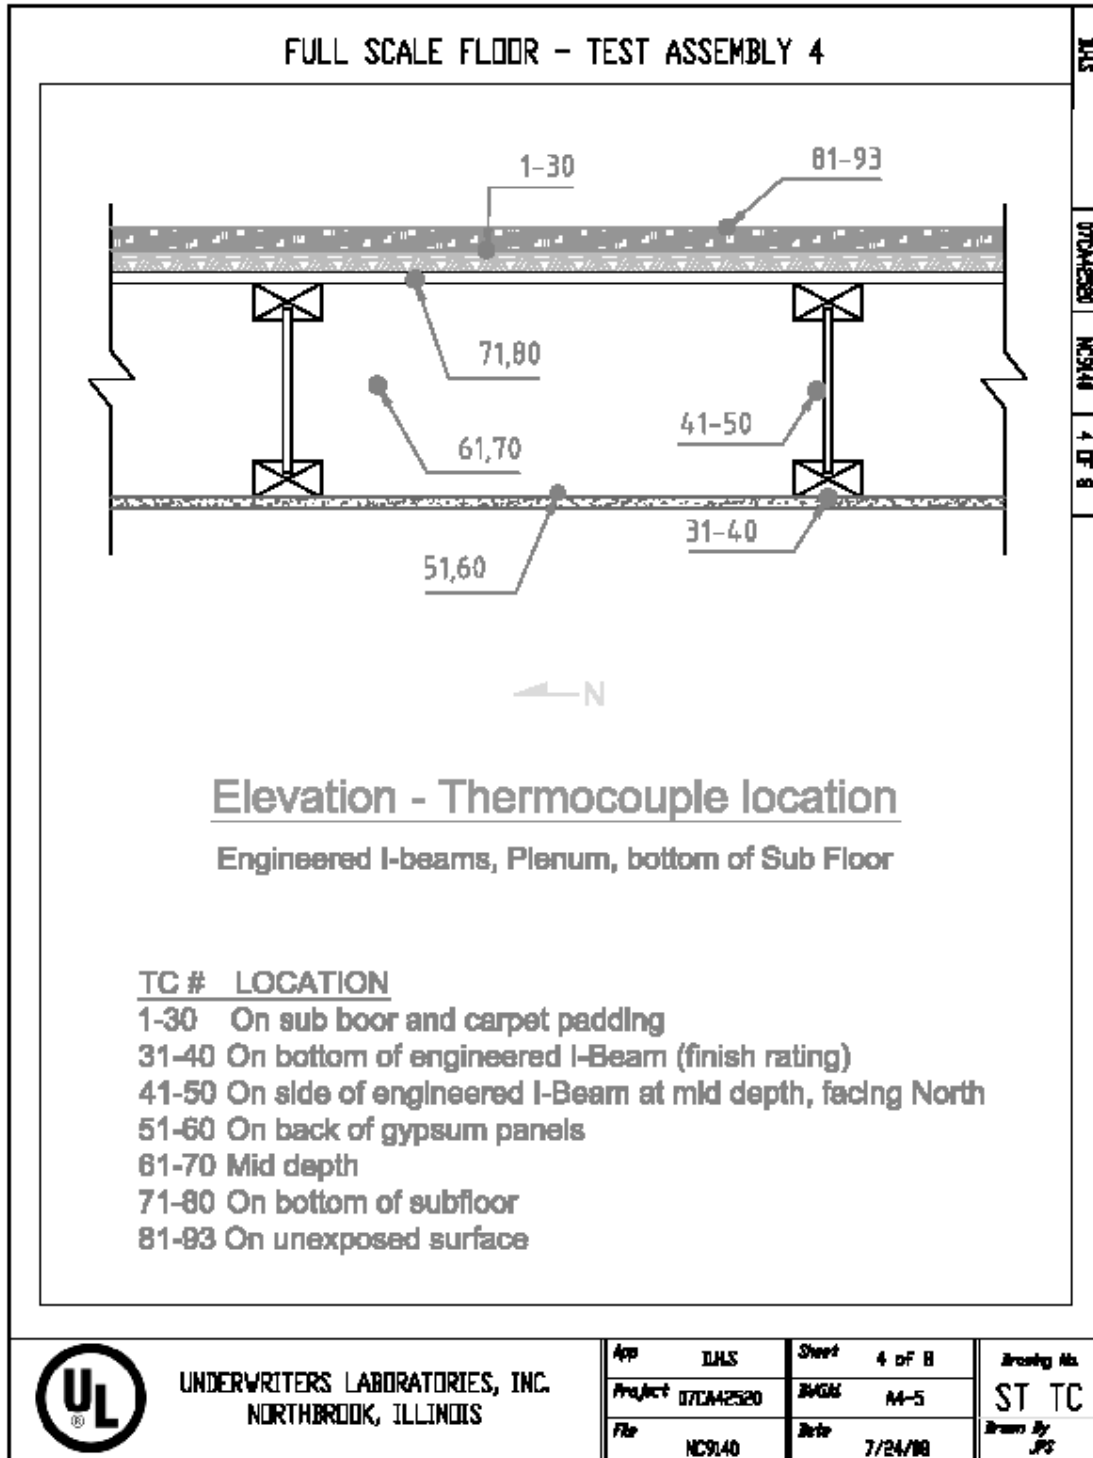
Figure A.4.3 – Thermocouple Locations - Elevation.

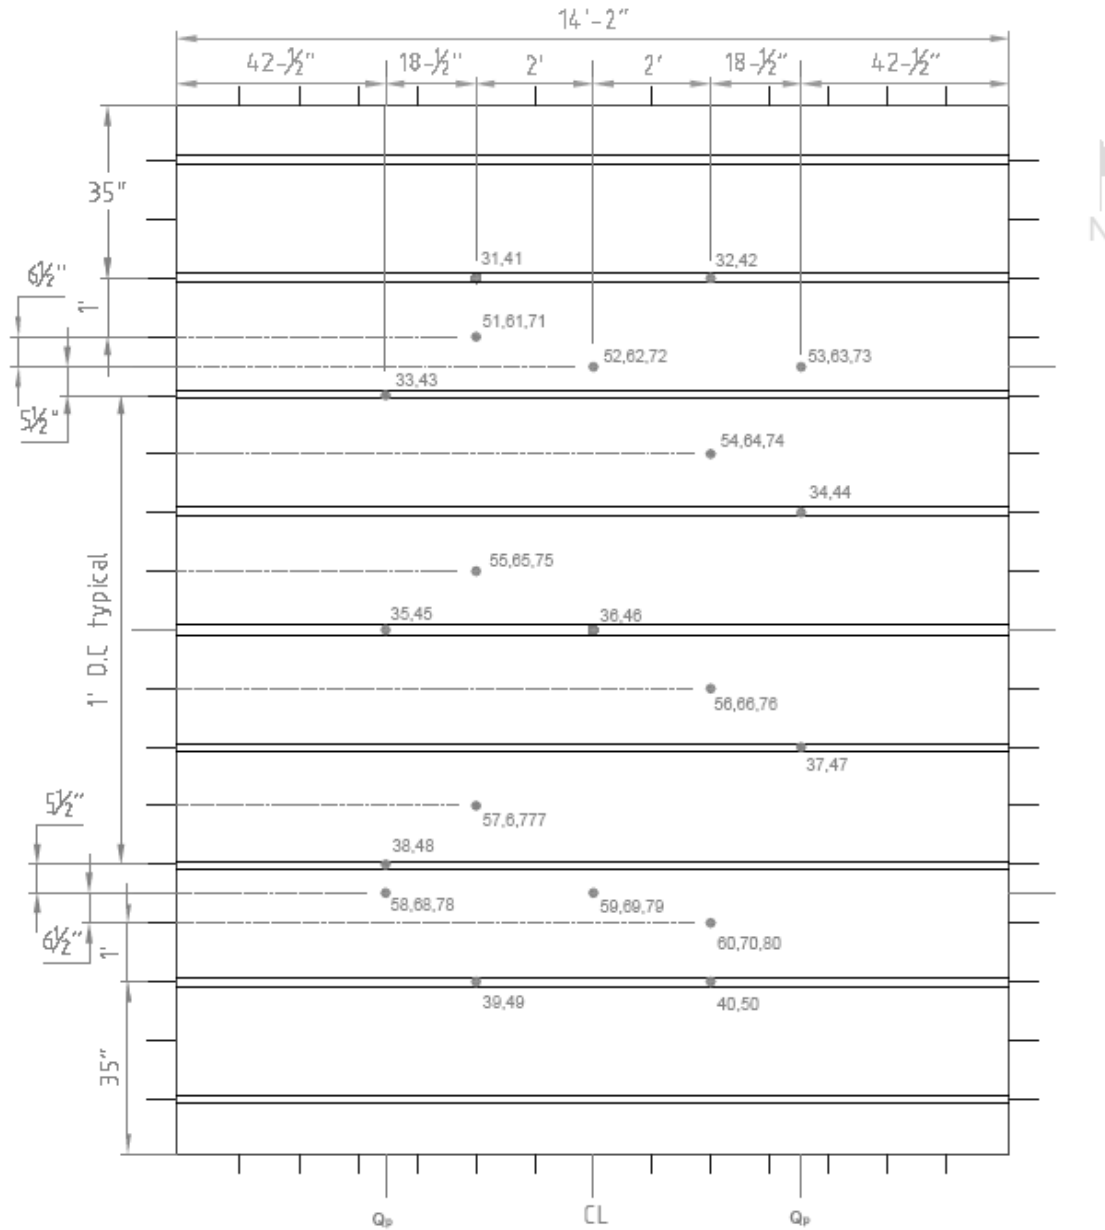
Figure A.4.4 – Thermocouple Locations on Wood Members.

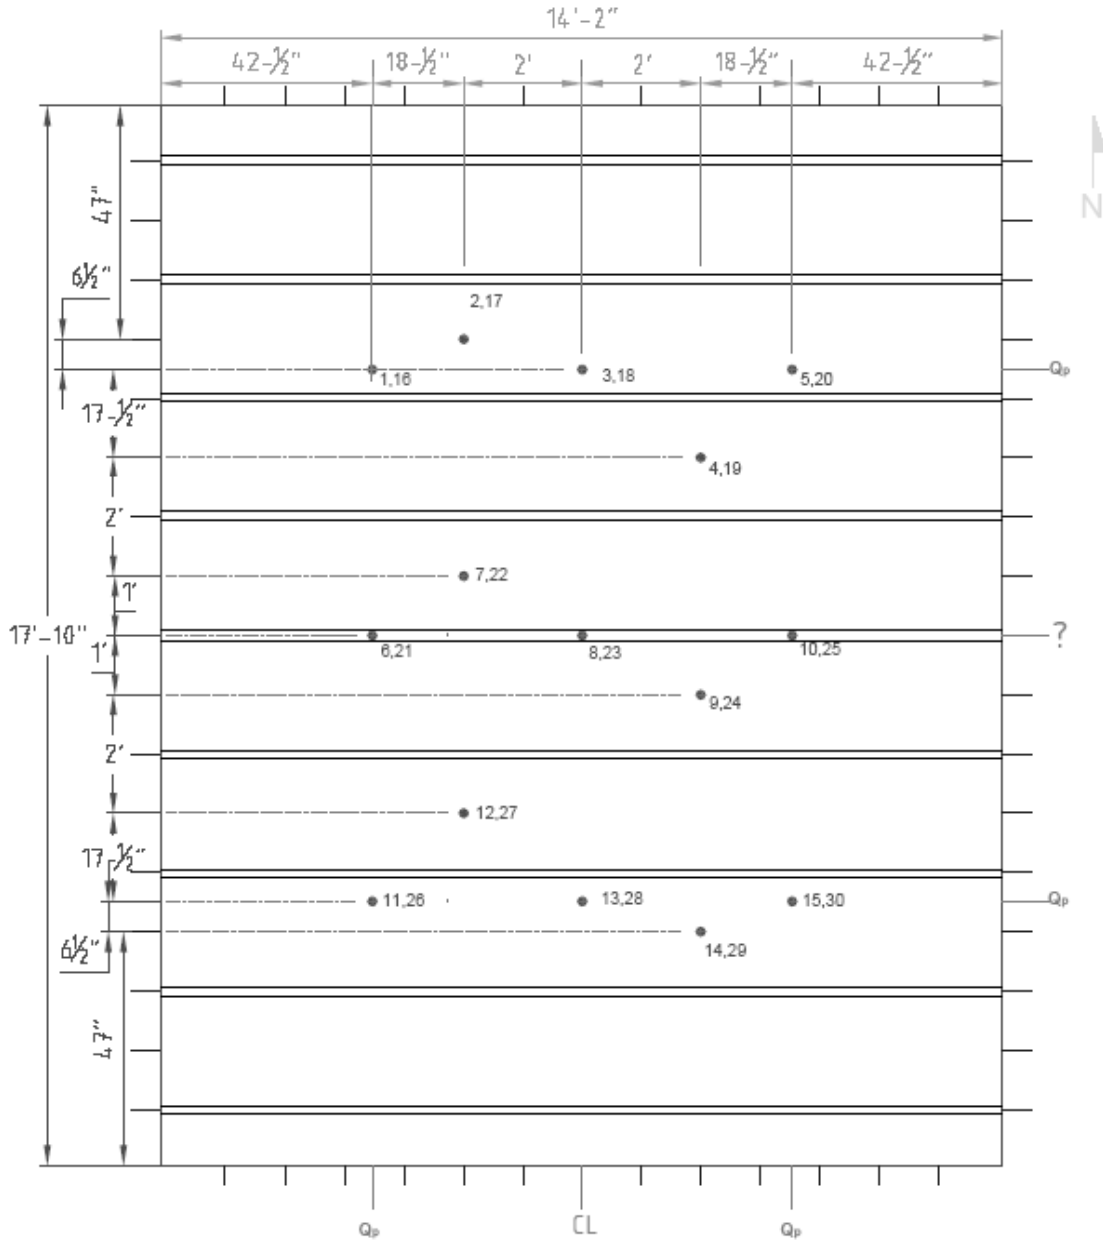
Figure A.4.5 – Thermocouple Locations on Subfloor and Carpet Padding.

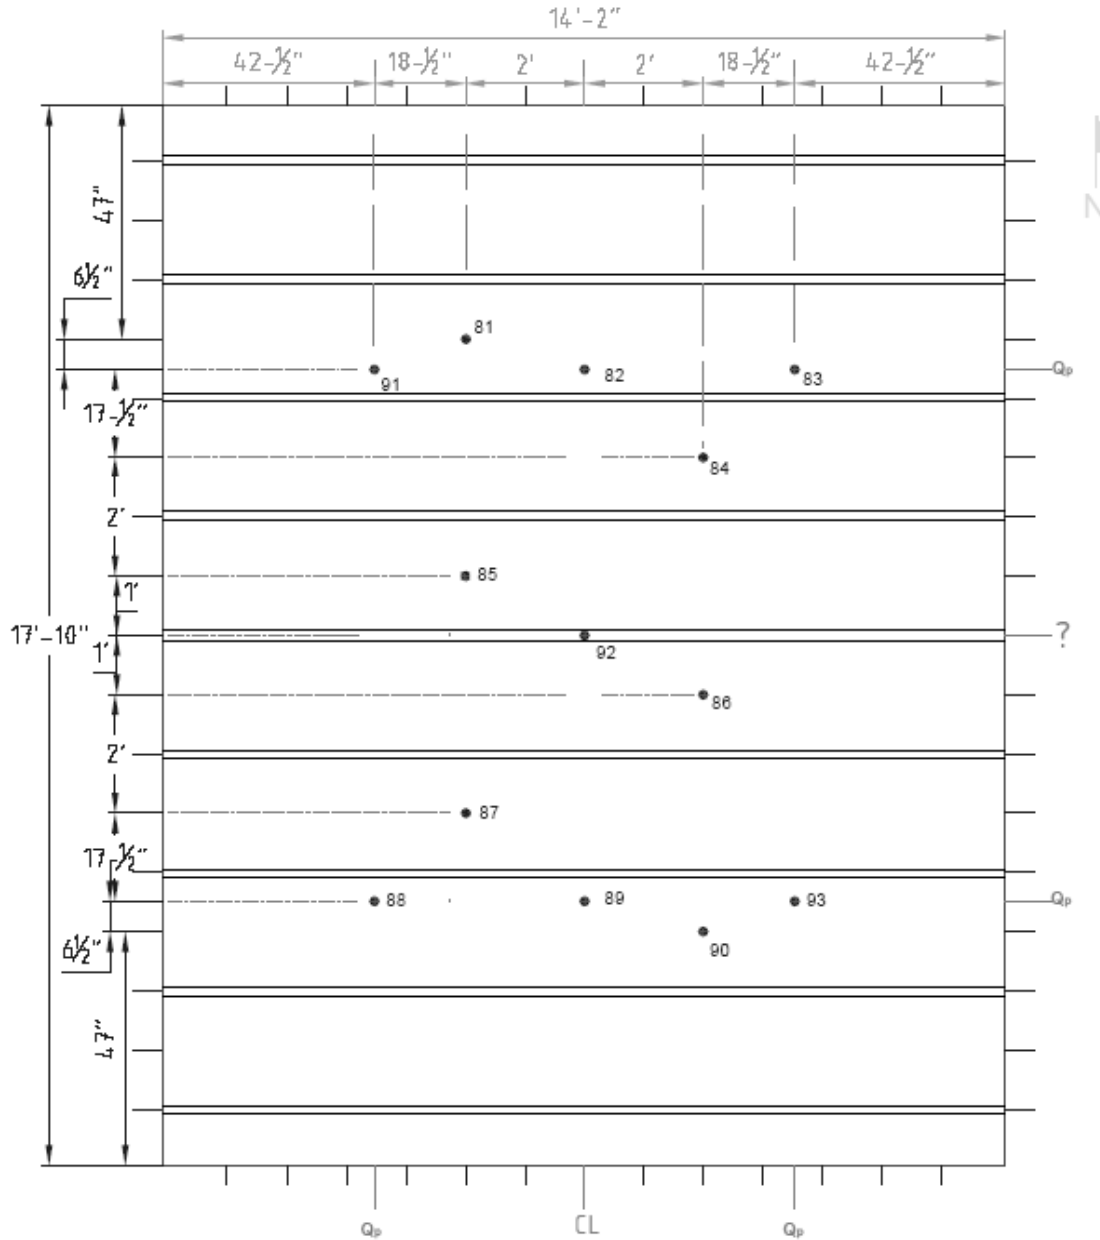
Figure A.4.6 – Thermocouple Locations on Unexposed Surface.

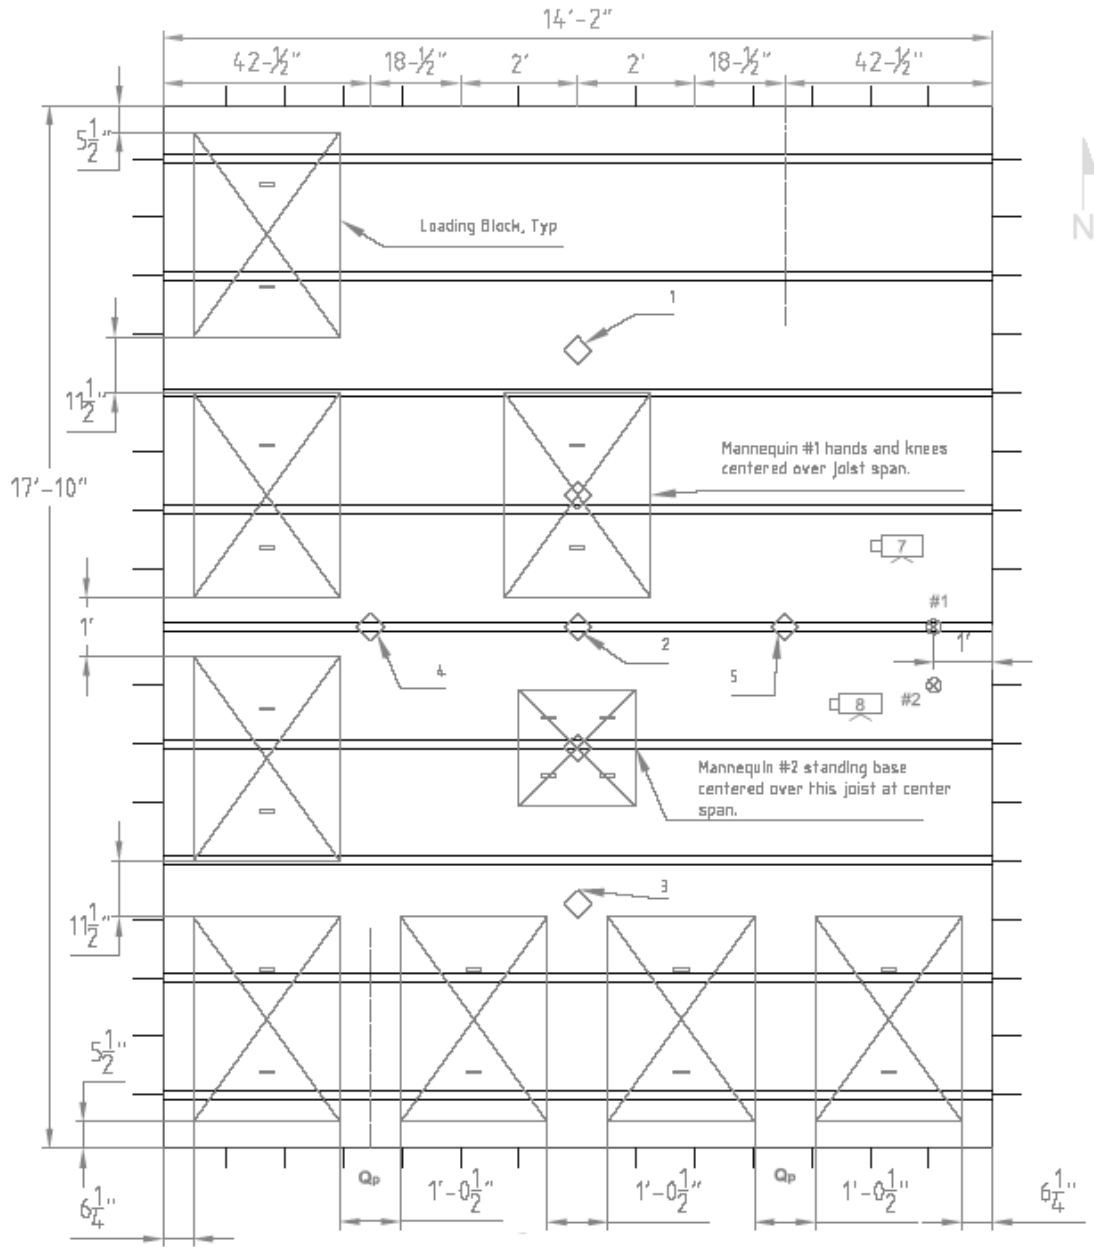
Figure A.4.7 – Loading and Instrumentation Layout (See Figure A.4.8).

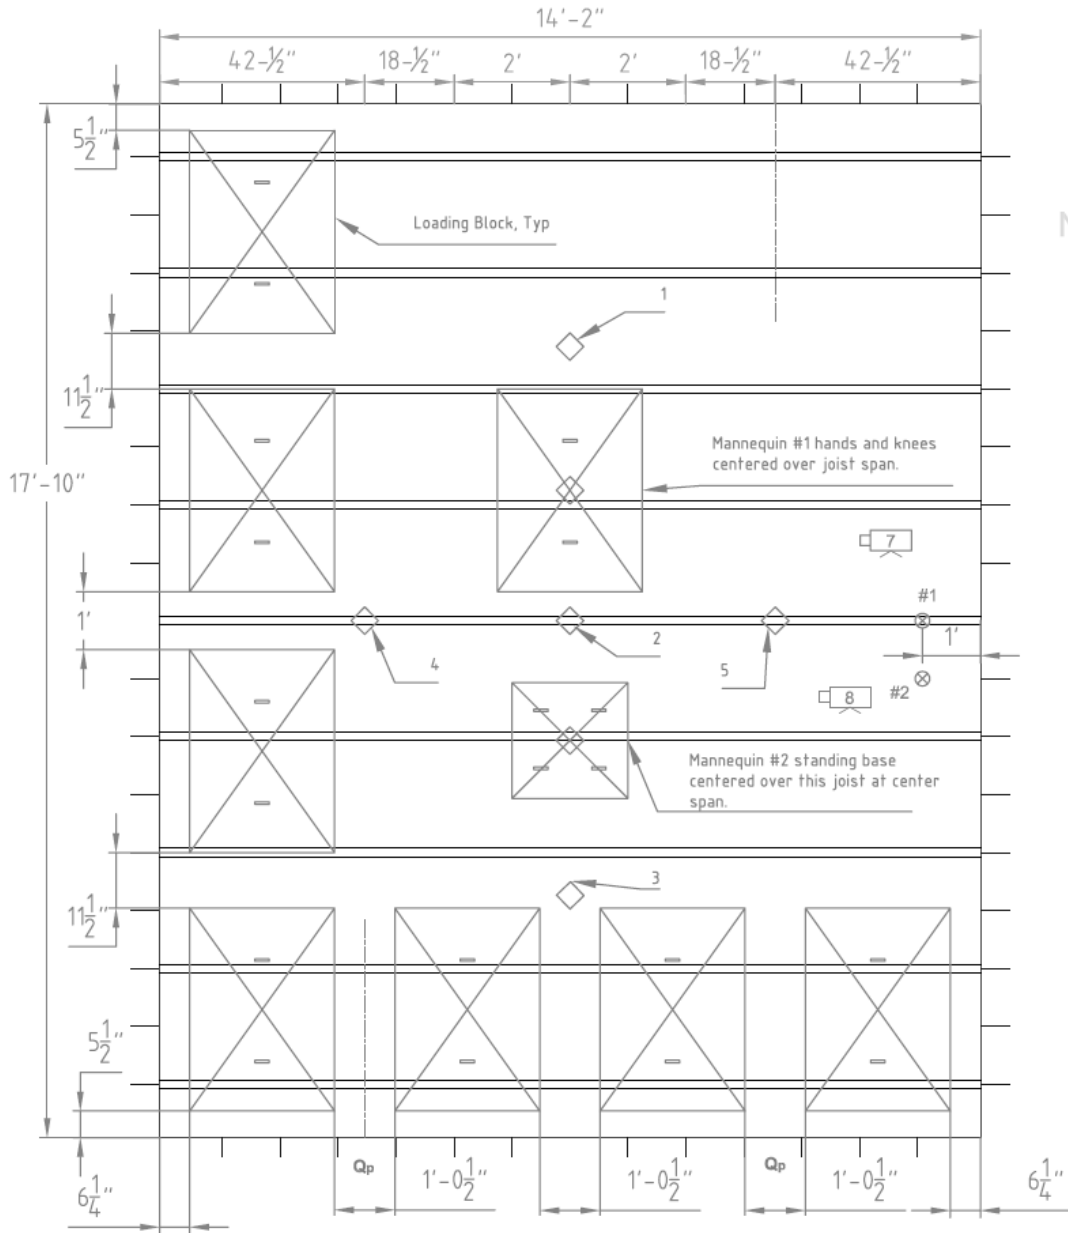
Figure A.6.7 – Loading and Instrumentation Layout (See Figure A.6.8)

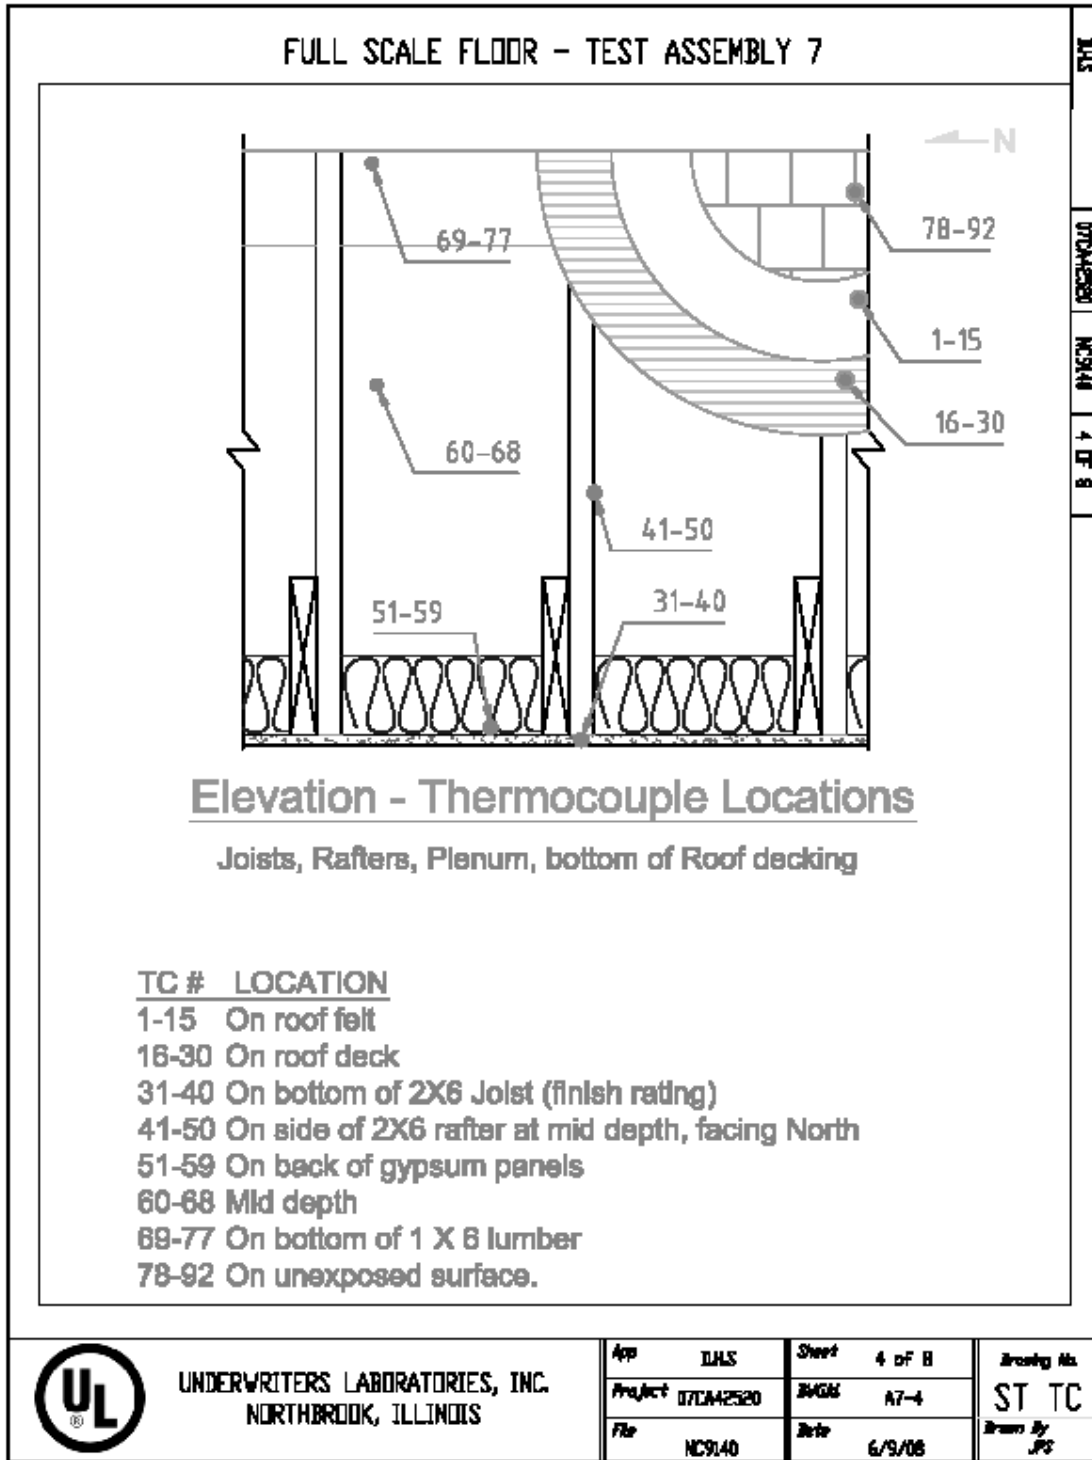
Figure A.7.3 – Thermocouple Locations - Elevation.

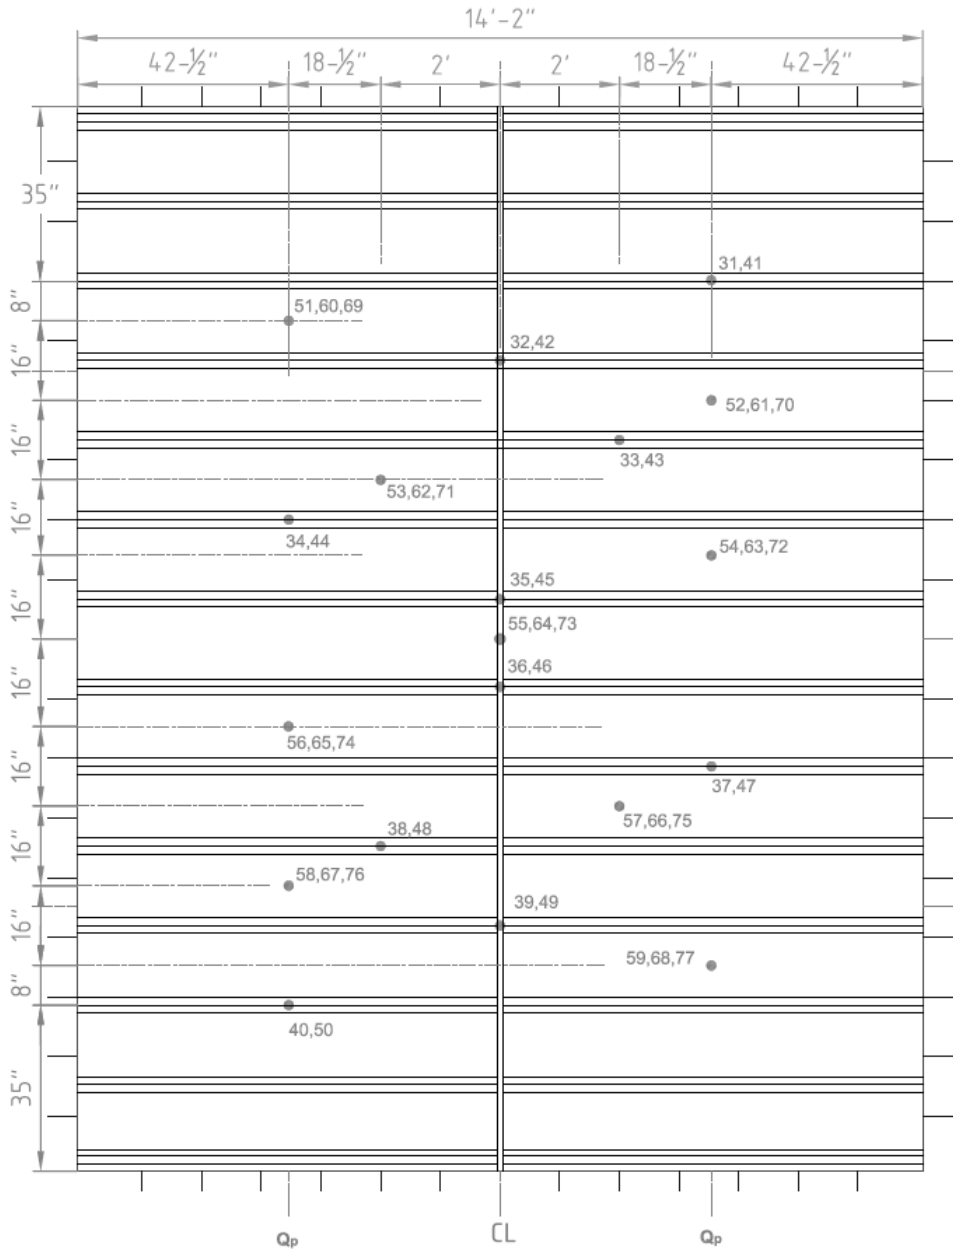
Figure A.7.4 – Thermocouple Locations on Wood Members.

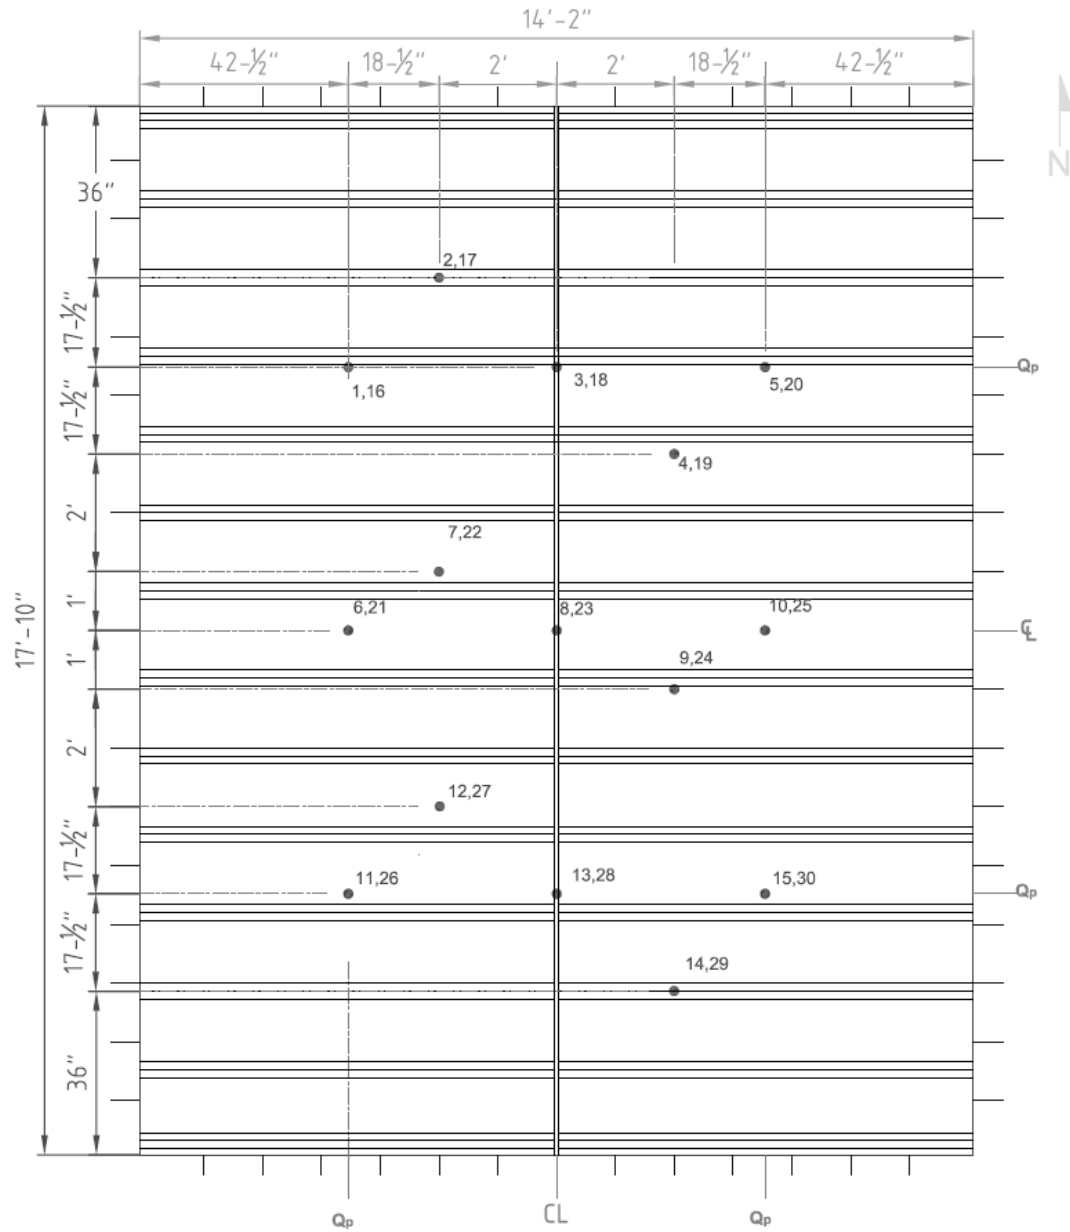
Figure A.7.5 – Thermocouple Locations on Roof Deck and Roof Felt.

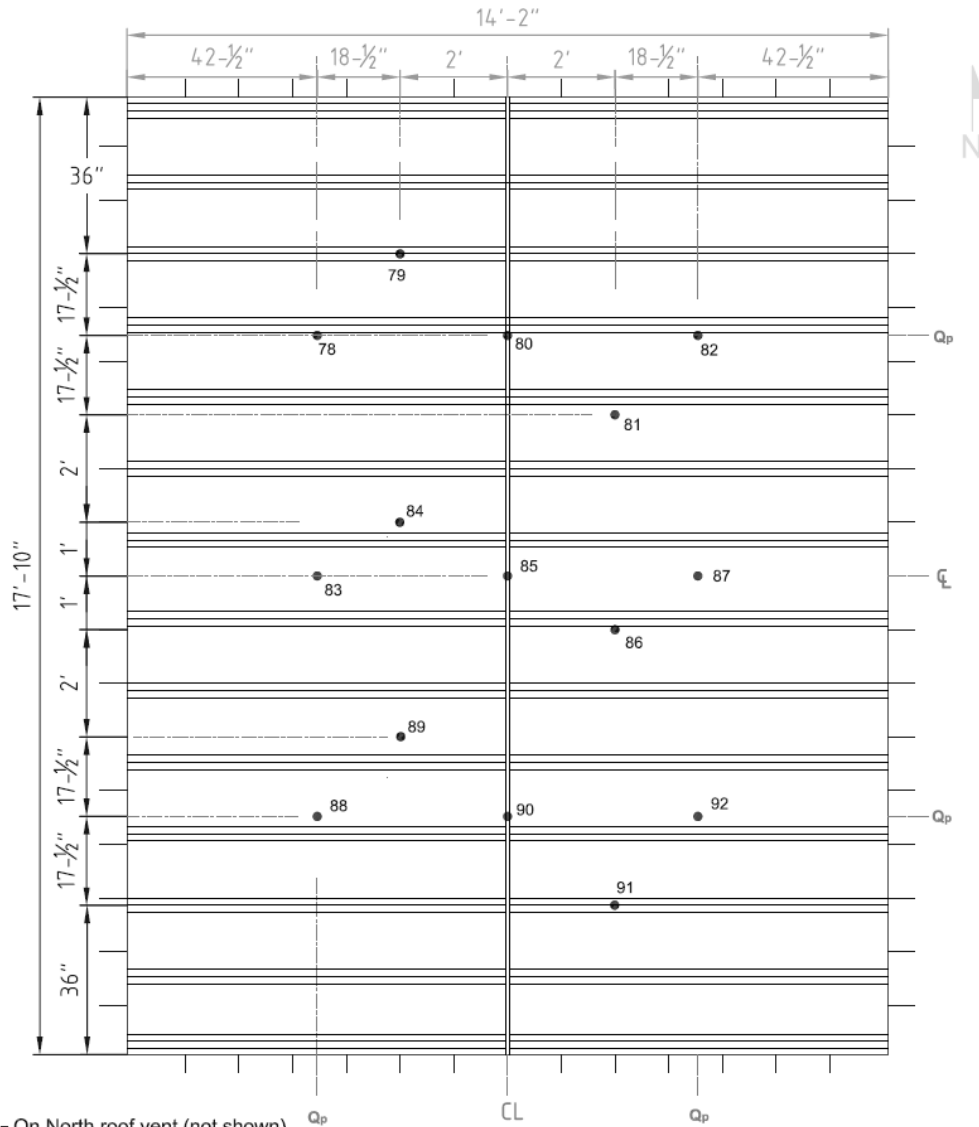
- 93 - On North roof vent (not shown)
- 94 - On Center roof vent (not shown)
- 95 - On South roof vent (not shown)

Figure A.7.6 – Thermocouple Locations on Unexposed Surface.

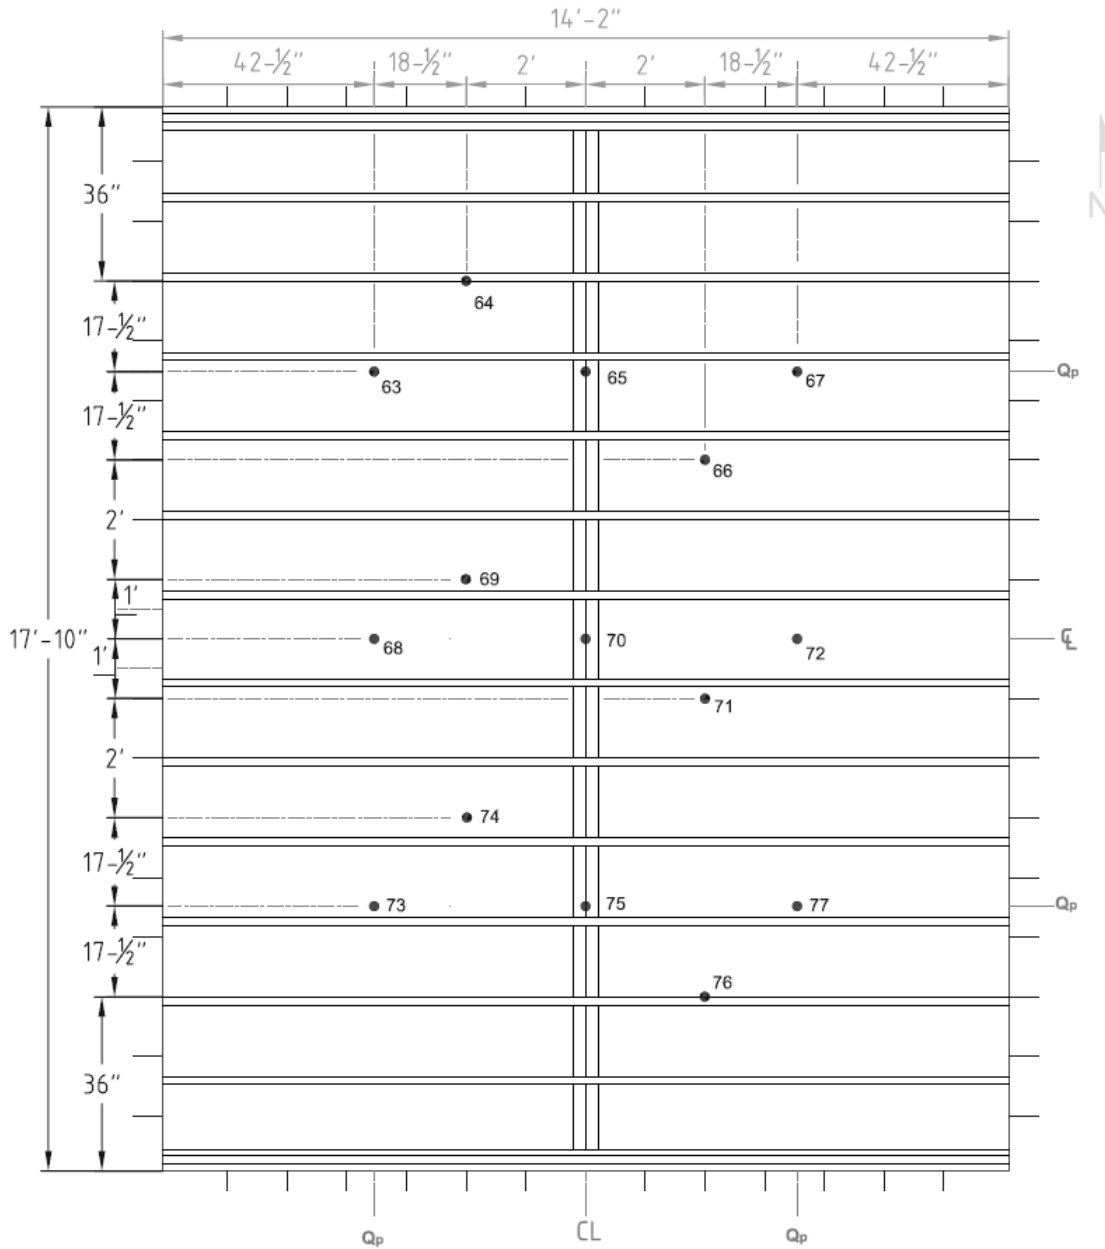
Figure A.8.6 – Thermocouple Locations on Unexposed Surface.

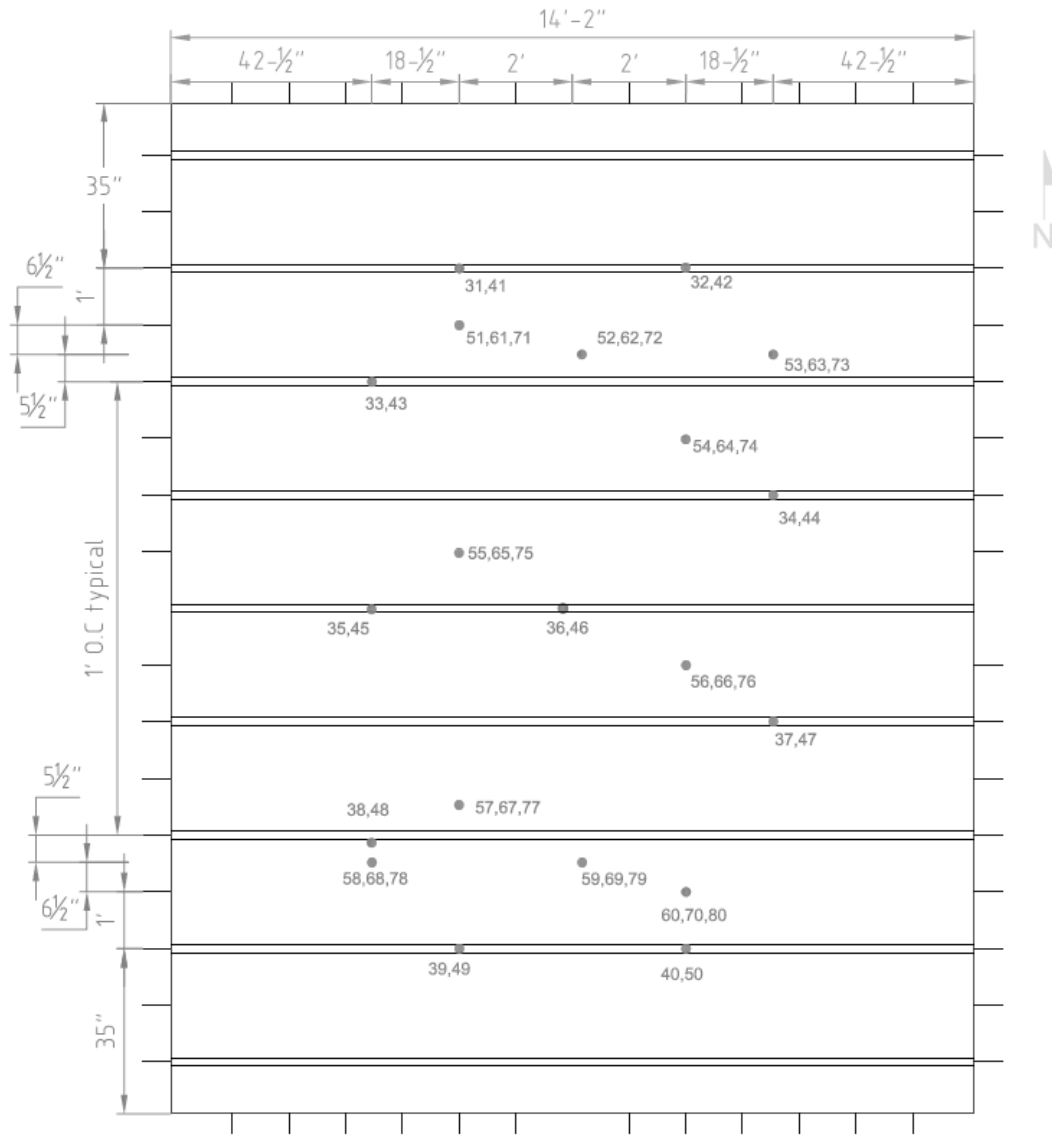
Note:
T.C.'s 72 & 79 Moved 2 In. West
due to sheathing cut short from ridge.

Figure A.9.4 – Thermocouple Locations on Wood Members.
