LEE'S SUMMIT FIRE STATION ENGINEER: P. KULLBERG DRAWN BY: J. BURNETTE SURVEYOR: S. WHITAKER CHECKED BY: CRAFT/MADRID SHEET NO.: 01/01		REVISIONS: LEE'S SUMMIT, JACKSON CO. MISSOURI SEC. 6-747N-R31W 202301109-000 FEBRUARY 6, 2024	 STEVEN R. WHITAKER, MO, PLS NO. 2005019220 MCCLURE ENGINEERING COMPANY CORPORATE CERTIFICATE LICENSE NO. 201200935 S. WHITAKER@MCCLUREVISION.COM
---	--	---	---

4/26/24

Lee's Summit Fire Dept.

Concept Budgets

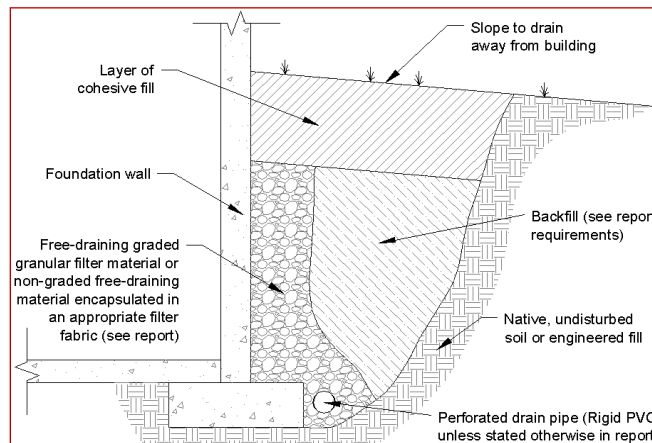
Below-grade walls should be waterproofed, and water stops should be placed at construction joints. To reduce the potential for hydrostatic loading on the below grade walls and to reduce the potential for seepage into below grade areas, a perforated rigid plastic drain line installed behind the base of walls and extends below adjacent grade is recommended. The invert of a drain line around a below-grade building area or exterior retaining wall should be placed near foundation bearing level. The drain line should be

sloped to provide positive gravity drainage to daylight or to a sump pit and pump. The drain line should be surrounded by clean, free-draining granular material having less than 5% passing the No. 200 sieve, such as No. 57 aggregate. The free-draining aggregate should be encapsulated in a filter fabric. The granular fill should extend to within 2 feet of final grade, where it should be capped with compacted cohesive fill to reduce infiltration of surface water into the drain system.

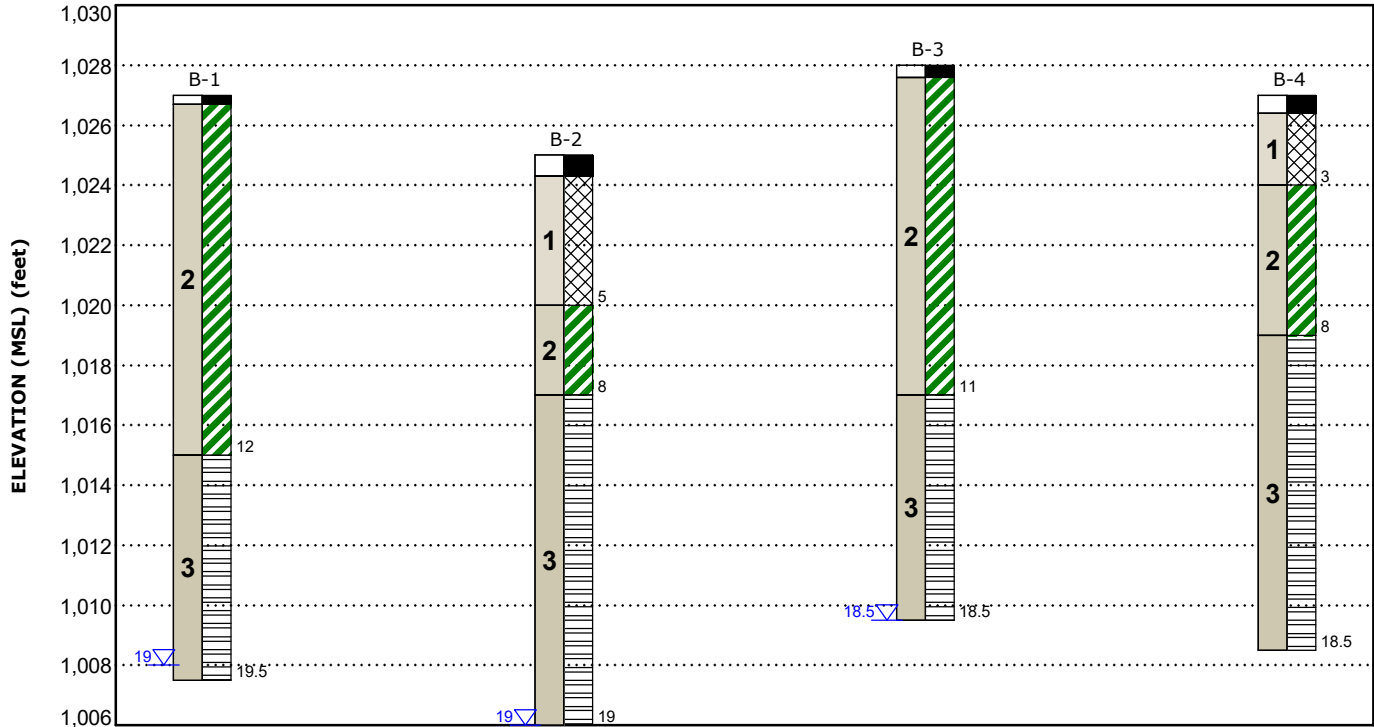
GeoModel

This is not a cross section. This is intended to display the Geotechnical Model only. See individual logs for more detailed conditions.

Model Layer	Layer Name	General Description	Legend	
1	Existing Fill	Fat clay with variable amounts of gravel	■ Asphalt	▨ Fat Clay
2	Residual Clay	Fat clay, medium stiff to very stiff	▨ Shale	▩ Fill
3	Bedrock	Highly to moderately weathered shale with sandstone seams

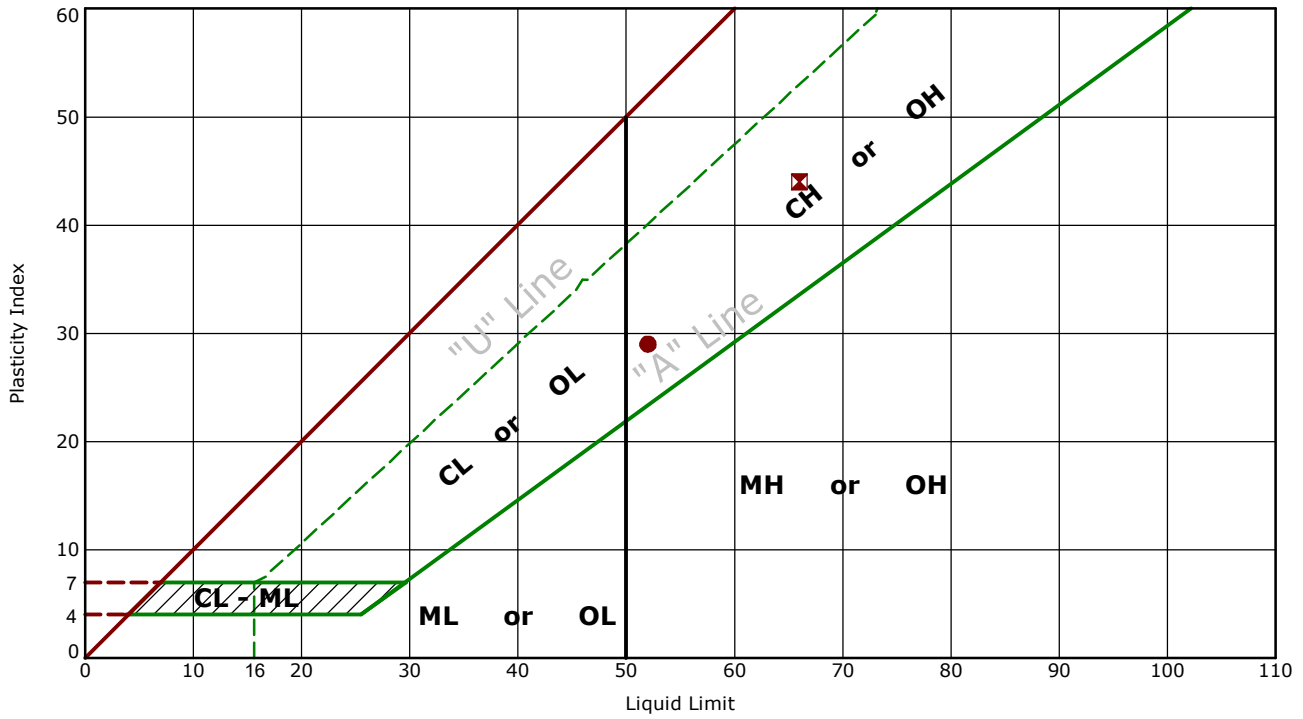
Atterberg Limit Results

ASTM D4318

Boring ID	Depth (Ft)	LL	PL	PI	Fines	USCS	Description
●	B-1	3 - 5	52	23	29			
☒	B-4	3 - 5	66	22	44

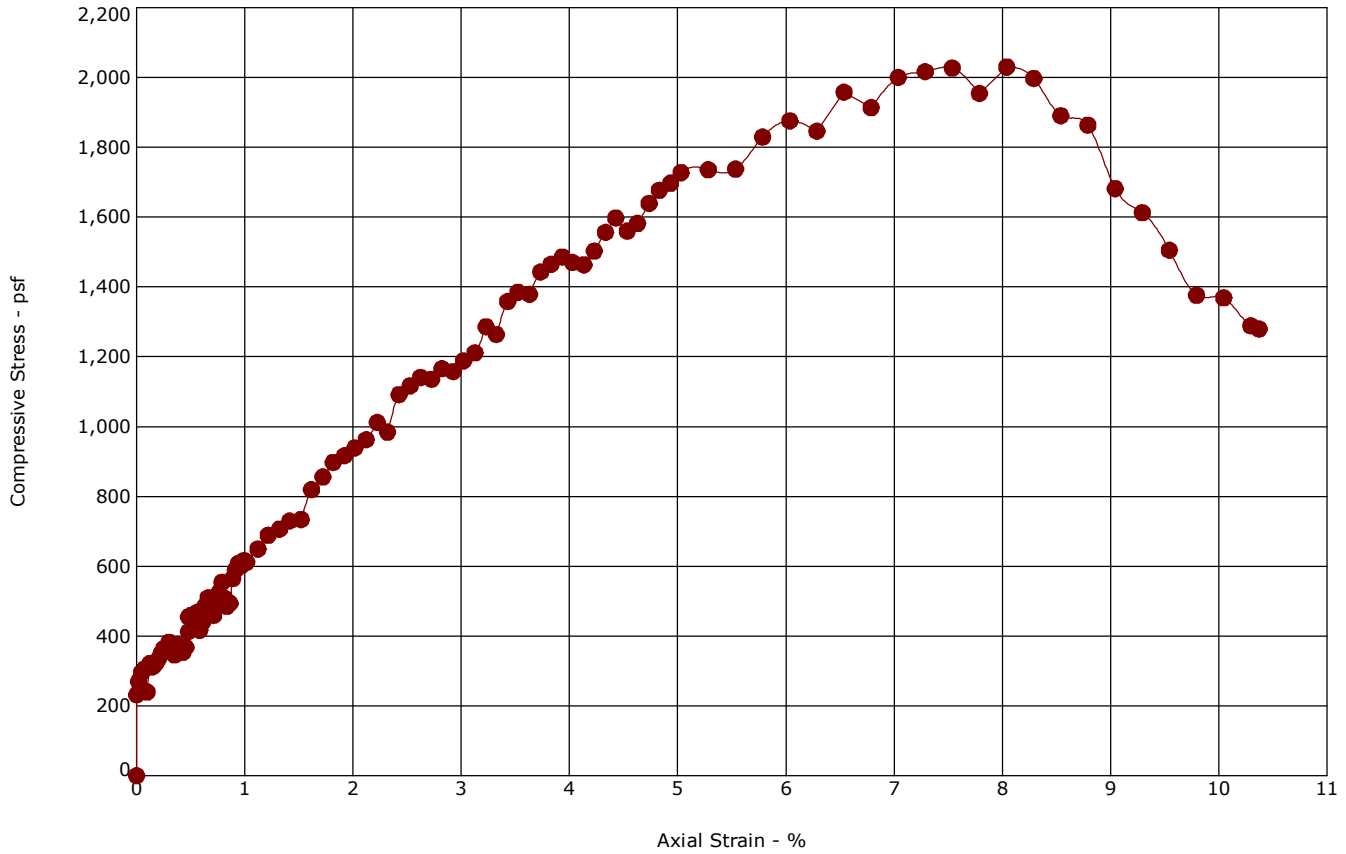
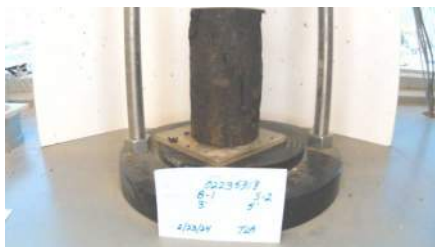
Unconfined Compression Test ASTM D2166

Boring ID	Depth (Ft)	Sample type	LL	PL	PI	Fines (%)	Description
B-1	3 - 5	Shelby Tube	52	23	29

Specimen Failure Mode	Specimen Test Data
	Moisture Content (%): 26.0
	Dry Density (pcf): 94
	Diameter (in.): 2.72
	Height (in.): 5.81
	Height / Diameter Ratio: 2.13
	Calculated Saturation (%):
	Calculated Void Ratio:
	Assumed Specific Gravity:
	Failure Strain (%): 8.04
	Unconfined Compressive Strength (psf): 2030
	Undrained Shear Strength (psf): 1015
	Strain Rate (in/min): 0.0581
	Remarks:

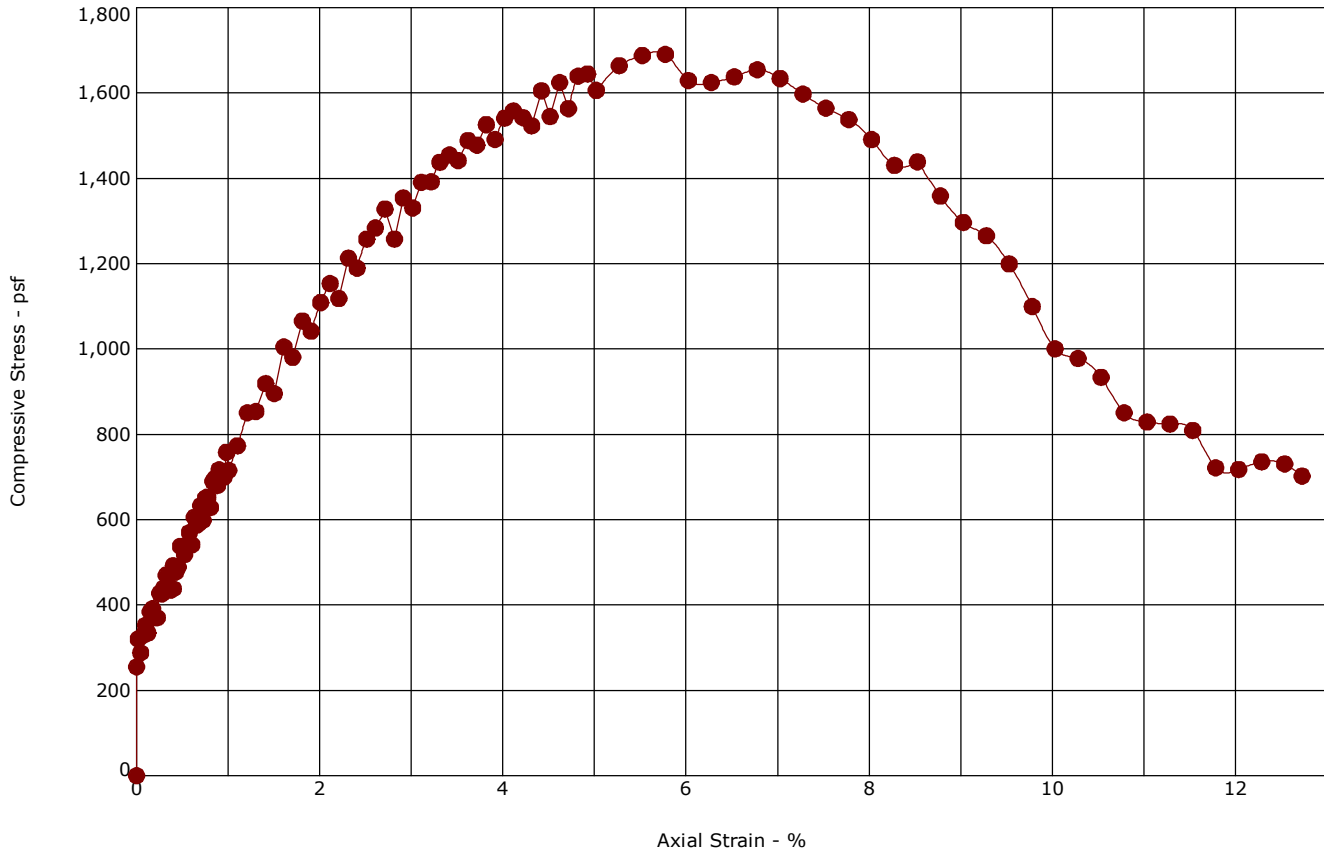
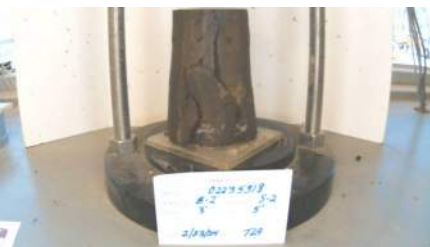
Unconfined Compression Test ASTM D2166

Boring ID	Depth (Ft)	Sample type	LL	PL	PI	Fines (%)	Description
B-2	3 - 5	Shelby Tube

Specimen Failure Mode	Specimen Test Data
	Moisture Content (%): 30.7
	Dry Density (pcf): 90
	Diameter (in.): 2.85
	Height (in.): 5.69
	Height / Diameter Ratio: 1.99
	Calculated Saturation (%):
	Calculated Void Ratio:
	Assumed Specific Gravity:
	Failure Strain (%): 5.77
	Unconfined Compressive Strength (psf): 1691
	Undrained Shear Strength (psf): 845
	Strain Rate (in/min): 0.0569
	Remarks:

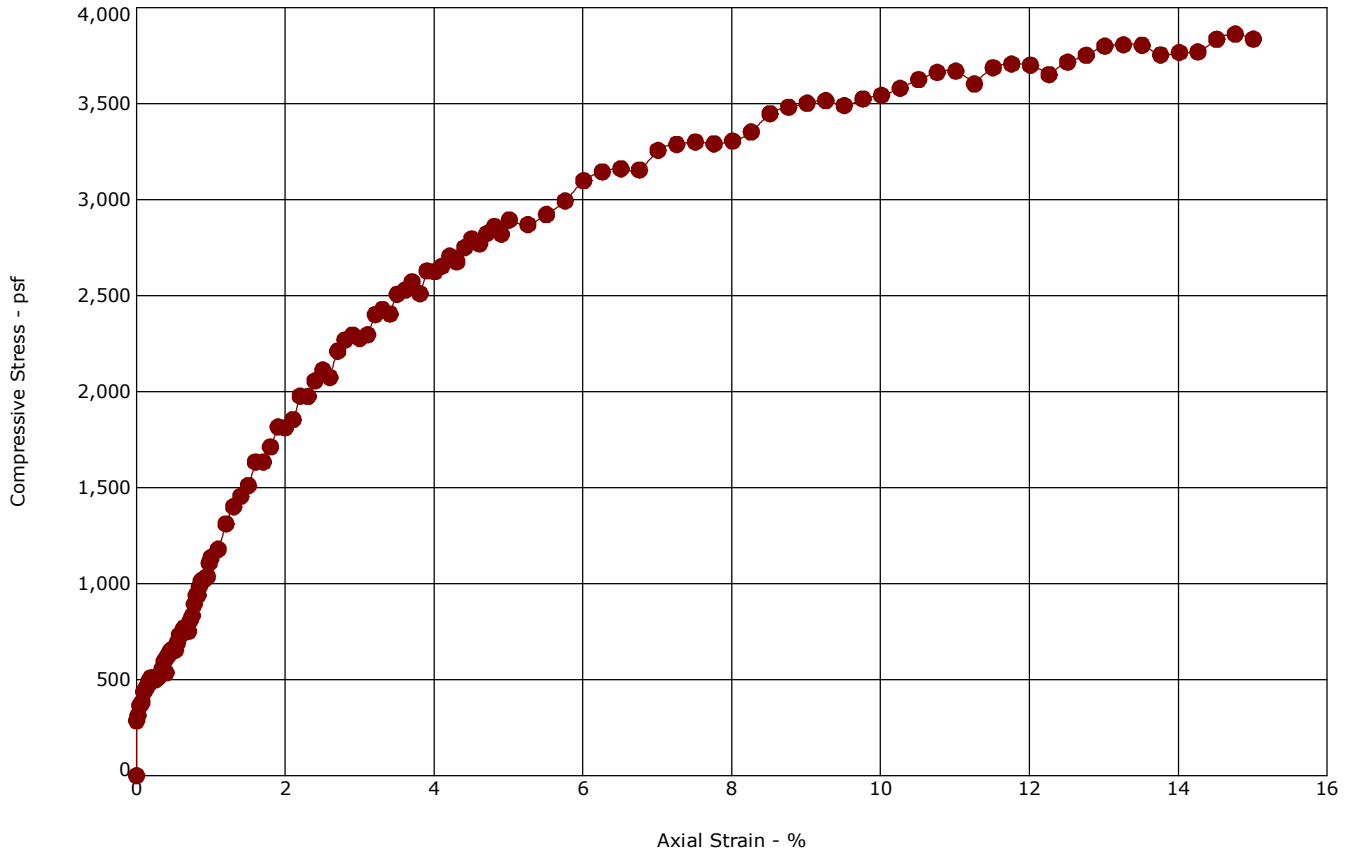
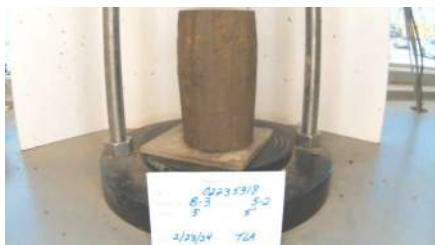
Unconfined Compression Test ASTM D2166

Boring ID	Depth (Ft)	Sample type	LL	PL	PI	Fines (%)	Description
B-3	3 - 5	Shelby Tube

Specimen Failure Mode	Specimen Test Data
	Moisture Content (%): 23.9
	Dry Density (pcf): 101
	Diameter (in.): 2.75
	Height (in.): 5.78
	Height / Diameter Ratio: 2.10
	Calculated Saturation (%):
	Calculated Void Ratio:
	Assumed Specific Gravity:
	Failure Strain (%): 14.77
	Unconfined Compressive Strength (psf): 3862
	Undrained Shear Strength (psf): 1931
	Strain Rate (in/min): 0.0577
	Remarks:

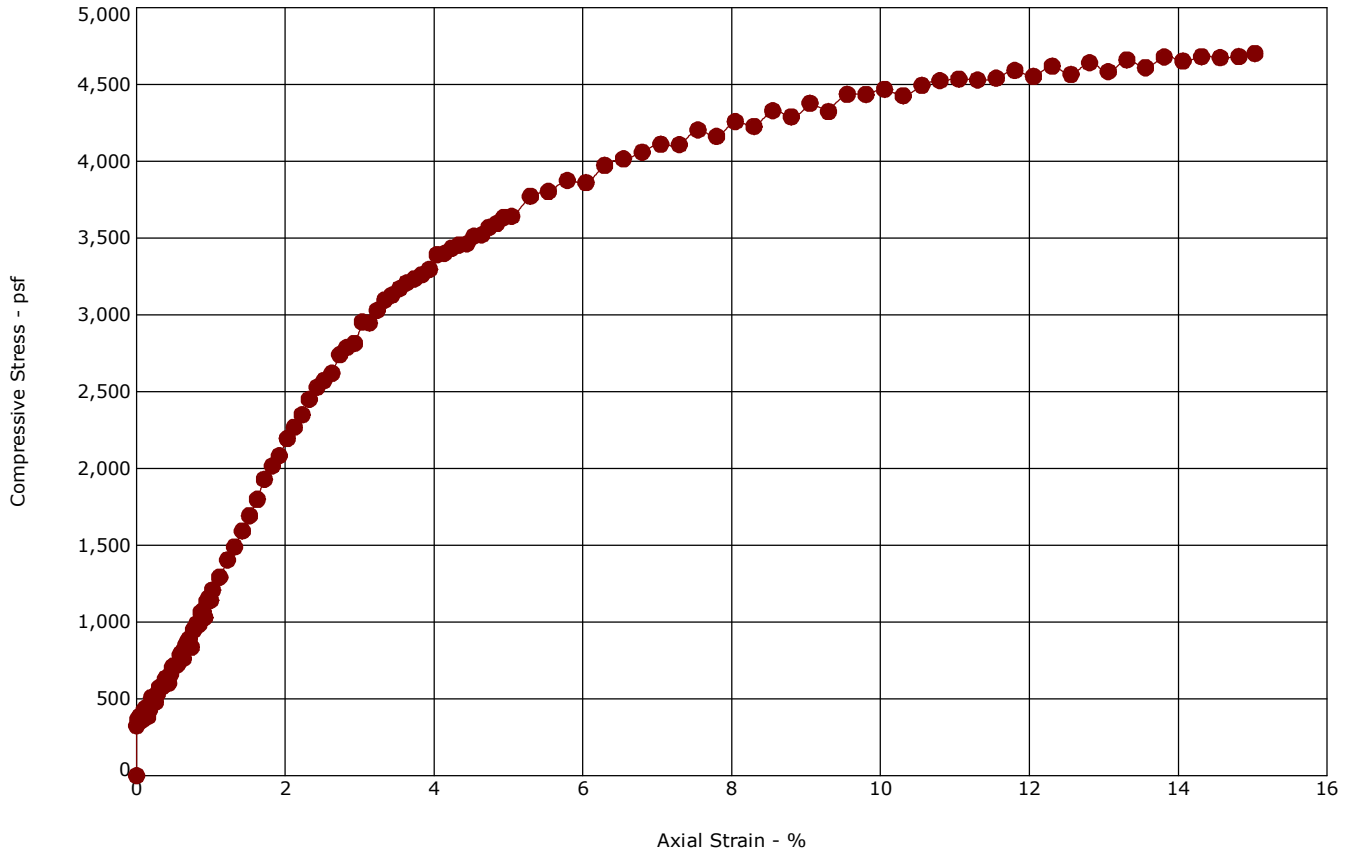
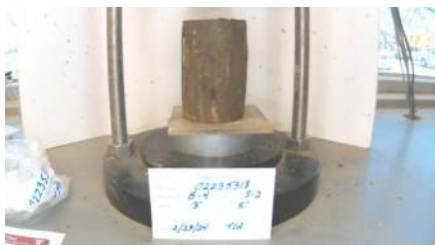
Unconfined Compression Test ASTM D2166

Boring ID	Depth (Ft)	Sample type	LL	PL	PI	Fines (%)	Description
B-4	3 - 5	Shelby Tube	66	22	44

Specimen Failure Mode	Specimen Test Data
	Moisture Content (%): 18.5
	Dry Density (pcf): 106
	Diameter (in.): 2.61
	Height (in.): 4.70
	Height / Diameter Ratio: 1.80
	Calculated Saturation (%):
	Calculated Void Ratio:
	Assumed Specific Gravity:
	Failure Strain (%): 15.00
	Unconfined Compressive Strength (psf): 4699
	Undrained Shear Strength (psf): 2349
	Strain Rate (in/min): 0.0471
	Remarks:

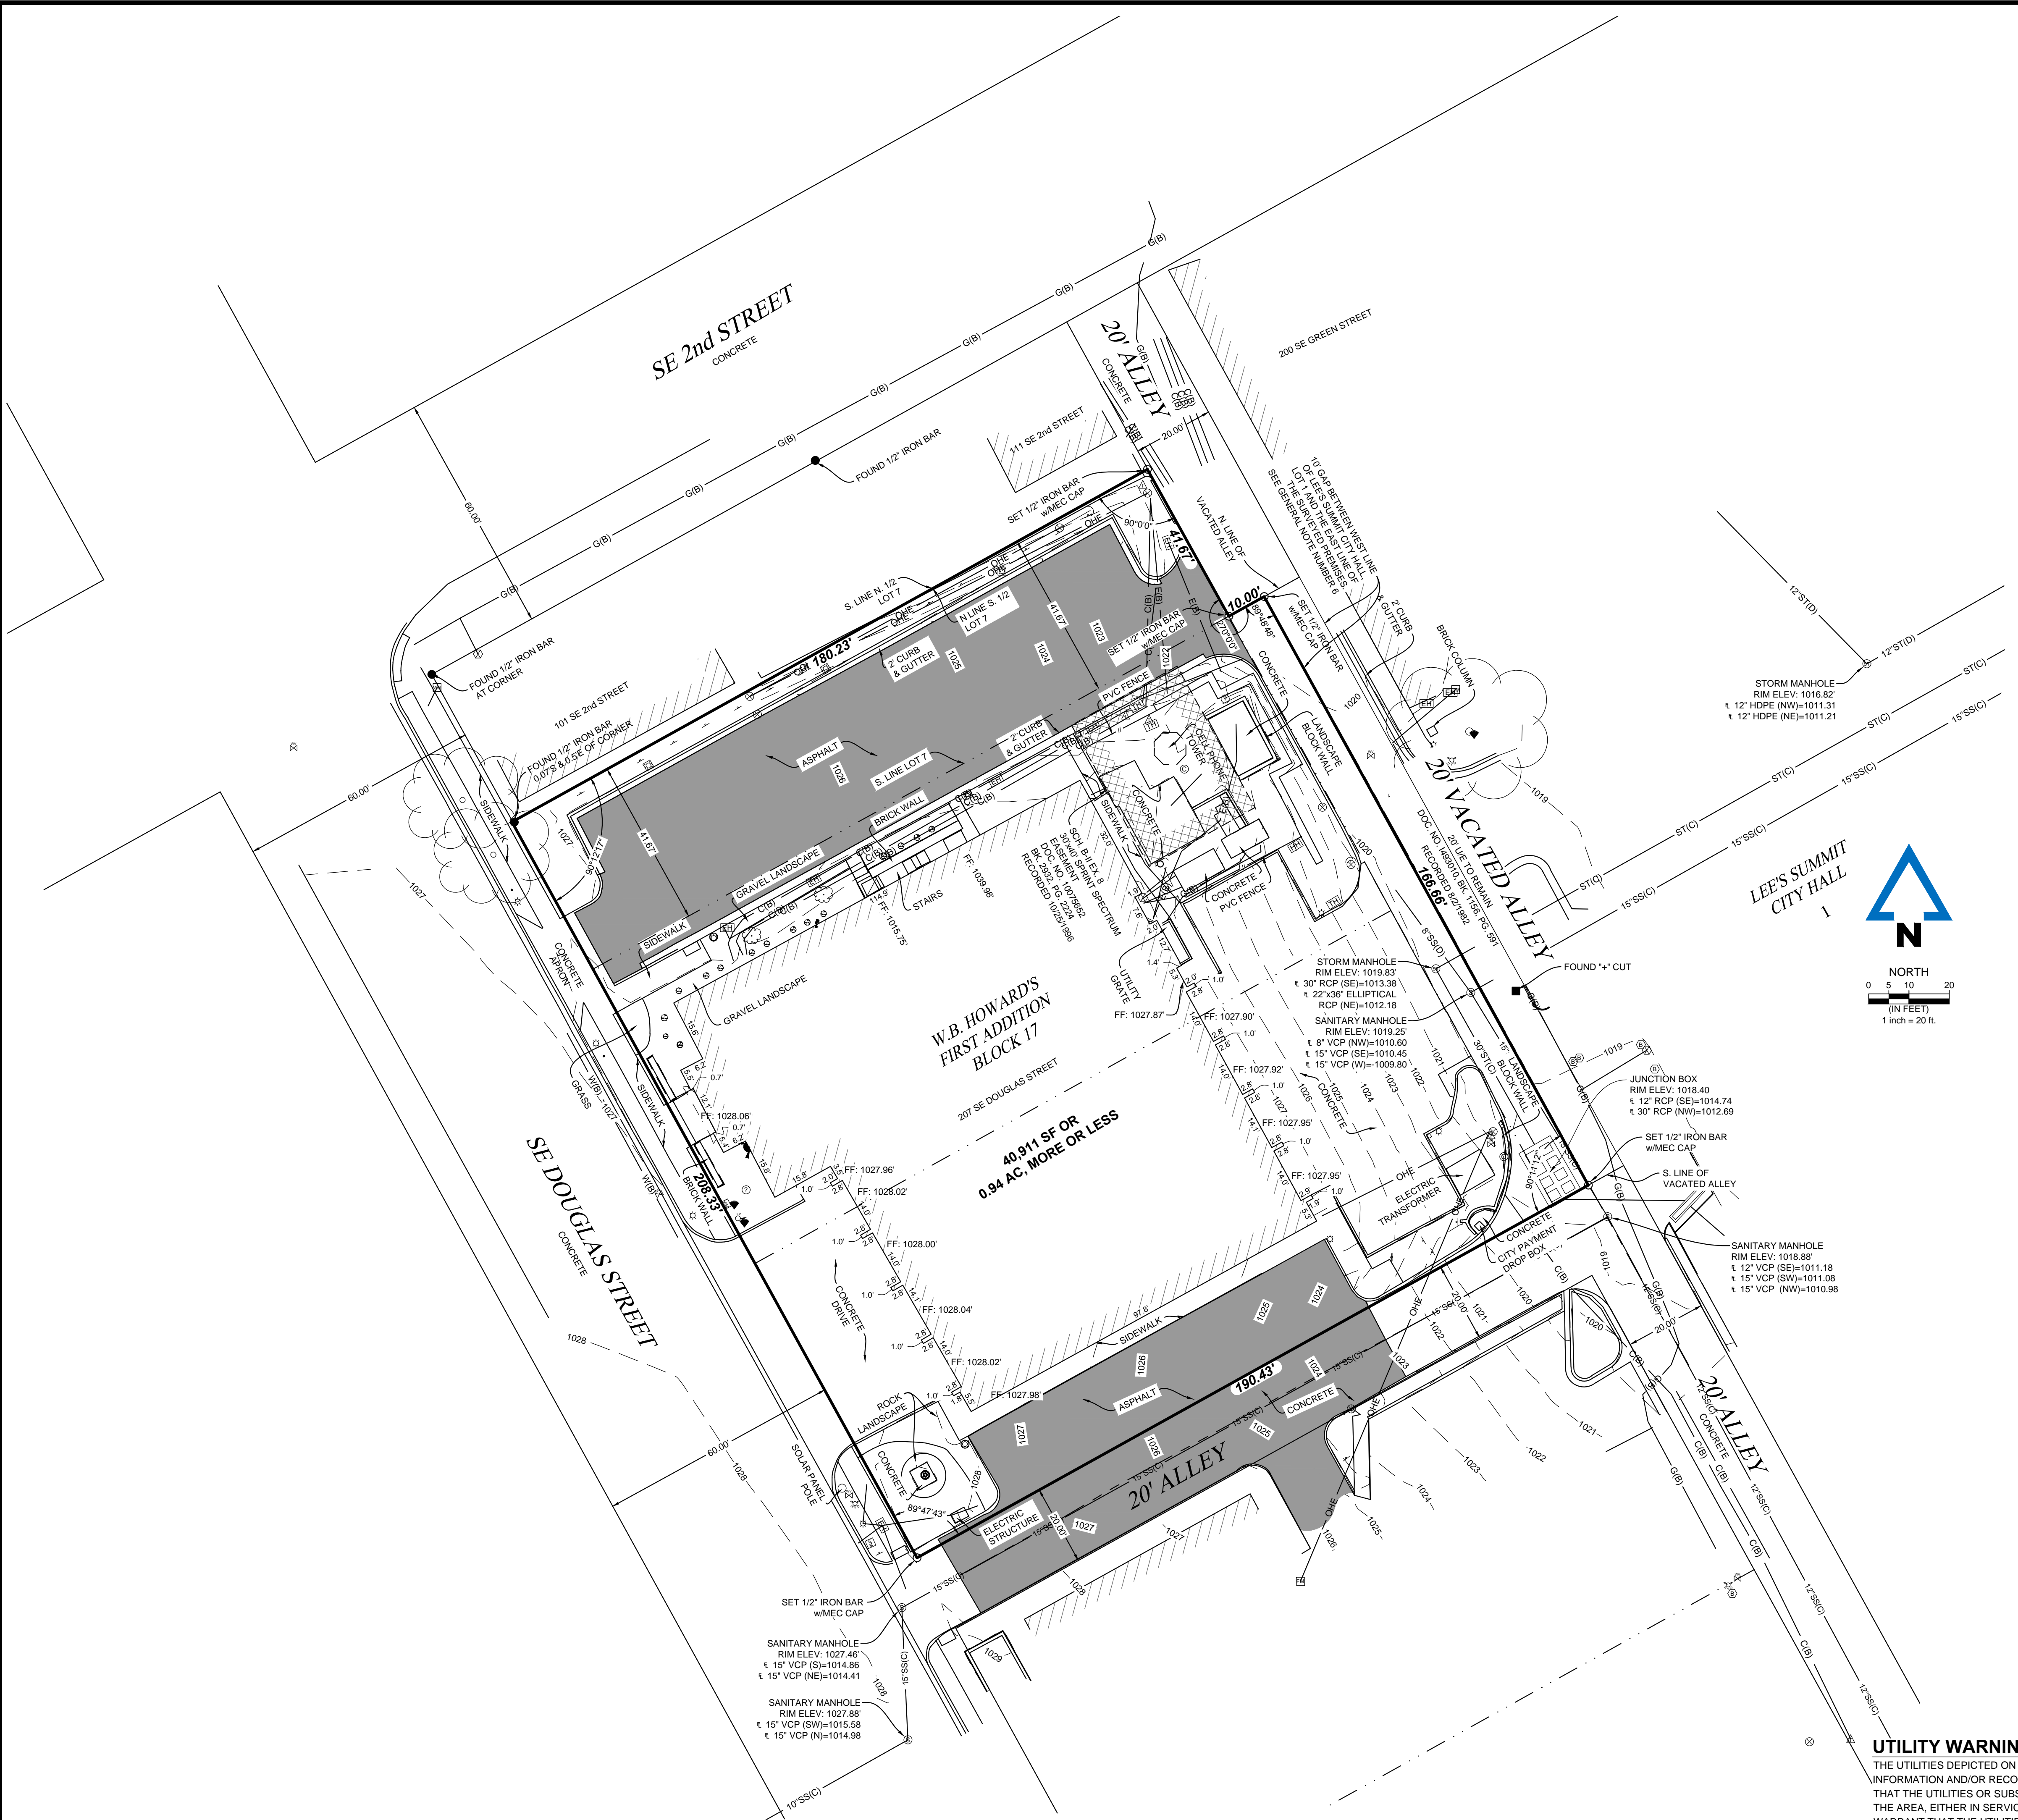
- INFORMATION SHOWN ON THIS SURVEY WAS TAKEN FROM COFFELT LAND TITLE, INC. TITLE NO. 24068513, EFFECTIVE DATE, JANUARY 25, 2024.
- BASIS OF BEARINGS: MISSOURI STATE PLANE, WEST ZONE.

- CLASS OF SURVEY: URBAN
- A 10 FOOT GAP EXISTS BETWEEN THE WEST LINE OF LEE'S SUMMIT'S CITY HALL, LOT 1 AND THE EAST LINE OF THE SURVEYED PREMISE. A 20 FOOT WIDE ALLEY WAS VACATED BY DOCUMENT NUMBER I493010, BK 1156, PG 591. RECORDED 8/2/1982. SAID DOCUMENT DOES NOT DESCRIBE HOW THE ALLEY WAS TO REVERT BACK TO ADJACENT OWNERS. SEE SCHEDULE B-II EXCEPTION NO. 7.

CP#	NORTHING	EASTING	ELEV.	DESCRIPTION
100	1000416.87	2824242.64	1022.28	/ WSW TOP FLANGE BOLT YELLOW FIRE HYDRANT
101	1000174.21	2824108.09	1027.88	/ CTR MH LID DOUGLAS ST
200	1000235.07	2823954.56	1029.12	/ 100D POLE BARN NAIL
201	1000547.59	2824011.44	1026.24	/ 0.5IN IB W BLUE MEC C.P CAP
202	1000385.00	2824286.79	1019.02	/ CUT PLUS
203	1000168.28	2824073.90	1028.63	/ CUT PLUS
