Re: Cost Change Proposal Number 2, 57831683-22 Cathodic Protection Program FY22

# Change of Contract Price Proposal No.2

57831683-22

Cathodic Protection Program FY22

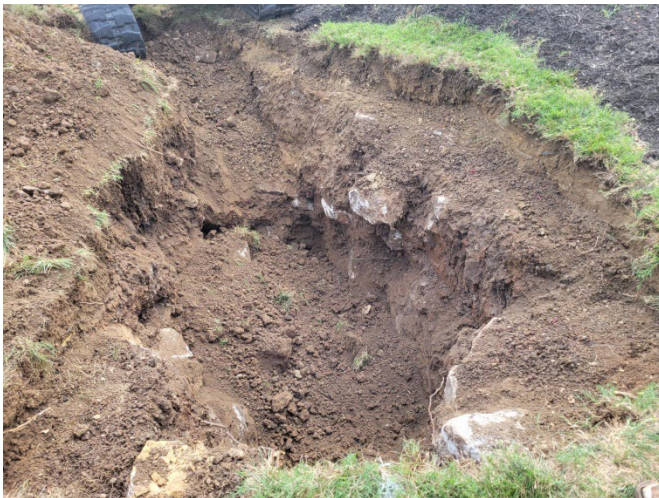
Image 1: OP-79 Rock

During excavation, large boulders, rock, and construction debris have been encountered. At OP-80, a loose boulder approximately 4ftx7ftx2ft in size was removed to reach the water main. Anodes OP-91 through OP-107 have had rock shelves and large, loose rocks, that have impacted installation times. At OP-79, a discarded piece of water pipe was found. This debris and rock is removed, to limit any negative impact to future excavations and water department work. Clean-up is also effected, with more time needed to rid the surface area of rocks and debris to provide a suitable base for sod.

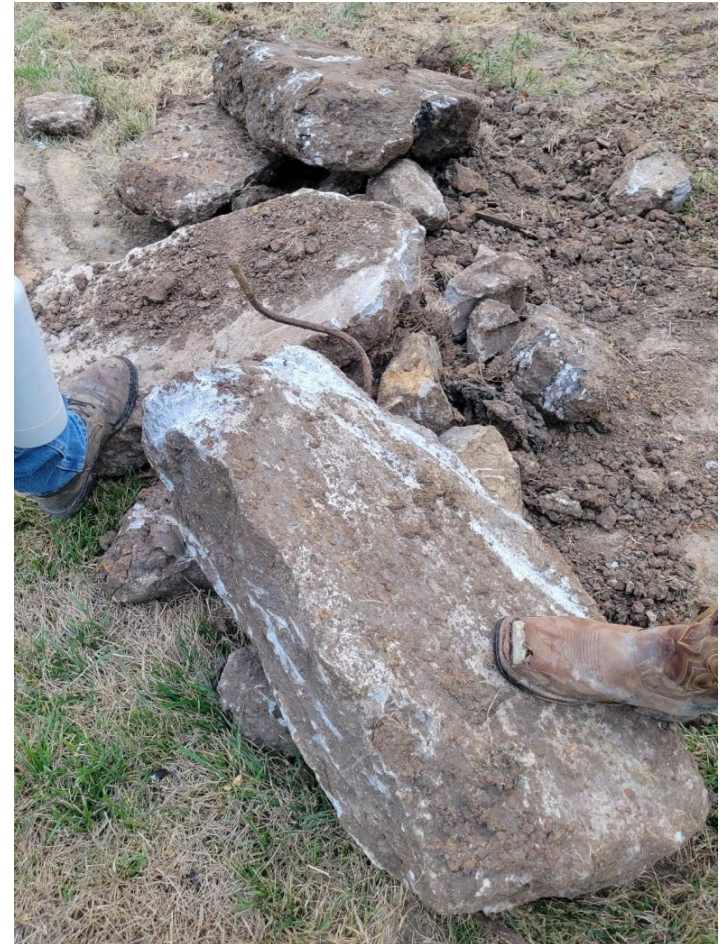
Image 2: OP-80 Loose Rock

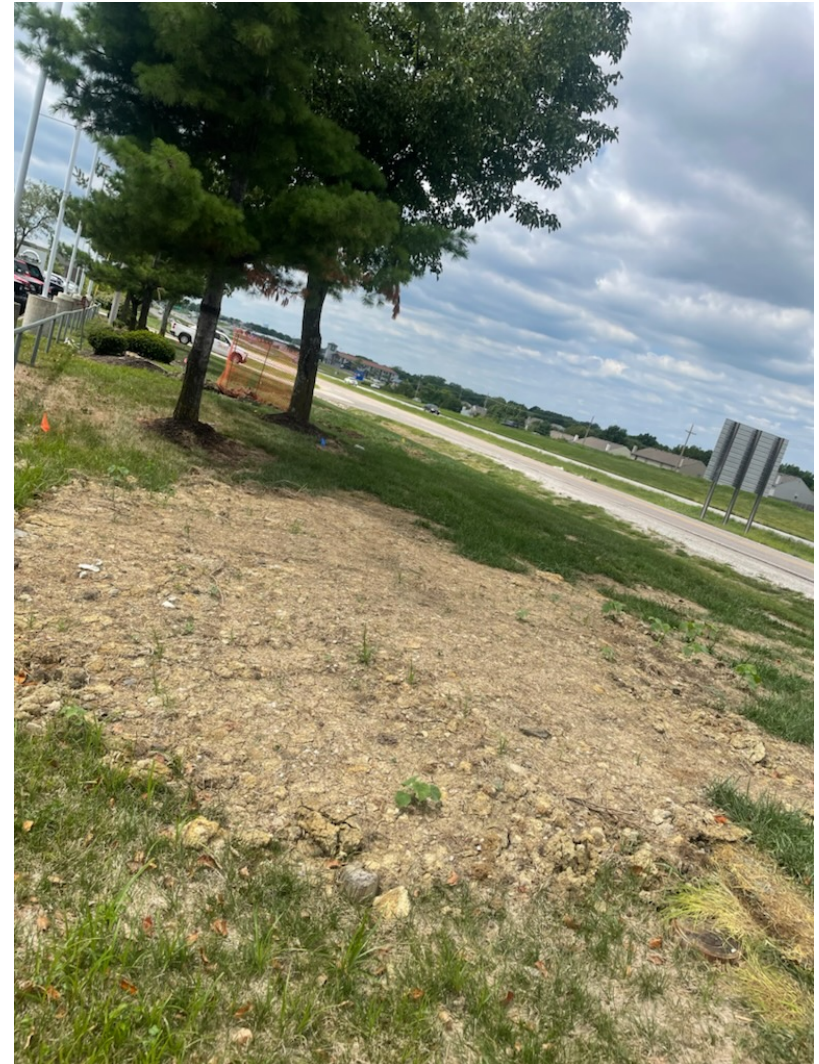
Image 3: OP-62 Disturbed Surface Area

Sod, fertilizer, and labor needs are increased with the greater excavation footprint. The surface area disturbed during an 8ft excavation can be over five times in size compared to a 4ft excavation due to increases in trench lengths and benching requirements. Labor times triple during clean-up, with more time needed to prep and lay sod over a much larger area. Additionally, more resources are needed to water and maintain the sod.

With OP-77 as an example, pipe depth was 7.8ft and the resulting excavation was 16ftx13ft in size, with a dirt spoil pile measuring 18ftx22ft. Where a 4ft excavation typically requires 1.5 rolls of sod, a site of this size can require more than 25 rolls. Preparation and sod installation times have tripled at these sites.
