MINE MITIGATION STUDY
MINE FILLING AT PRYOR CROSSING
LEE'S SUMMIT, MISSOURI

DECEMBER 22, 2020

J035637.02

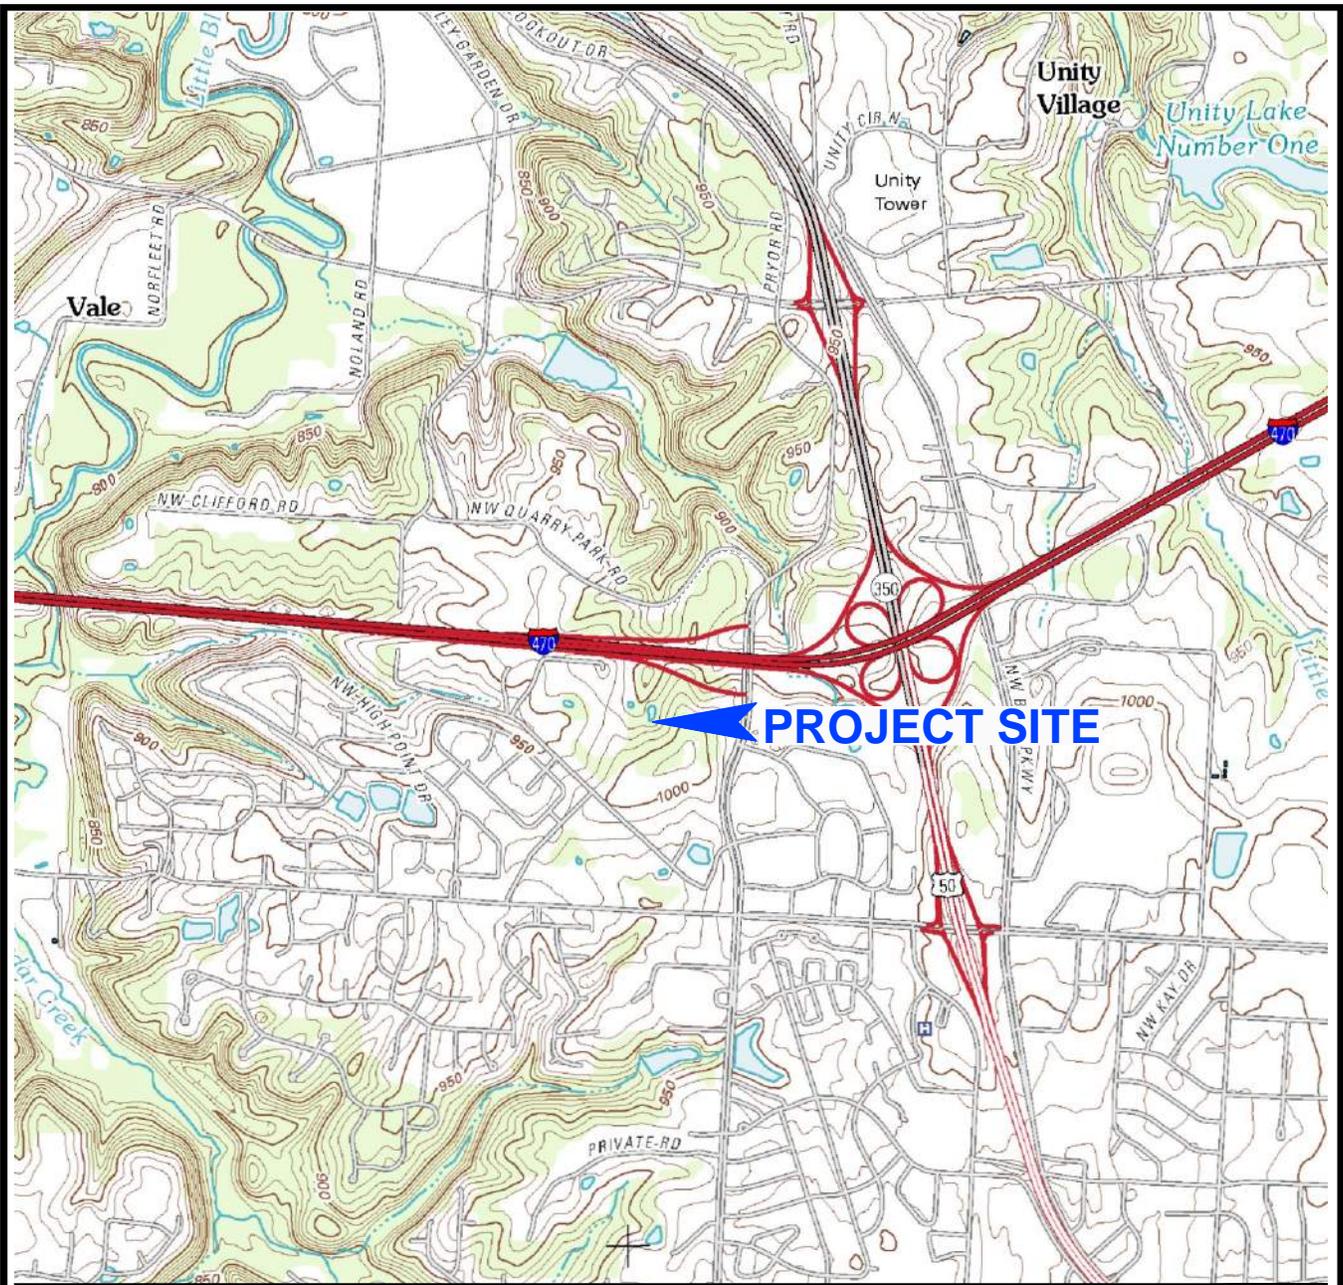
FIGURE 1

Figure 1 - Site Location and Topography

Streets of West Pryor, LLC (SWP, LLC) is currently developing a parcel in Lee's Summit, Missouri. The triangular parcel is bounded by NW Lowenstein Drive, NW Pryor Road and Interstate 470 (I-470) as shown in Figure 1. Portions of the property are underlain by mine space. Presently, the Streets of West Pryor development has been limited to the east side of the property in an area not underlain by mine space. It is our understanding SWP, LLC would like to further develop the parcel by constructing Pryor Crossing subdivision (which consists of single and multifamily residential homes) over the undermined property.

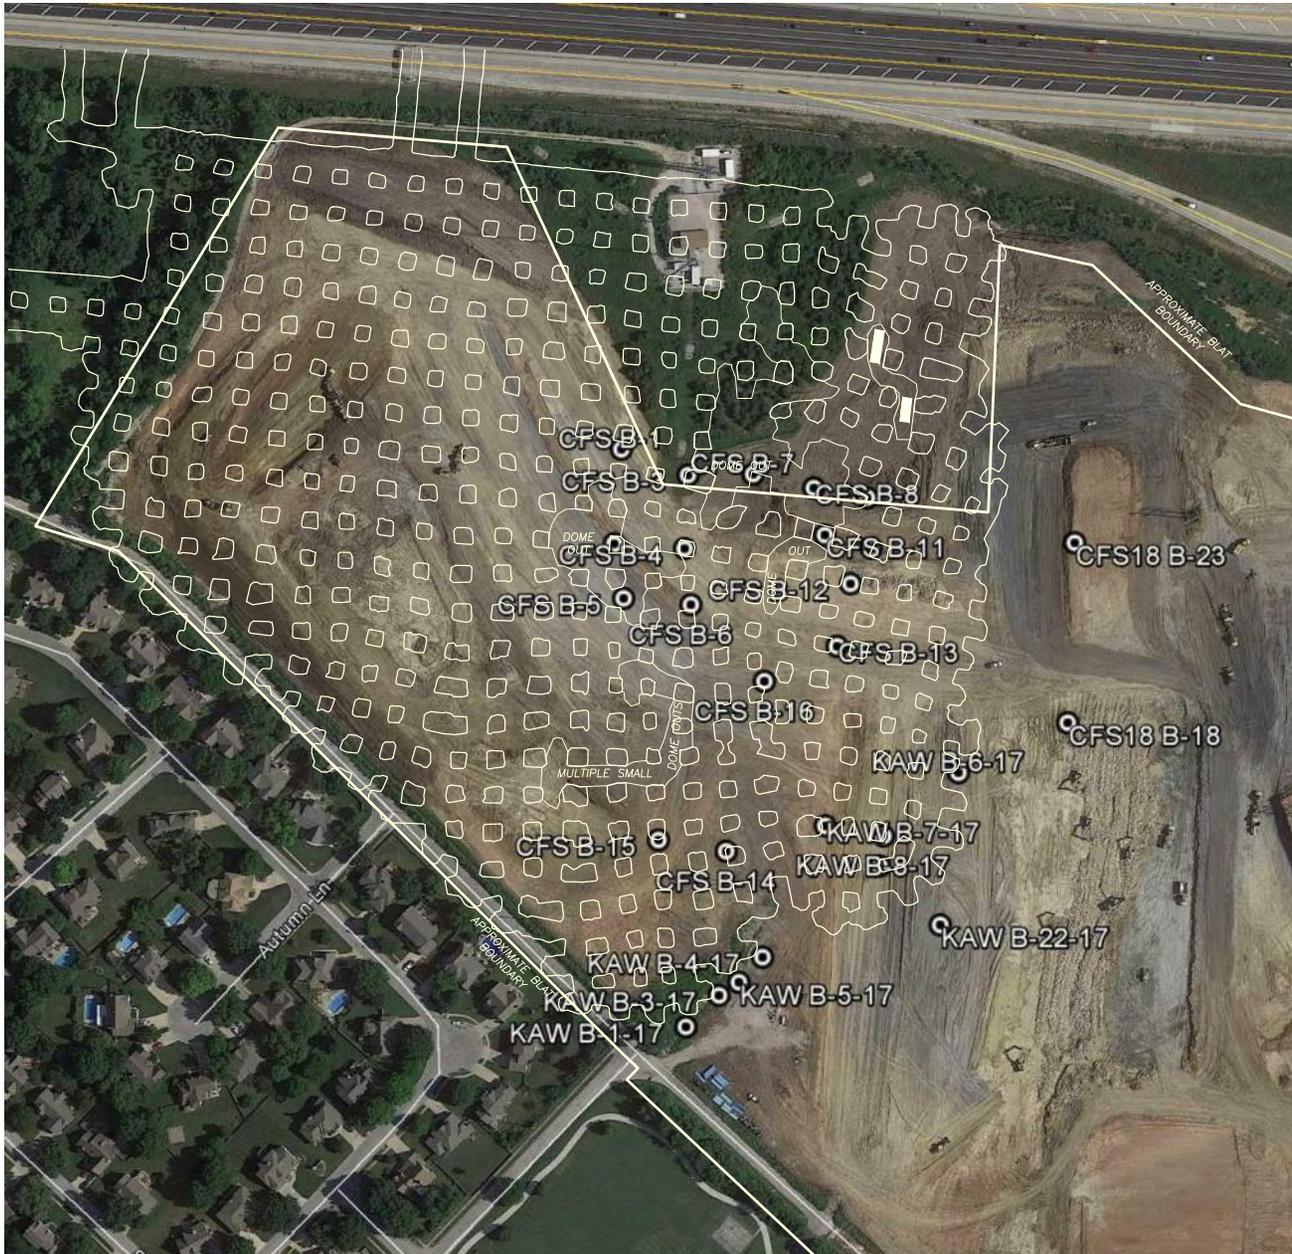
Figure 2 - Aerial Photograph of Site, Locations of Borings Drilled by Others, and Mine Outline
