**GEOLOGIC EXPLORATION
AMERICAN TOWER SITE ID 305846
LEE'S SUMMIT
LEE'S SUMMIT, MISSOURI**

Geotechnology Job No. J029737.03

June 15, 2017

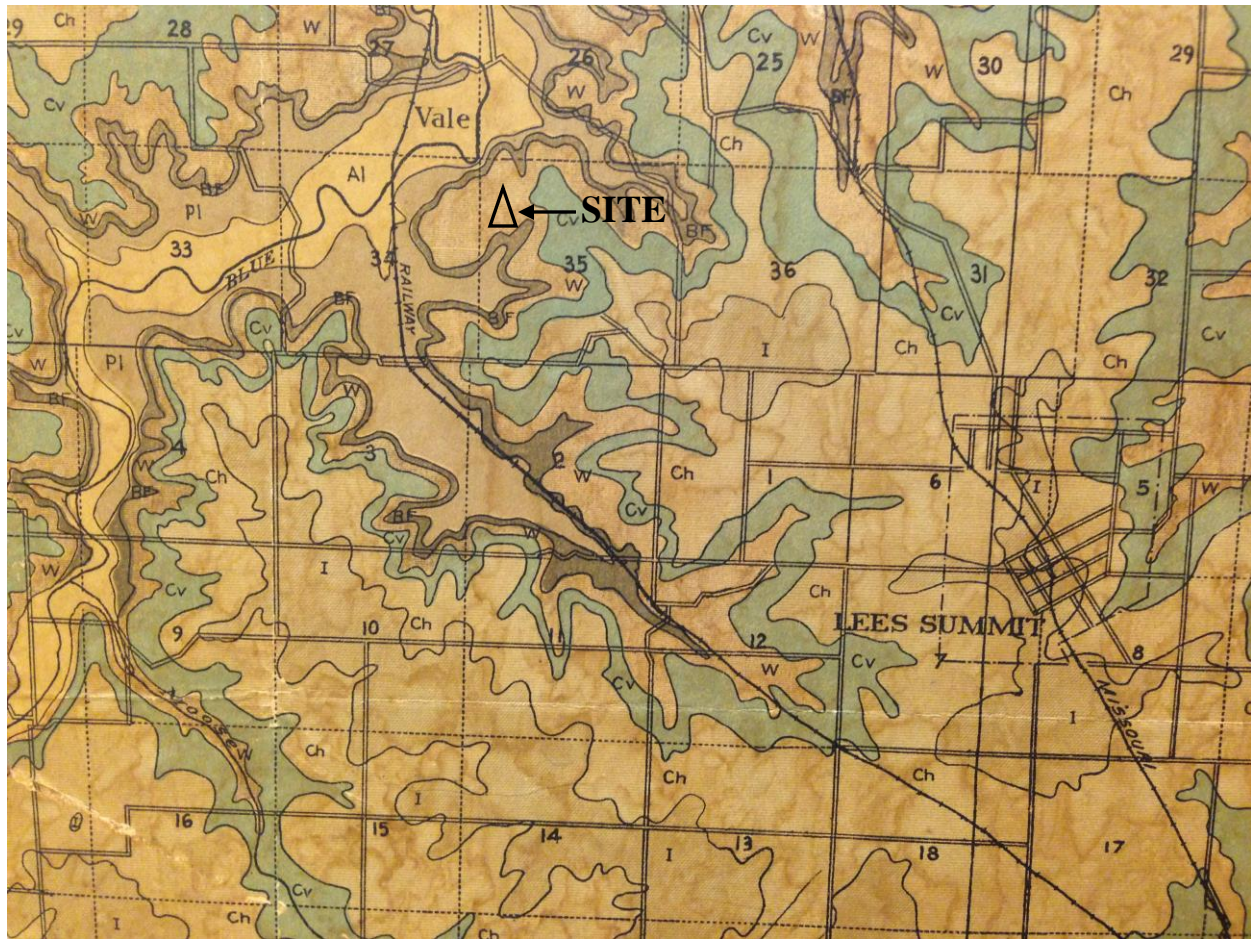
Figure 2: Geological location of the site (courtesy Missouri Bureau of Geology and Mines (1917))

The project site is within the uplands and the soils are residuum from shale and limestone per the Soil Survey of Jackson County, Missouri. Mapping by the Missouri Bureau of Geology and Mines (1917) indicates the near-surface geology of the general area of the site is the Winterset Limestone of the Kansas City Group of the Pennsylvanian System (see Figures 1 and 2).

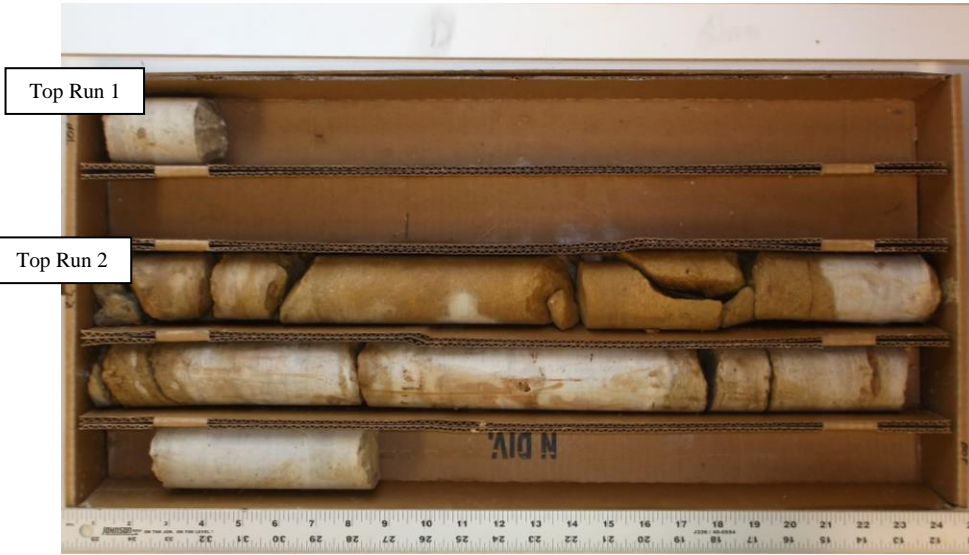
Boring B-1

<u>Run No.</u>	<u>Depth (ft)</u>	<u>Recovery (%)</u>	<u>RQD (%)</u>
1	9.75 – 10.0	100	100
2	10.0 – 15.0	88	72

Probes P-3 and P-4 were drilled using an ATV-mounted CME-550 rotary drill rig equipped with a 3-inch diameter polycrystalline diamond compact (PDC) bit. Soil and rock samples were not collected and the stratigraphy was determined based on the drill cuttings. Borings B-1 and -2 were drilled using an ATV-mounted Diedrich D-50 rotary drill rig equipped with 3 3/4-inch inside diameter hollow-stem augers. Standard penetration tests (SPTs) were performed using an automatic hammer. Split-spoon samples were obtained at the depths indicated on the boring logs presented in Appendix B. Explanations of the terms and symbols used on the boring logs are also included in Appendix B. The borings were extended into bedrock using double-tube NQ wireline methods. The rock cores were placed in cardboard boxes and transported to our laboratory. Photographs of the rock core are presented in Appendix C.

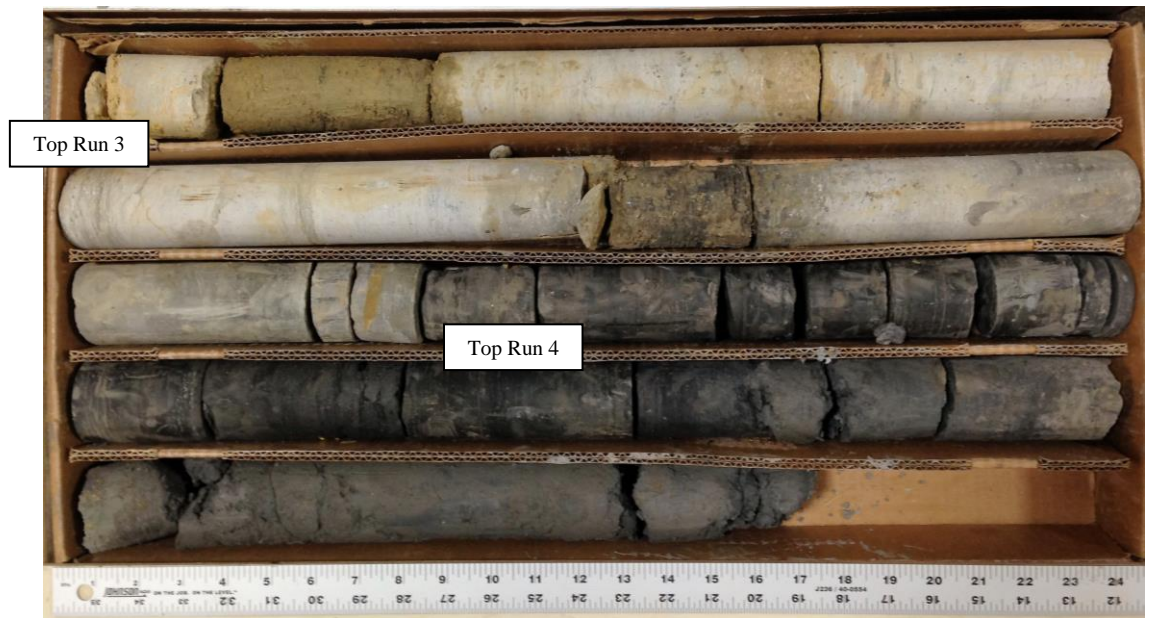
<u>Run No.</u>	<u>Depth (ft)</u>	<u>Recovery (%)</u>	<u>RQD (%)</u>
3	15.0 – 20.0	95	84
4	20.0 – 25.0	97	62

<u>Run No.</u>	<u>Depth (ft)</u>	<u>Recovery (%)</u>	<u>RQD (%)</u>
5	25.0 – 30.0	93	65
6	30.0 – 33.0	100	97

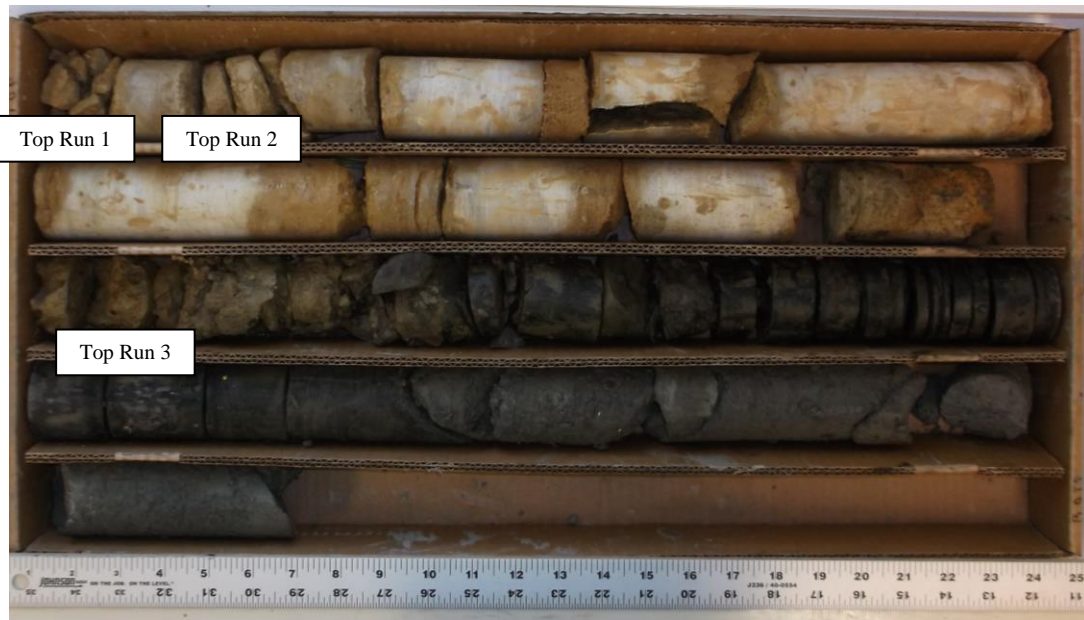
Boring B-2

<u>Run No.</u>	<u>Depth (ft)</u>	<u>Recovery (%)</u>	<u>RQD (%)</u>
1	10.0 – 10.5	83	0
2	10.5 – 15.5	68	57
3	15.5 – 20.5	85	20

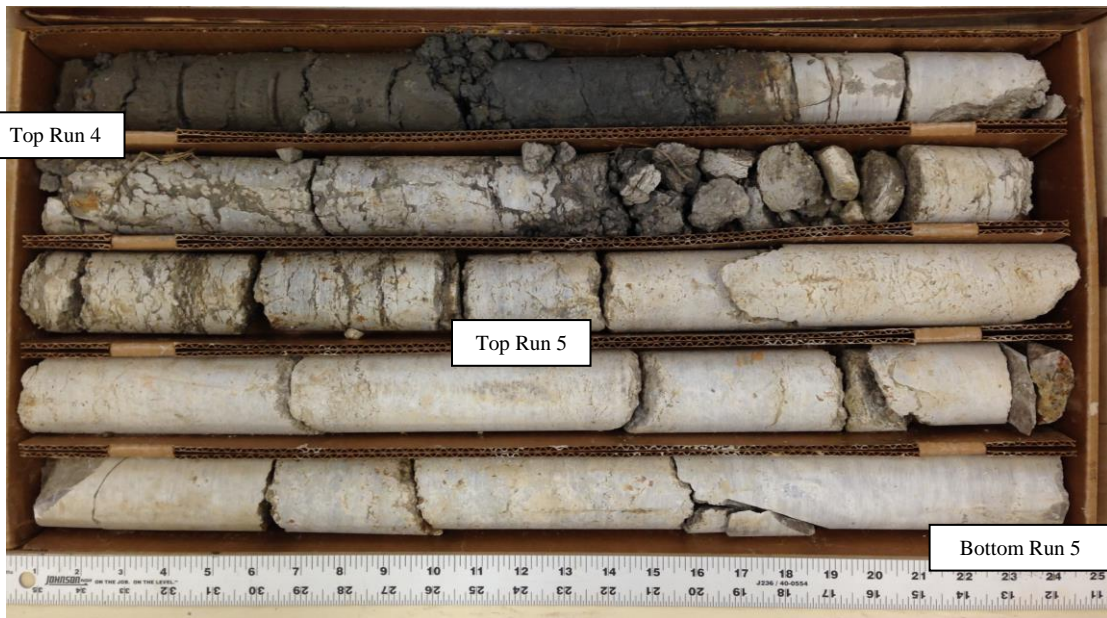
Boring B-2

<u>Run No.</u>	<u>Depth (ft)</u>	<u>Recovery (%)</u>	<u>RQD (%)</u>
4	20.5 – 25.5	100	62
5	25.5 – 30.5	100	97
