LEE'S SUMMIT FIRE STATION 1

FEASIBILITY STUDY

Lee's Summit, MO

May 2024

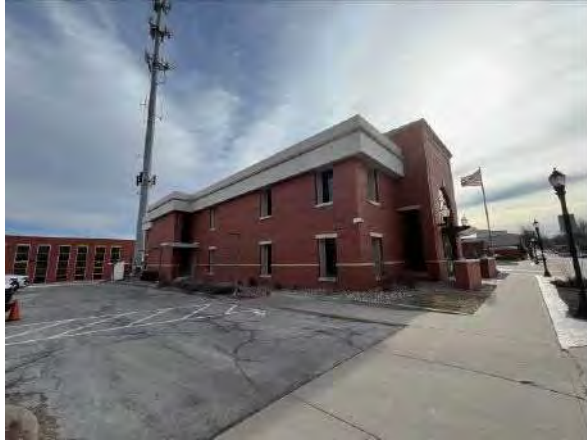
Photo #1 Facing E: Overview of site from W corner

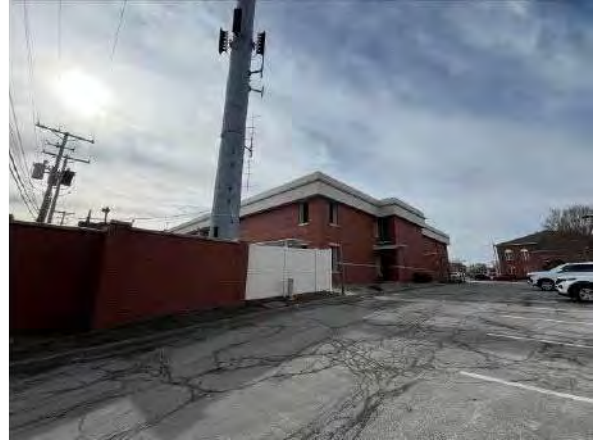
Photo #2 Facing S: Overview of site from N corner
